2019 Long Shoreline Survey- 180 Parcels

Pearl Lake Survey—92 Parcels

Munson Lake Survey— 93 Parcels

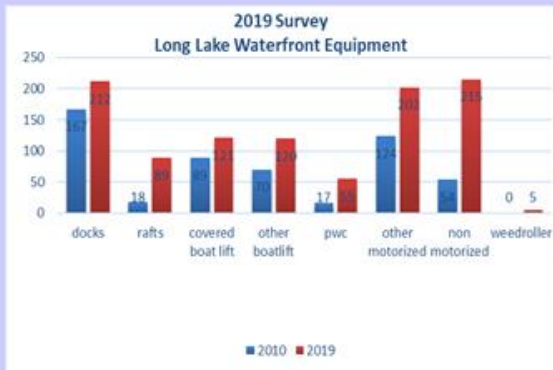
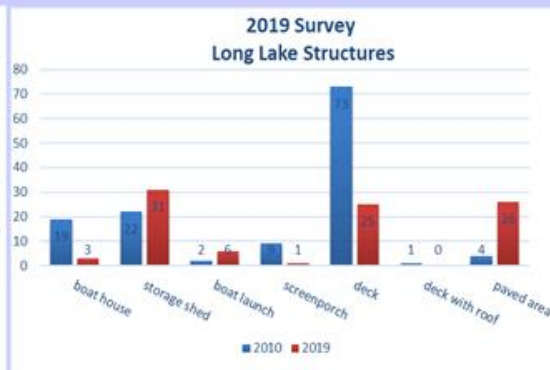
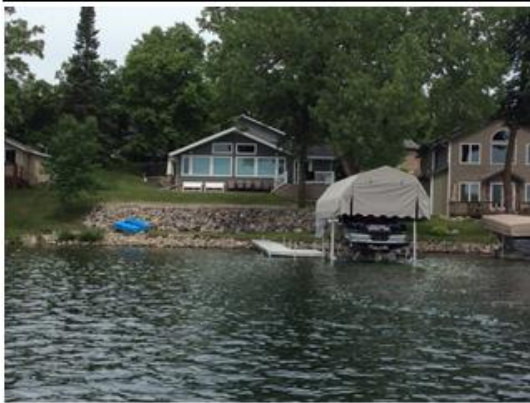
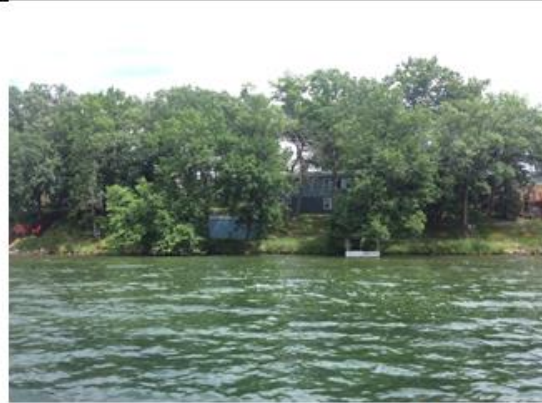
Long's shoreline is 6% natural, 7% minimally altered, 19% moderately altered, and 68% greatly altered. Greatly altered shoreline increased by 230% from the 2010 survey mostly due to removal of natural trees, shrubs, and vegetation and replacing with lawns, sand blankets, and rip-rap. Waterfront equipment changes over that past decade include increases in docks, rafts, lifts, but the most notable were the increases in personal watercraft, kayaks, and boats. Waterfront structures saw a marked decrease in the number of boat houses, decks, however there was an increase in storage sheds, stairways and paved landing areas.

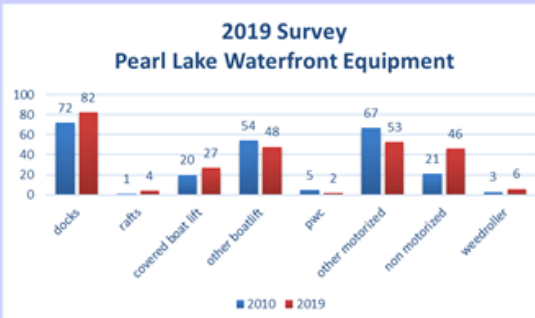
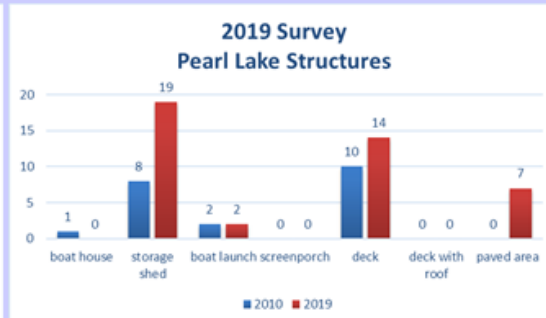
Pearl Lake is a relatively small lake on the Western peripheral of the District. Since the last survey in 2010, development has increased. The number of greatly modified lots has increased by 54% while the number of natural lots has decreased by 5%. That being said, Pearl lake still retains 35% of its lots as minimally modified. The Lake also experienced an increase in non-motorized watercraft and a decrease in motorized watercraft, signifying more low-impact recreation such as paddleboards and kayaks. A total of 11 lots have added storage shed since 2010, and 3 new docks have been added.

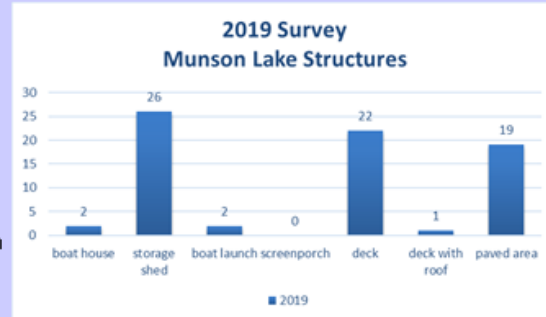
Munson has been highly developed, with 53% of sites being "greatly modified". Like other District lakes, development on Munson has increased greatly. Development has focused on the Northern part of the lake, with some on the isthmus between Munson and Sallie. A large natural area has been left undeveloped on the West side of the lake due to a large wetland located there.
