Campbell Creek Geomorphology Assessment

Jason Vinje & Lori Clark
MN DNR Clean Water Specialists

Campbell Creek Background

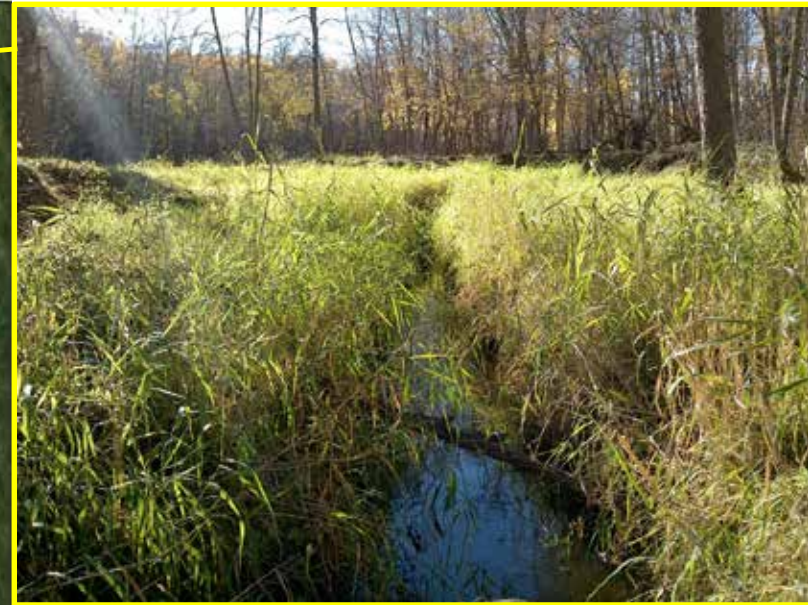
Downstream view from start of longitudinal profile. Some incision but areas with floodplain access at bankfull.

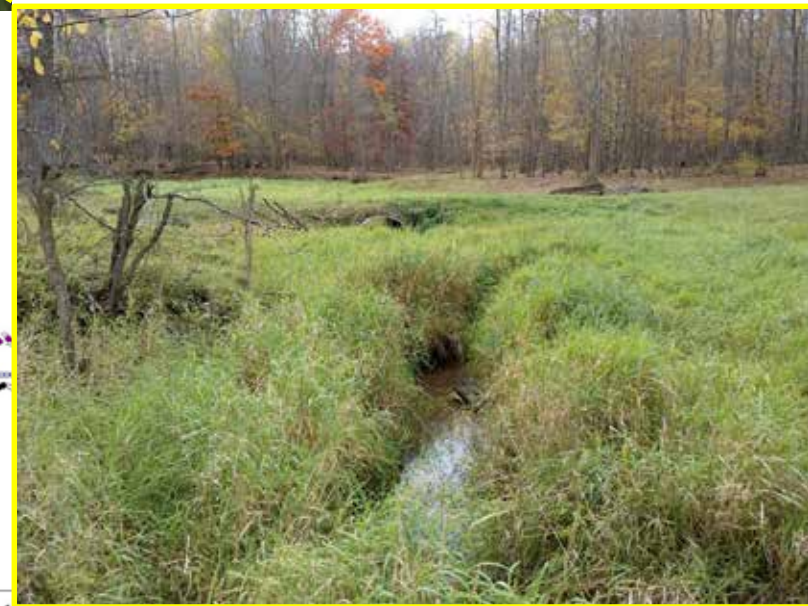
Downstream view from just upstream of culvert crossing. Good floodplain access at bankfull

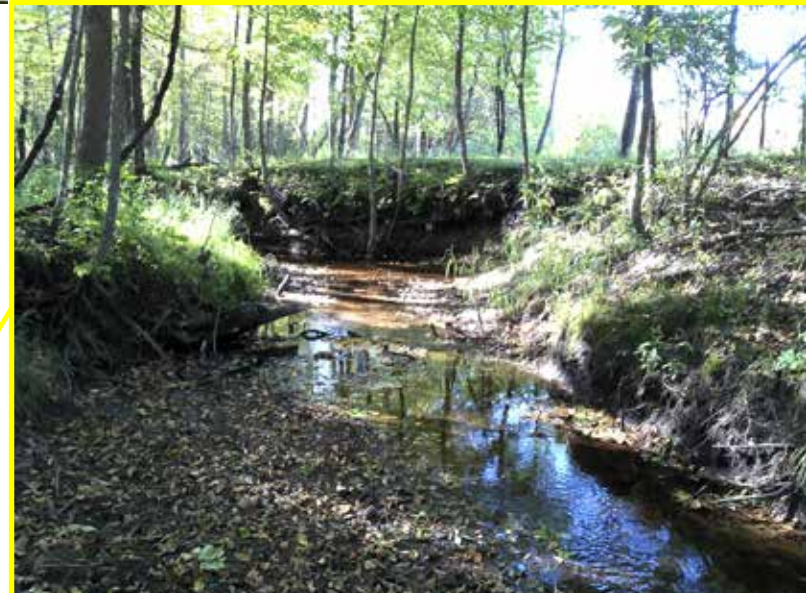
Downstream view within incised and moderately entrenched section of reach, just upstream of pool 32+12. Historically, a wide floodplain was accessible here.

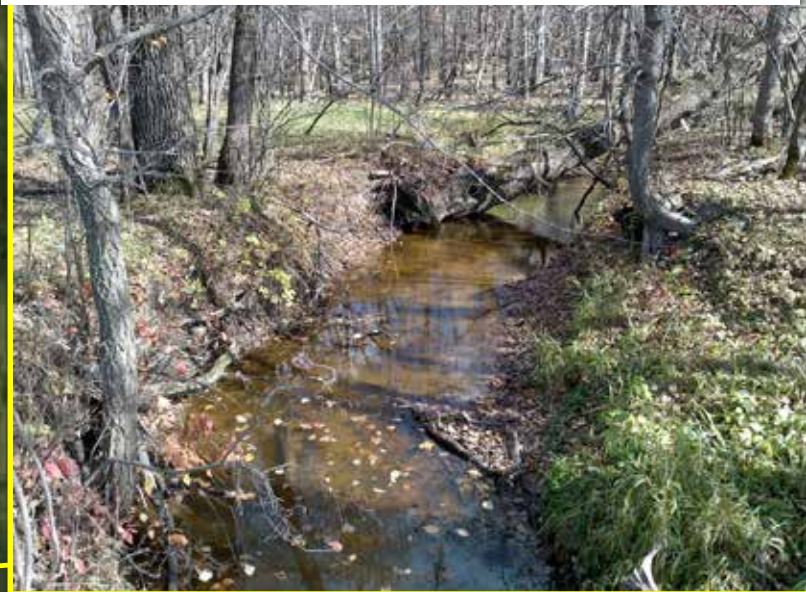
Upstream view within incised and moderately entrenched section of reach, just upstream of CR 149 crossing. Historically, a wide floodplain was accessible here.

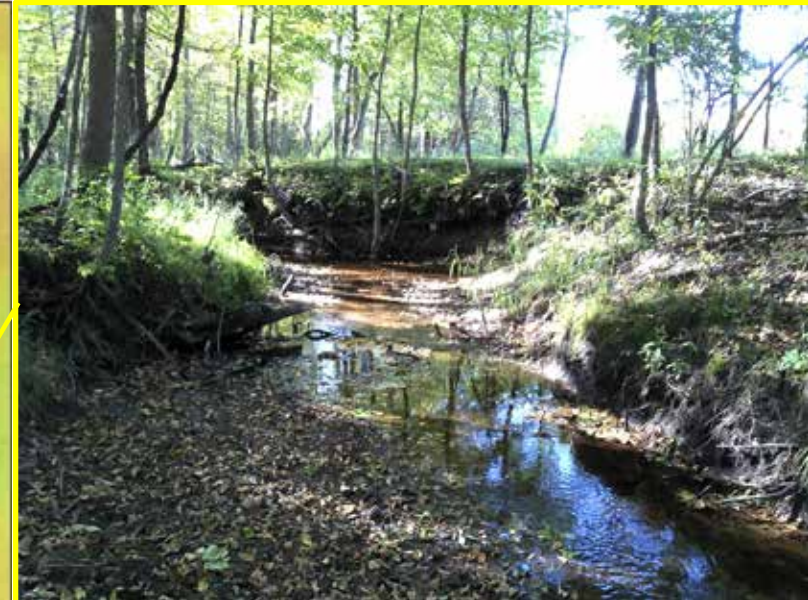
Downstream view within incised and moderately entrenched section of reach, just upstream of pool 32+12. Historically, a wide floodplain was accessible here.

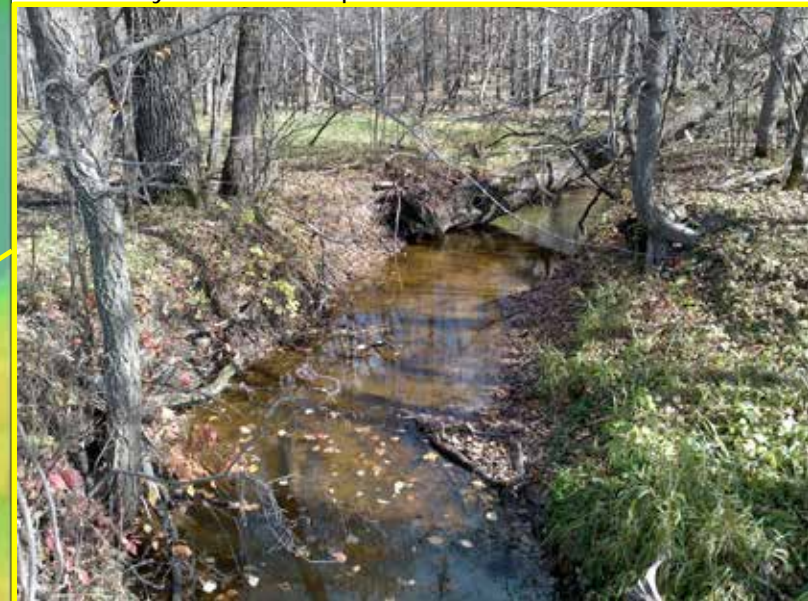
Upstream view within incised and moderately entrenched section of reach, just upstream of CR 149 crossing. Historically, a wide floodplain was accessible here.

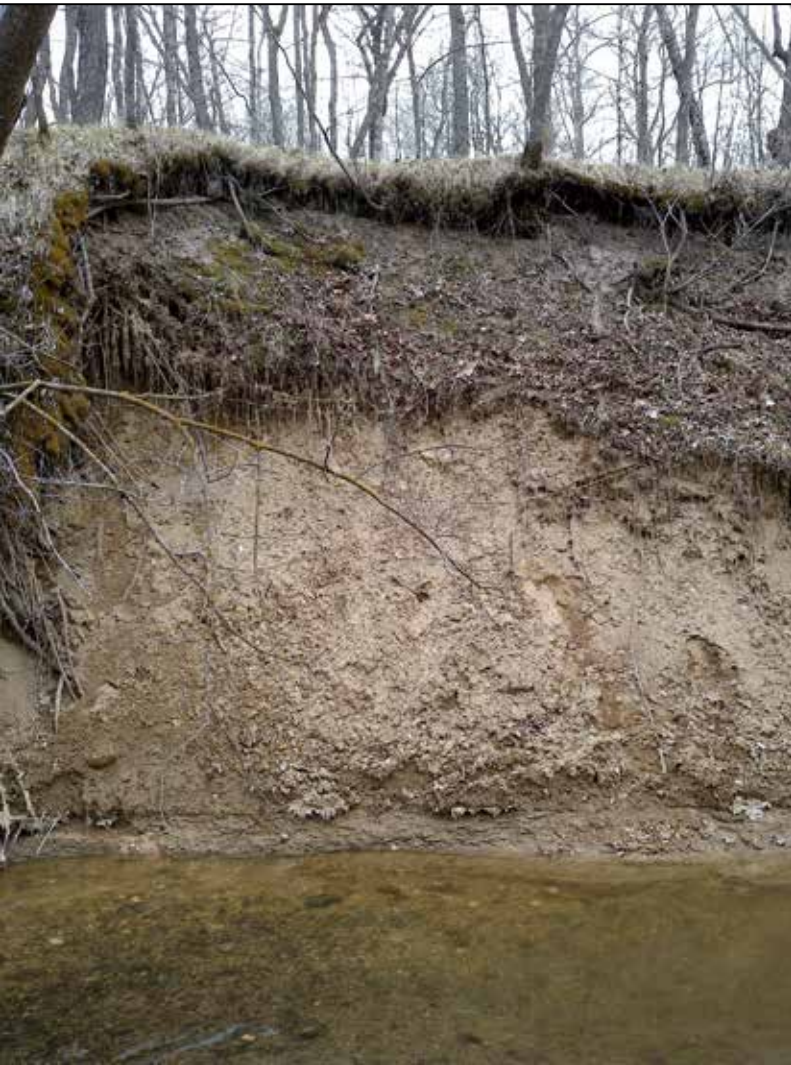
Monumented cut-bank cross-section

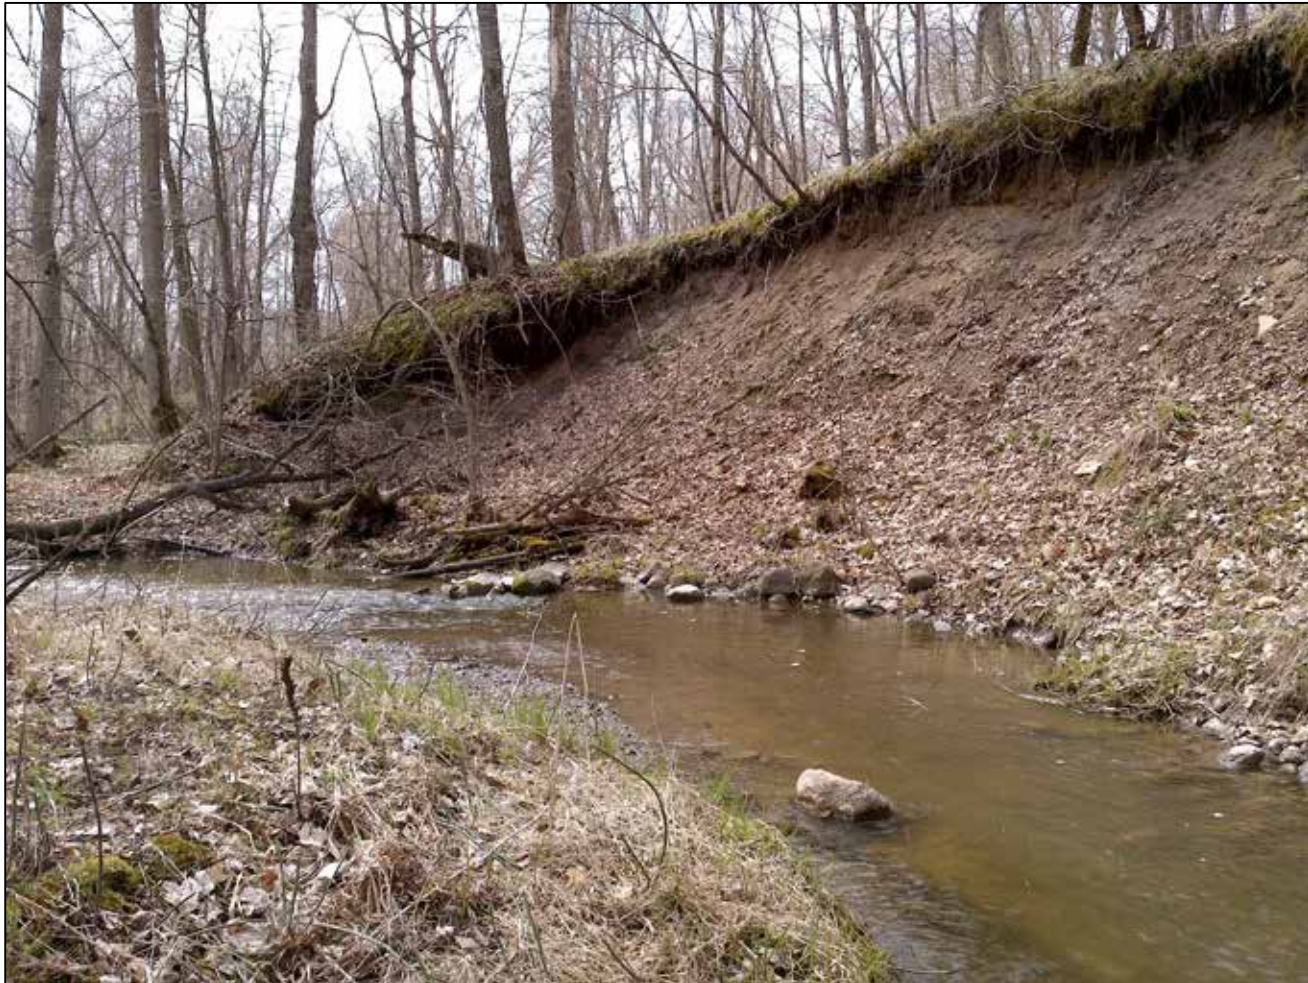
Bench forming at base of bank

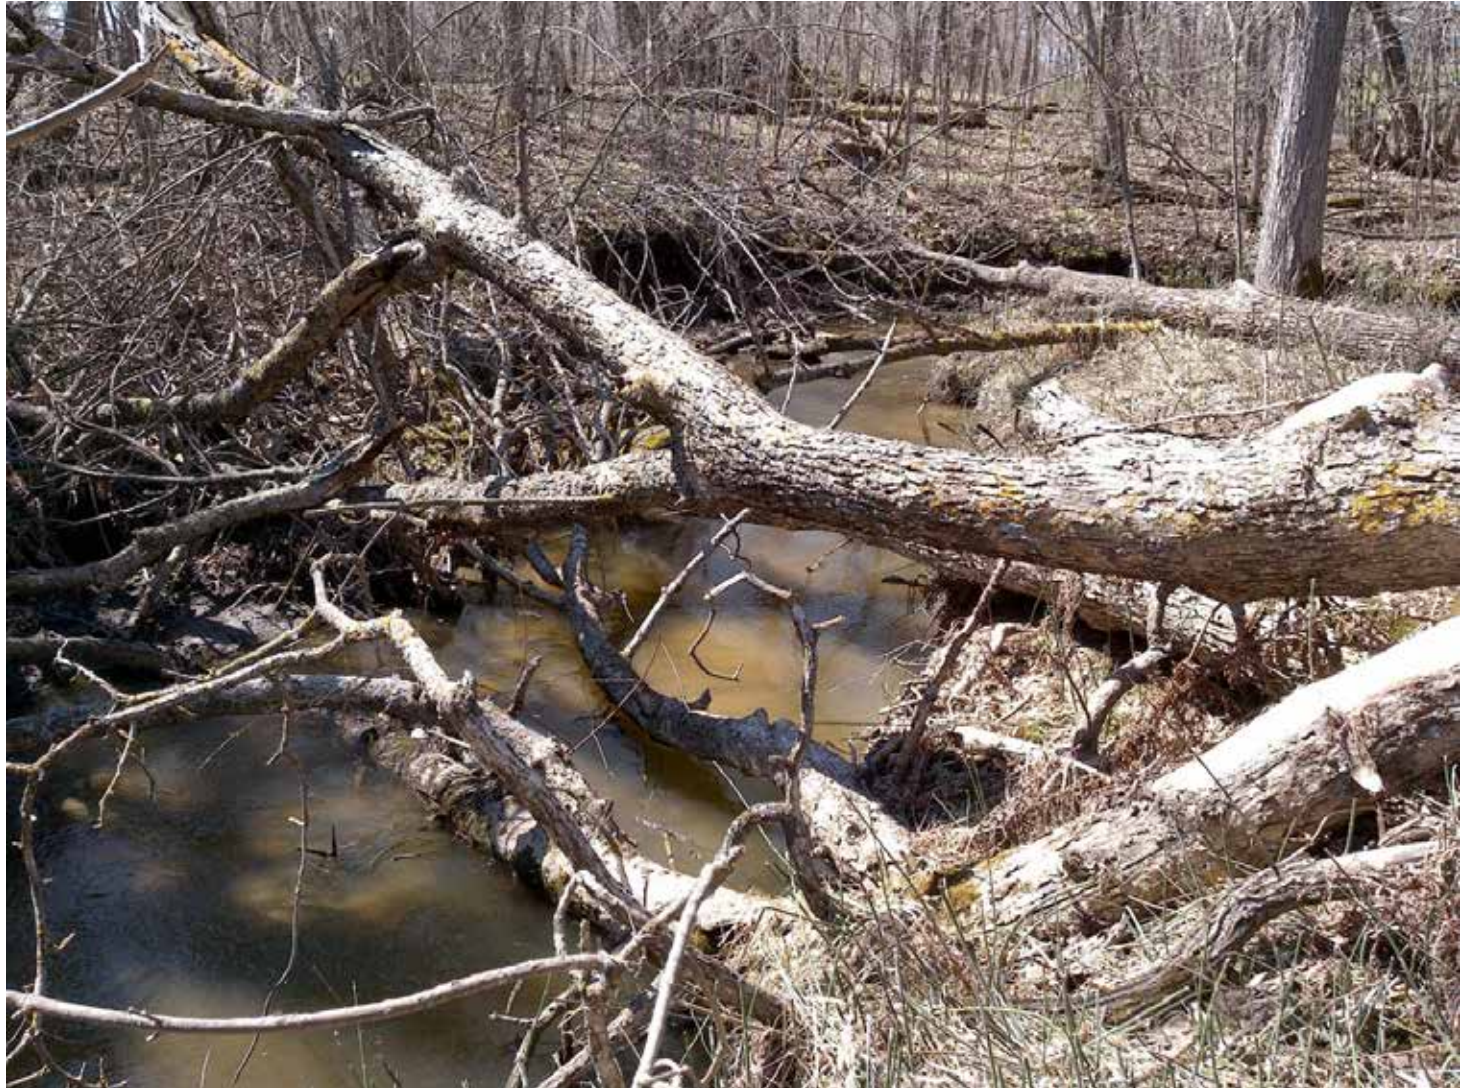
Debris jam example

- Where incised, raise stream bed elevation using rock riffle grade control structures
- Remove log/debris jams where causing bed/bank scour or deposition (woody debris is natural and beneficial)
- Encourage growth of deep rooted vegetation in upstream meadow area (does not need to be woody)
- Manage grazing to address bank trampling and overgrazing of riparian vegetation
- Monitor high cut-banks
 - Could pursue installing toe wood sod mats where flood plain is accessible on opposite bank (access might be an issue in some locations)

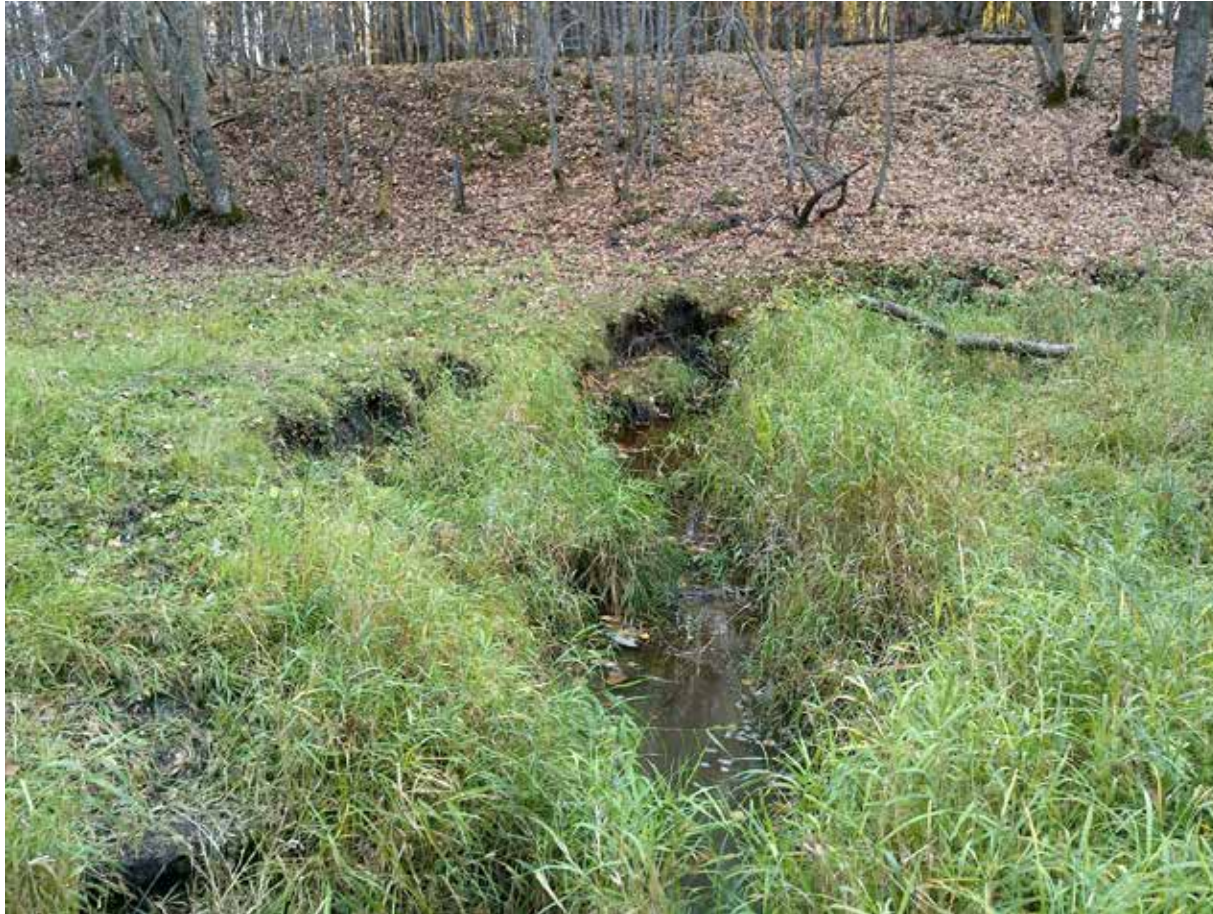
Bank cutting and slumping (vegetation example)

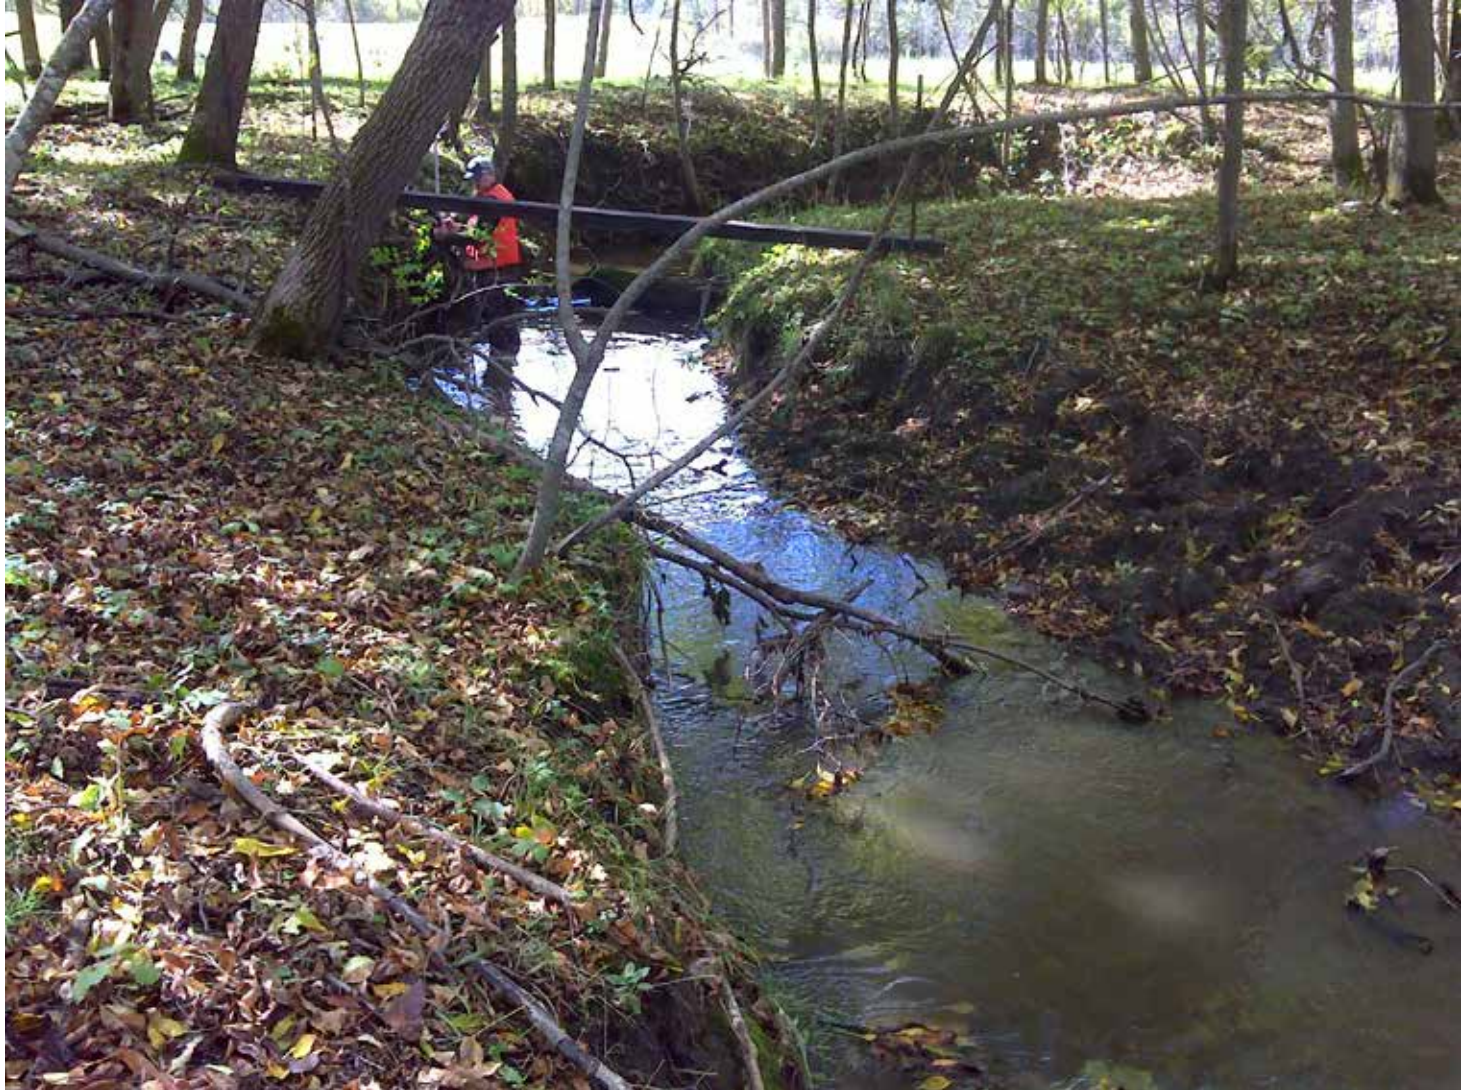
Bank trampling example
