# Upper Pelican River Subwatershed (HUC10 – 0902010307)

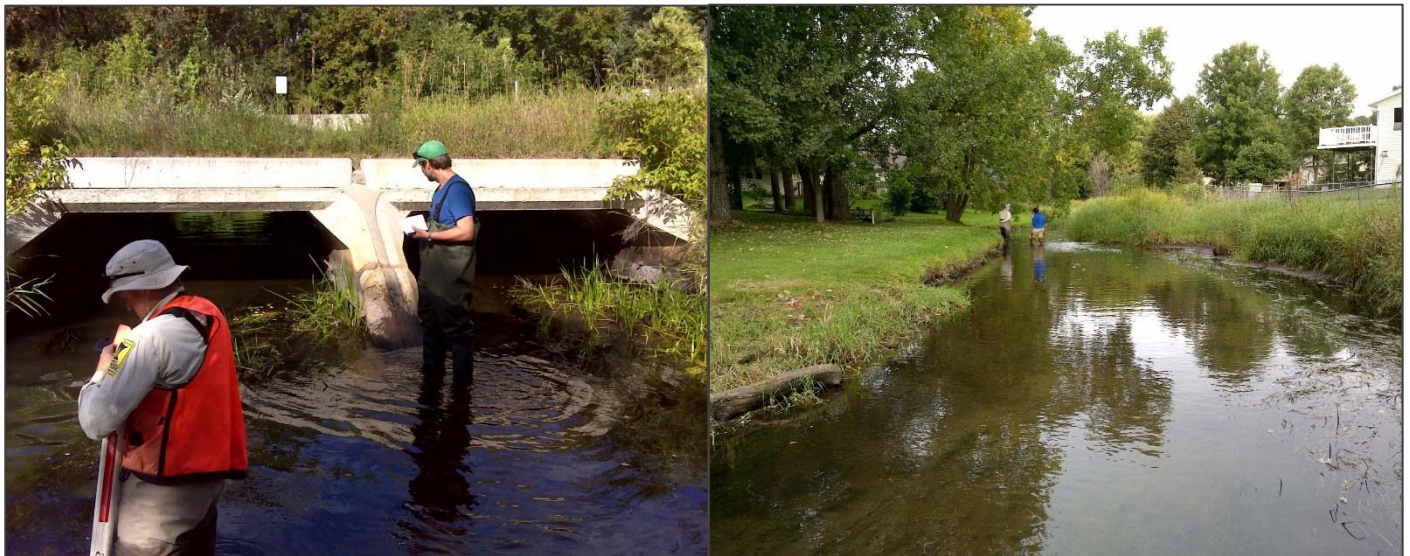
Bank erosion on the Pelican River was estimated between US Hwy 10 and Big Detroit Lake, in Detroit Lakes. In general, the stream banks were in good condition. Compared to the other nine bank erosion study reaches, this reach had the lowest rate (per foot) of estimated erosion (Figure 12). The Pelican River had frequent access to its adjacent floodplain and the bank height ratio was predominantly 1.0 (actual bank height compared to bankfull height). The riparian vegetation was predominantly perennial grasses, both manicured and more natural compositions. In several areas, trees, shrubs, and herbaceous plants provided shade and bank stability. Spotted touch-me-not (*Impatiens capensis*) was frequently observed along the water's edge.

Riffles with packed gravel were present within this study reach; however, in many areas, riffles were embedded with finer substrates (sand). Both road crossings at North Shore Drive and Lori Ave. consisted of two 10-ft. cement box culverts. Both crossings had significant deposition within the culverts (Figure 15). The alignment at the Lori Avenue crossing may be contributing to the accumulation of sediment with the tight bend immediately downstream. The bankfull width was estimated to be around 18 feet wide.

Figure 15. Pelican River between US Hwy 10 and Big Detroit Lake. Photos taken on 9/7/2018.

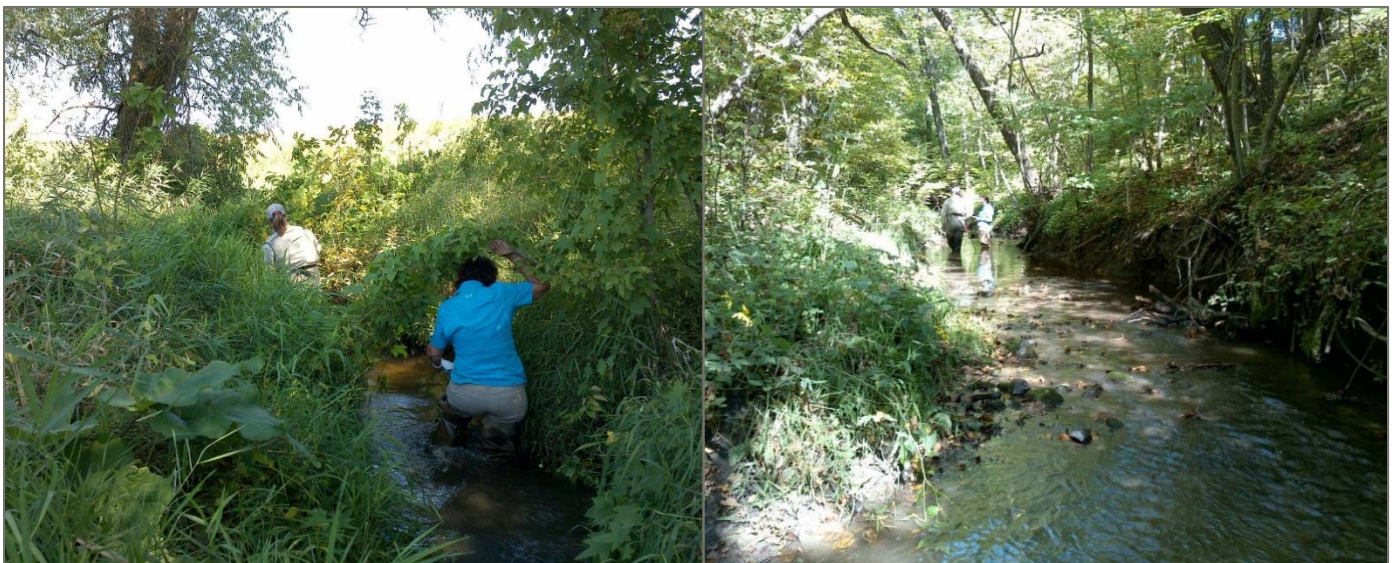
Bank erosion was assessed along two segments of Campbell Creek, totaling 1.9 miles. On 9/5/2018 bank erosion was assessed between 230<sup>th</sup> St. and CR 149. Through this reach several different stream types and riparian vegetation compositions were observed. Near 230<sup>th</sup> St. the channel had been straightened and spoil piles were adjacent to the channel. The channel and floodplain were narrow between these spoil piles (Figure 17). Moving downstream the riparian vegetation changed from herbaceous cover with sporadic tree canopy to forested cover. The channel widened out, and for the most part, a depositional flat was observed near the estimated bankfull elevation. Though the floodplain was wider, the channel still did bump against the valley walls in a few locations, creating high cut banks. Downed wood was also often directing flow into the valley walls; however, the opposite banks had access to a floodplain, which would help reduce velocities during flood events. The majority of these high banks appeared to be relatively stable.

Figure 17. Campbell Creek from 230<sup>th</sup> St to CR 149. Photos taken on 9/5/2018.

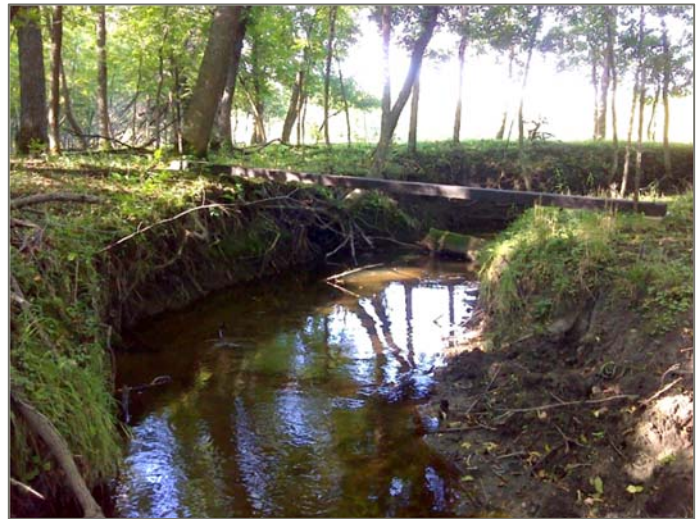
Riffles consisted of packed gravel and a few sporadic cobble-sized particles. Sand and finer particles were also observed in the channel. Moving towards CR 149, the channel did not have access to its floodplain and it was incised (Figure 18). Higher rates of erosion were measured through the lower end of the study reach. Some areas of the riparian zone were pastured. The cattle access points to the channel were accelerating bank erosion as well. Fine substrate deposition was occurring on the channel bed upstream of CR 149.

Figure 18. Campbell Creek upstream of CR 149. Photo taken on 9/5/2018.

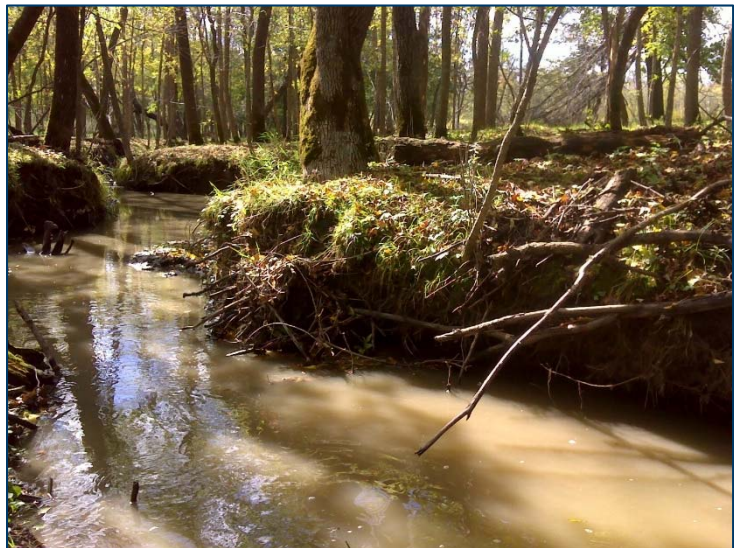
The Rosgen stream type at this location was an E5 with a narrow width-to-depth ratio (7.7) and a sand bed ( $D_{50} = 2$  mm). A Pfankuch stability assessment and detailed channel survey were completed on 9/21/2018. The Pfankuch stability rating was *poor* (unstable). The channel did not have access to its floodplain during minor flood events (incised). Due to this incision, the banks above bankfull elevation were steep and some mass wasting was evident (Figure 19). Cutting on the lower banks was present. The channel bed was inundated with fine particles on top of gravel substrate.

Figure 19. Campbell Creek. Photo taken on 9/21/2018.

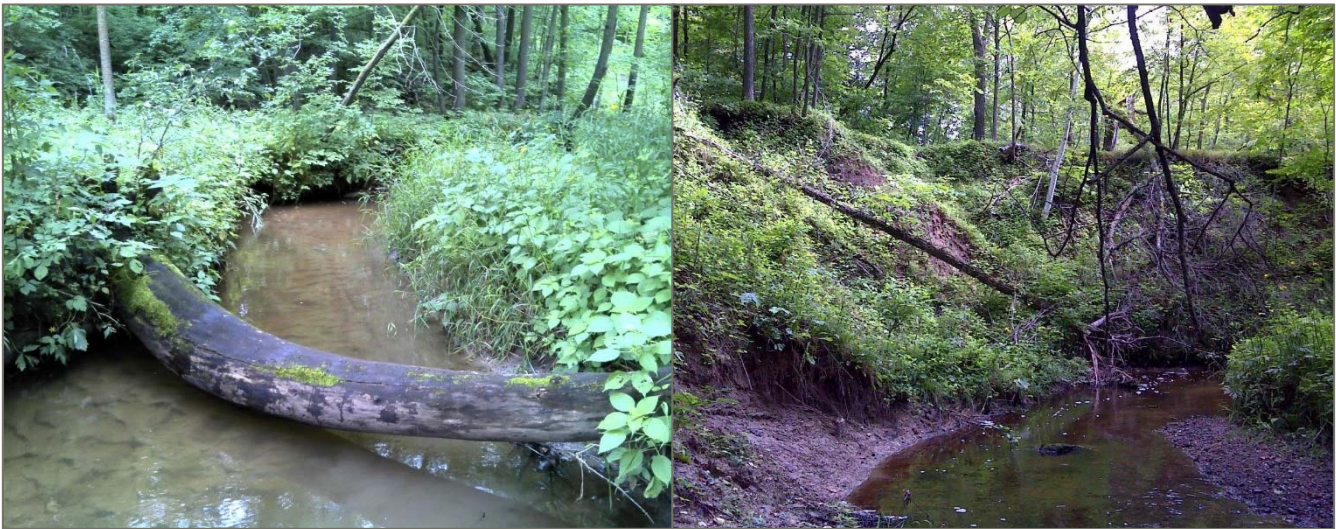
On 8/1/18, bank erosion was assessed downstream of CR 149 to Mud Lake. The substrate fluctuated between sand and packed gravels. Through some of the depositional areas the channel was inundated with fine particles and organic matter. There were several higher banks through this reach (Figure 20). Many of these taller banks were covered in perennial vegetation and had clay present in the soil profile, which can help the bank resist erosion. These high banks could be surveyed and monitored to assess actual erosion rates. Annual photos could also be taken to monitor changes over time.

Figure 20. Campbell Creek downstream of CR 149 to the outlet into Mud/Floyd Lakes. Photos taken on 8/1/2018.
