Campbell Creek Comprehensive Plan

Pelican River Watershed District
Campbell Creek Subwatershed

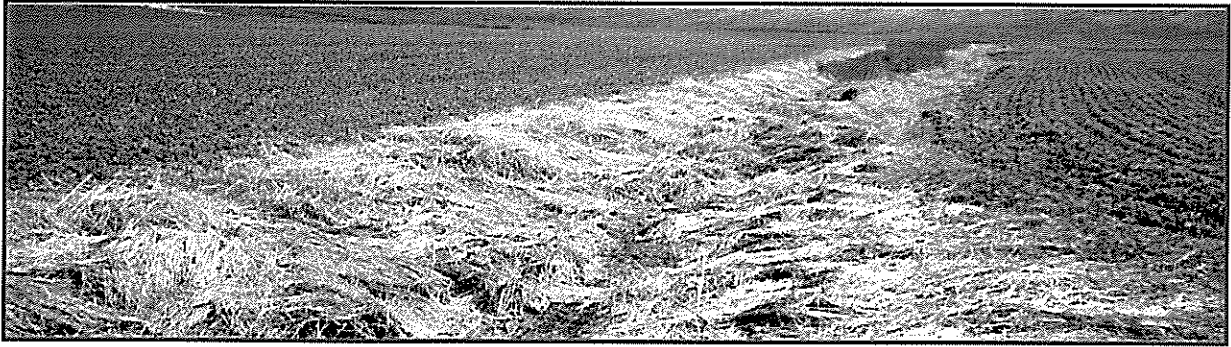
Example of a wetland ditched to convey flows to ditch 11/12

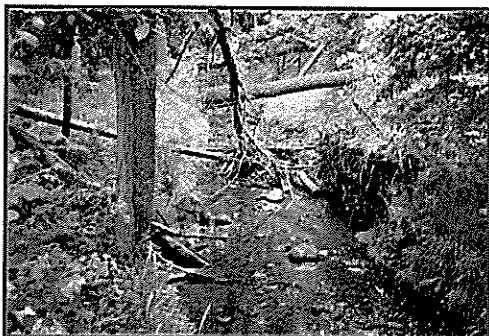
Type 1: Sticks (less than two inches) and grass. Relatively easy to remove with hand labor.

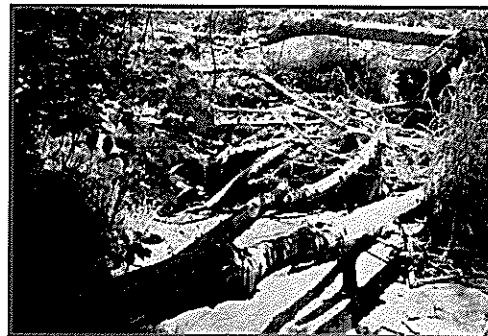
Type 3: Sticks and branches with some tree trunks greater than four inches. Requires more equipment than just hand labor (i.e., winch, chainsaw etc.)

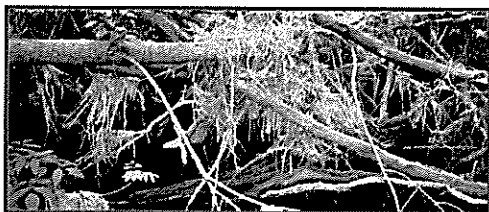
Type 2: Sticks and branches up to four inches. Still relatively easy to remove with hand labor but will likely need equipment such as chainsaw, etc.

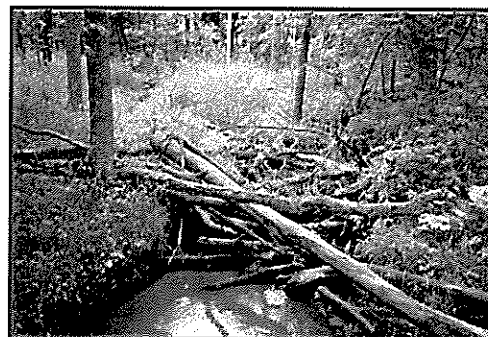
Type 4: Trees and branches greater than four inches. Requires more equipment than Type 3.

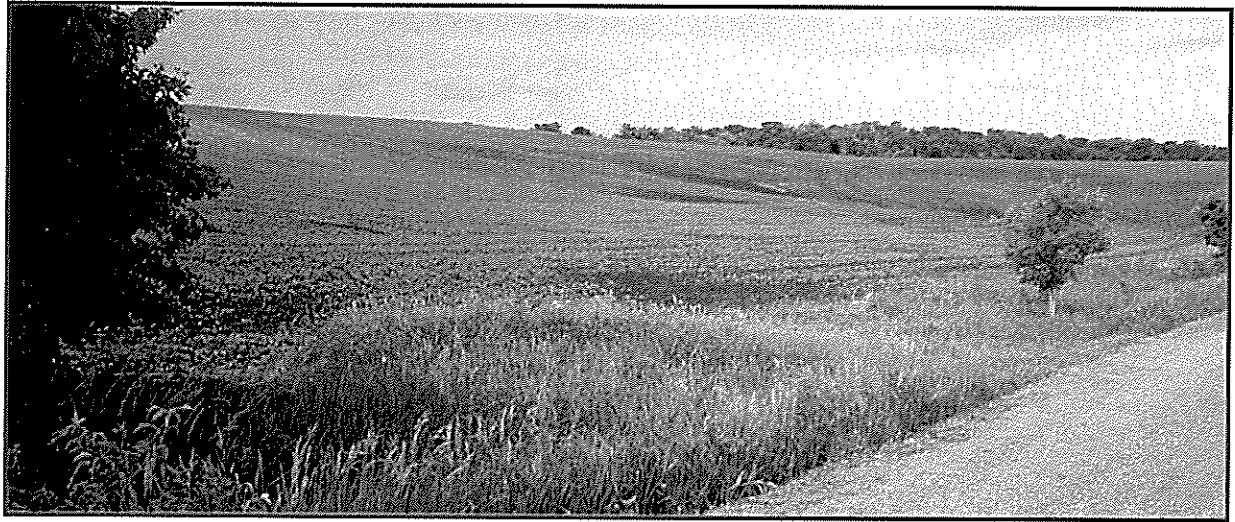
Okeson
Field

One area that could use water quality improvements is a field in section 28, north of CSAH 32, on the east side of the stream (see map 5).

The runoff from this gently sloping field exits at one point and appears to deliver sediment directly to the ditch. A small berm (about 0.5 to 1.0 foot high) coupled with a 15- to 30-foot wide buffer strip would reduce sediment delivery from this field to the stream. This field is located in a sub-basin (number 177 on Map 1) south of Campbell Lake. Since there is little ponding between Campbell Lake and Floyd Lake, land treatment in this area becomes all that more important.

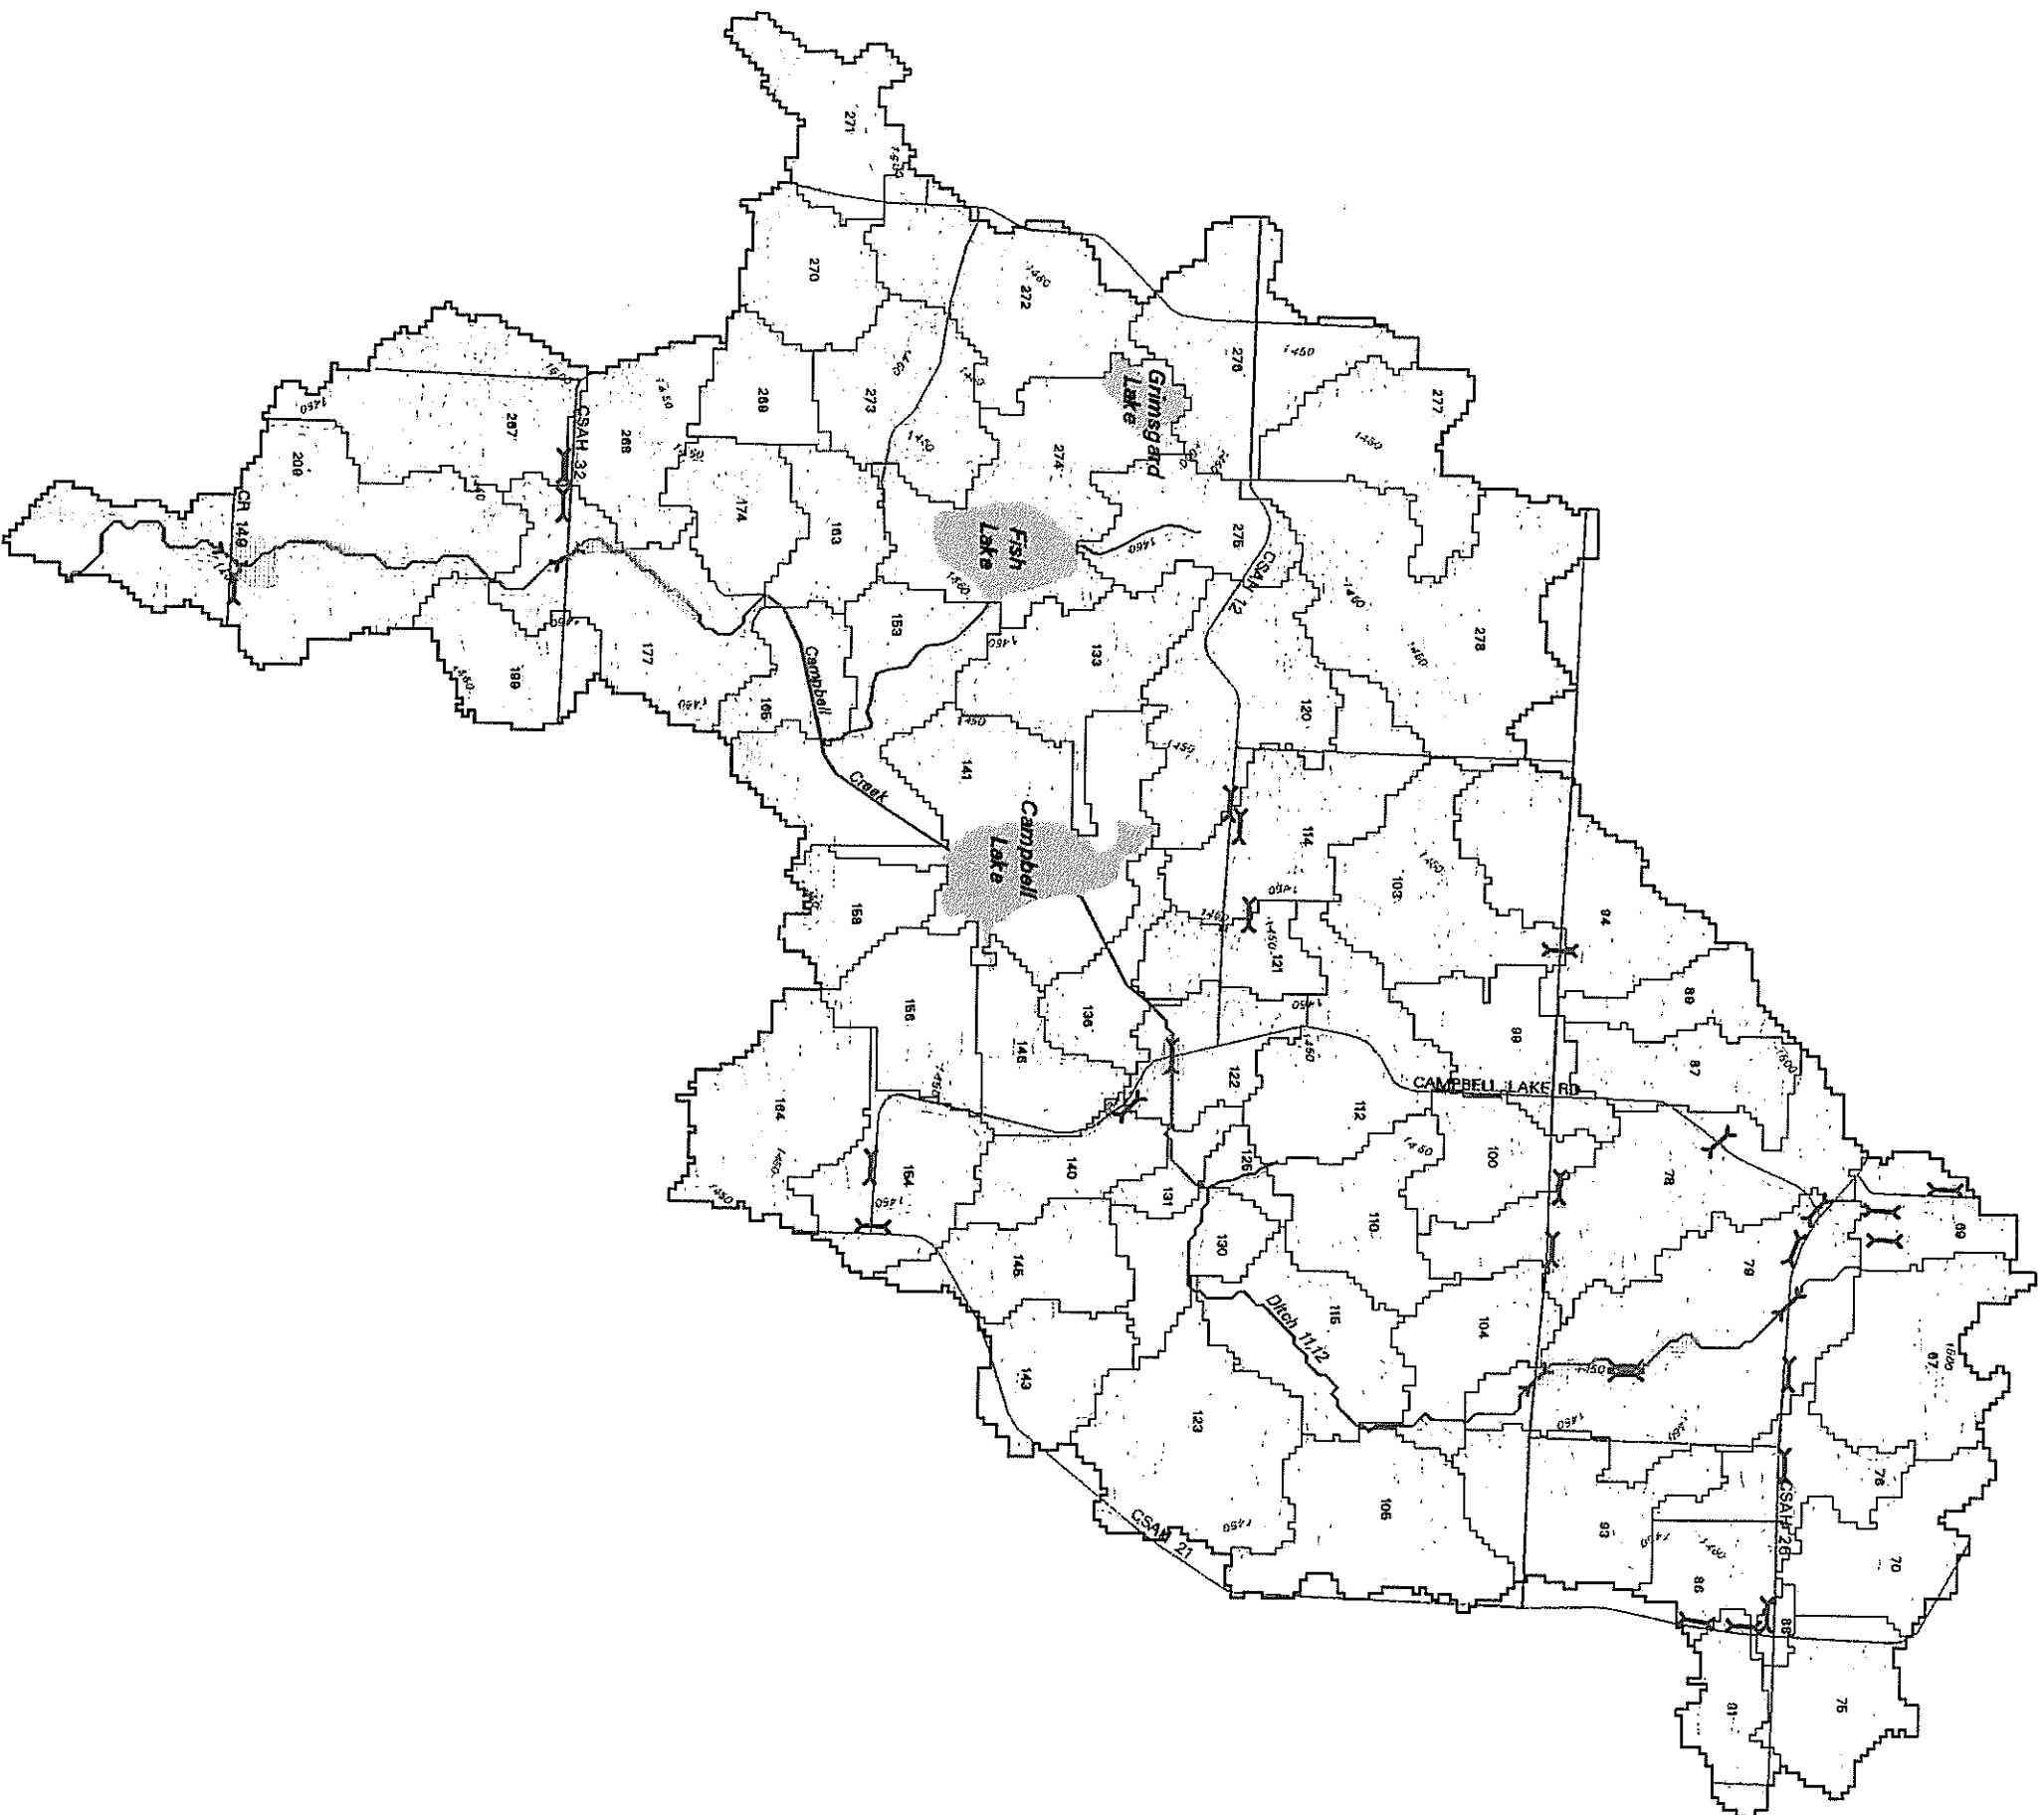
Map 4: Flooded Areas at Culvert Crossings

Hydraulic/hydrologic modeling of the Campbell Creek Subwatershed has shown that, in general, culvert crossings under roadways are not sized for stream flows generated by the runoff from the 100-year event. Culverts under the following roads restrict ditch flow and cause upstream flooding as shown on Map 5:

The areas of inundation, estimated culvert invert elevations, and roadway low points for each flooded area appear in Table 5. Culvert identification numbers come directly from the 1997 culvert inventory performed by the watershed.

This report recommends that a program of regular culvert inspection be implemented and that logs be kept of culverts inspected and each culvert's relative condition.

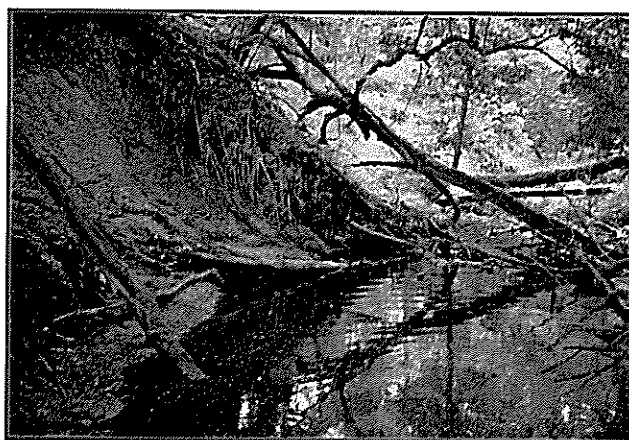
Most of the erosion along the banks of Campbell Creek and Ditch 11/12 is occurring in debris dam locations – both current and historic. Erosion has occurred in these locations primarily due to the debris dams deflecting flows into the banks of the stream. When flows are deflected into the stream bank, the resultant erosion removes vegetation and root structure. Once these are lost, erosion occurs at a much higher rate due to the lack of any structural stability in the soil.

Example of erosion along Campbell Creek downstream of a Debris Dam.

techniques — and the cost of these techniques — would best control erosion along this stretch of stream. It is likely that bioengineering techniques would be most

effective controlling erosion along this stretch of stream. Bioengineering uses live plant parts to reinforce the soil and prevent surface erosion.

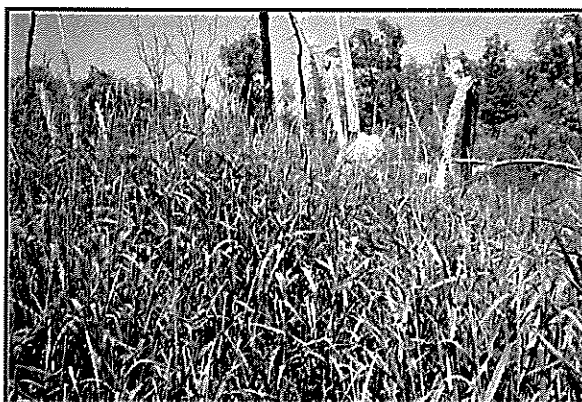
Example of an inactive beaver dam in Section 32.

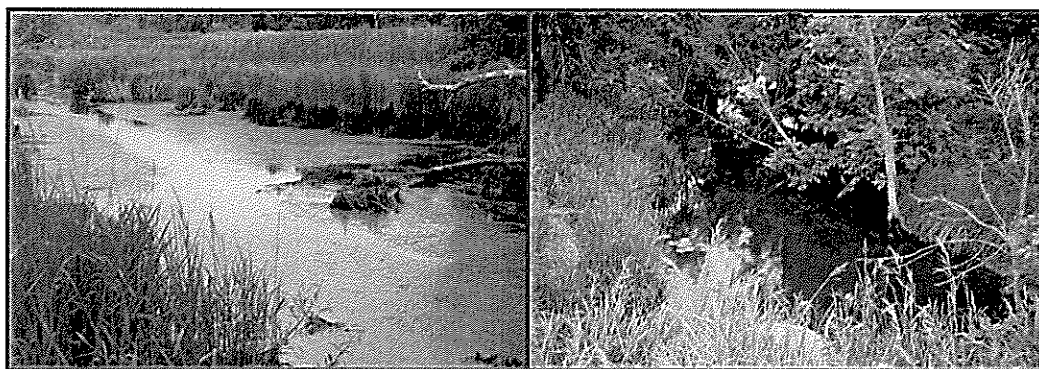
Water levels in the ditch dropped about one foot after dismantling this beaver dam in Section 23.
