PELICAN RIVER

Pearl Lake

Curly-leaf Pondweed Presence in Pearl Lake- 6/21/2018

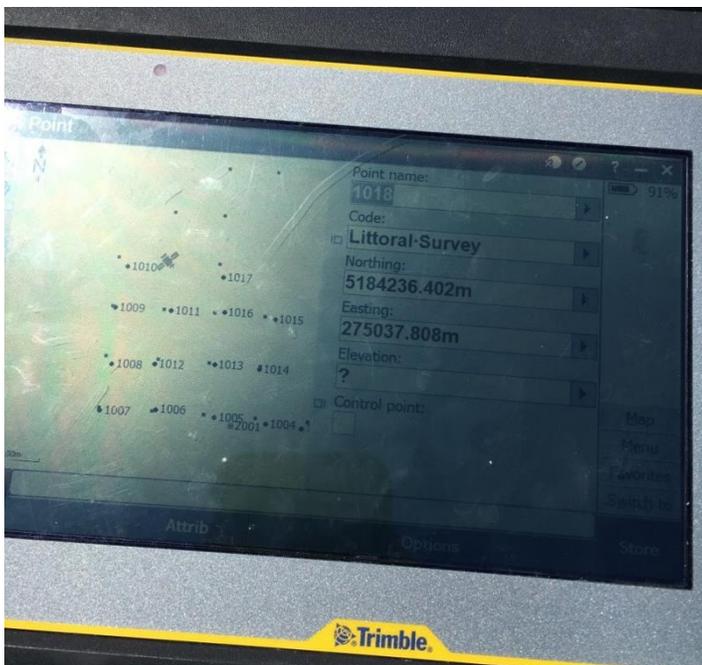
Above: The Trimble tablet used during the survey. The survey points are marked by the number, while the grid-points are unmarked. We indicated the presence of curly leaf by adding the attribute to the survey point.

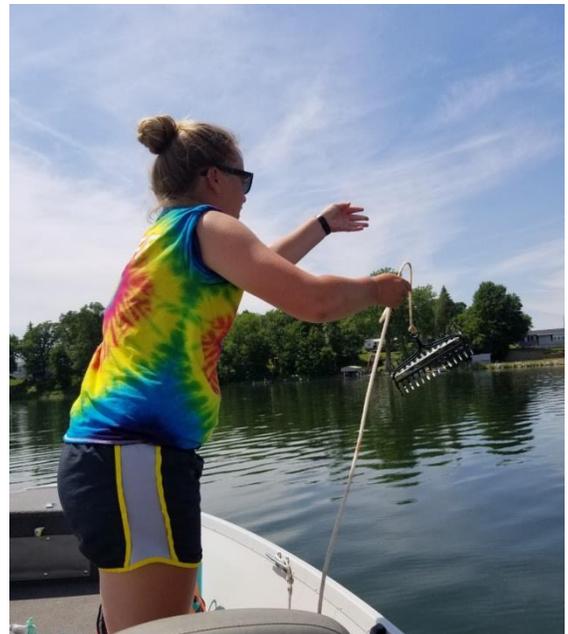
The tool used to survey the aquatic vegetation was a double sided garden rake attached to a rope. It was generally thrown 2-3 yards away from the boat.

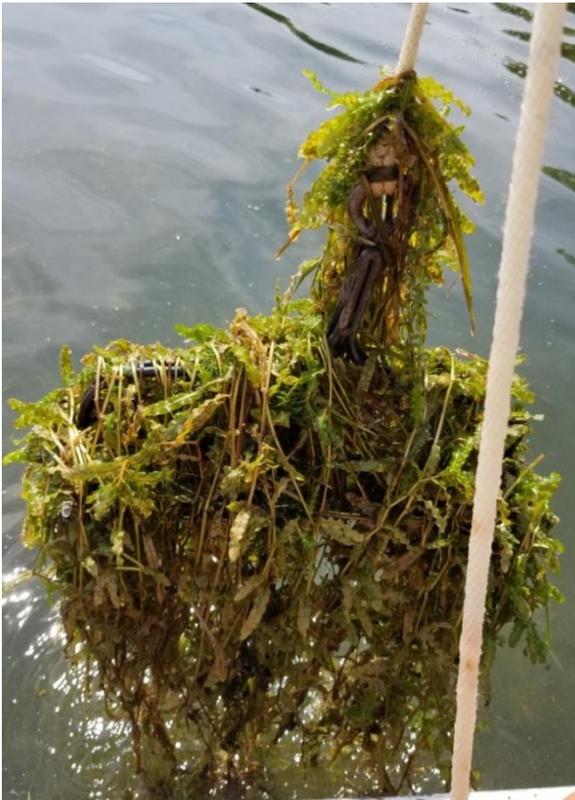
Left: Pictured is a rake from the highly dense stand of CLP. You can see the area outlined in pink on the map below. The rake had little to no native vegetation present.

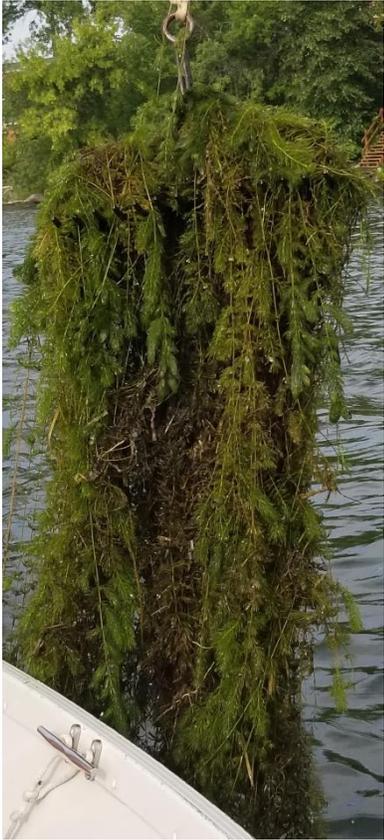
Right: This picture is an example of a rake from a survey point that yielded no CLP. There is a diversity of native species, a list of these species can be found on the next page. This picture shows a high density of coonstail as well as flat-stem pondweed, southern naiad, and northern milfoil.

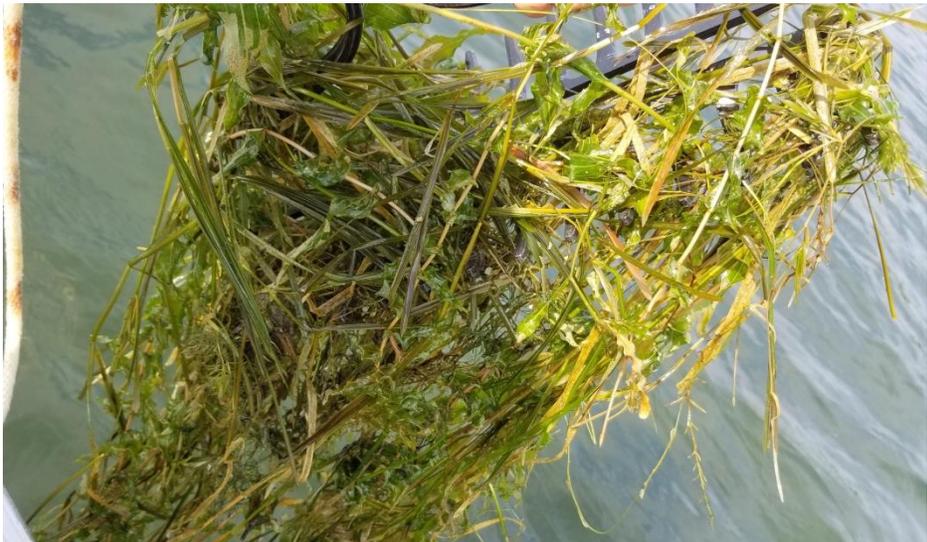
Right: Pictured is a rake that has a presence of CLP along with other native vegetation. This rake only had one sprig of CLP intermixed with other native aquatic vegetation.

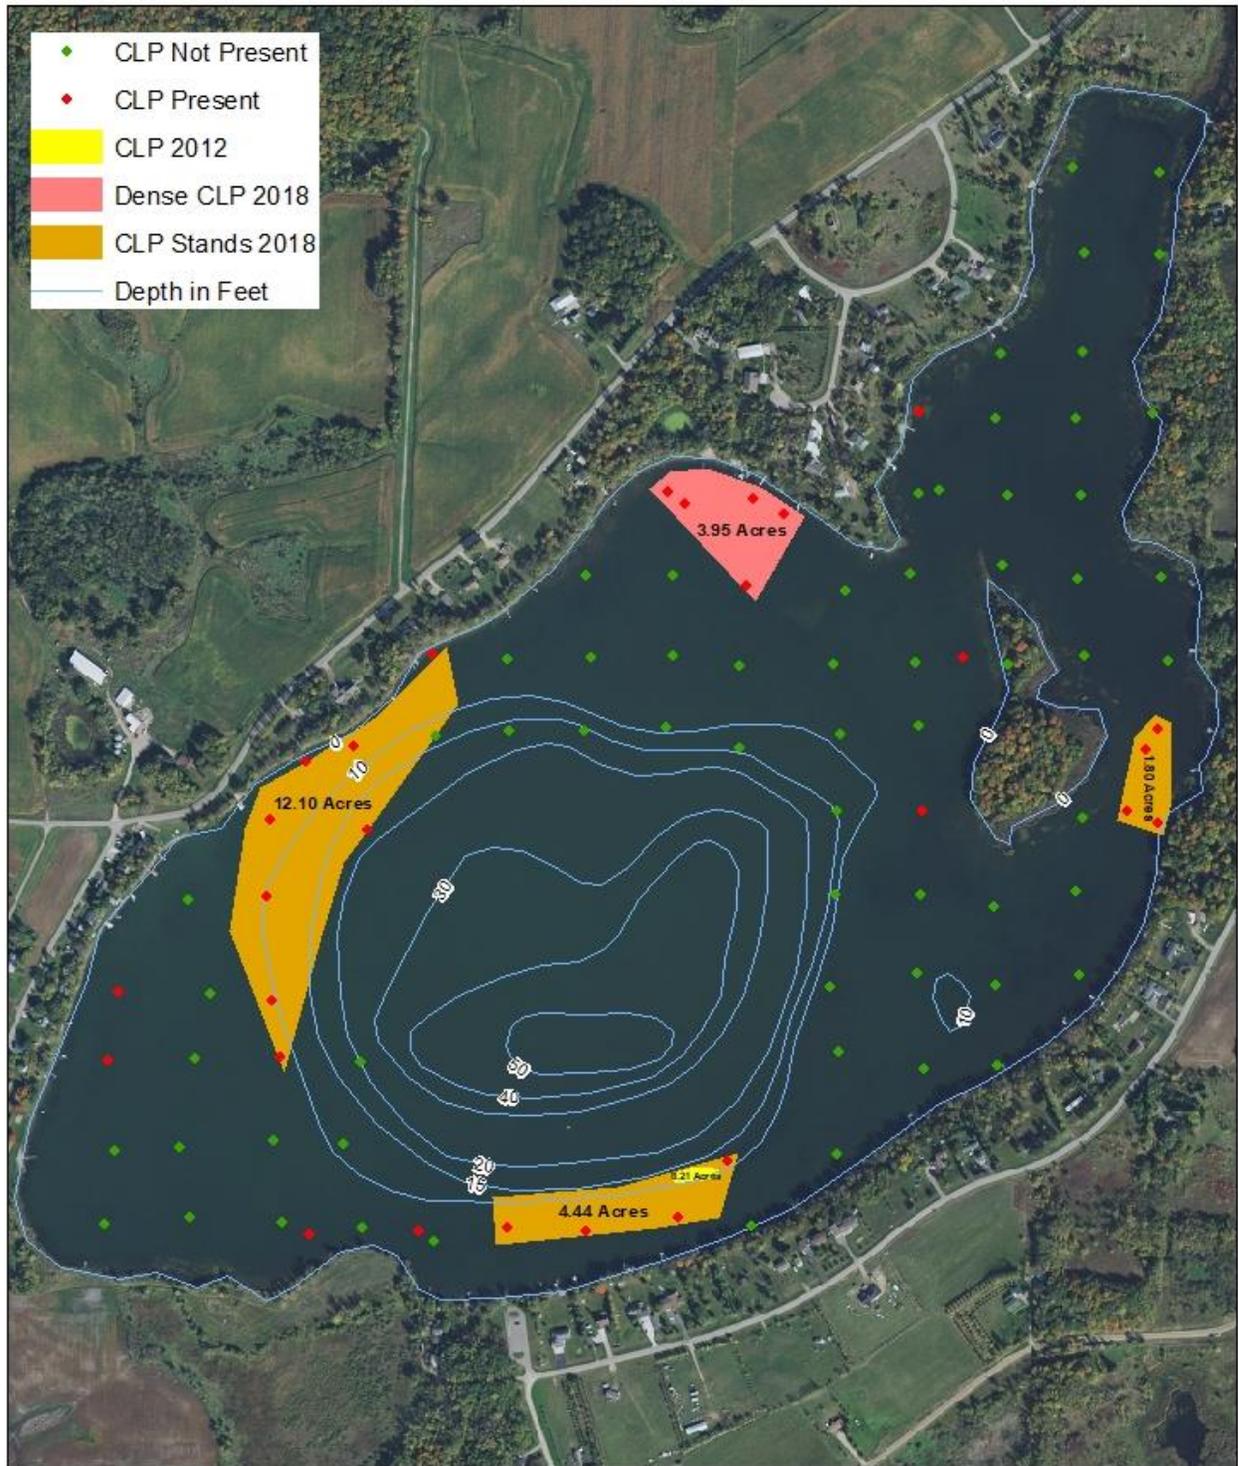
Green survey points showed no presence of CLP

Red survey points indicated CLP was found

The yellow polygon indicates the CLP area surveyed in 2012

CLP stands (shown in Orange) denote other vegetation was found along with CLP

The pink polygon shows where Curly-Leaf was the dominate vegetation present

Blue lines are lake depth in feet

A stand of CLP was determined when four or more survey points near each other had the presence of CLP

The red area is the area with an extremely high density of CLP and the orange areas are where CLP was not the dominant species and appeared sporadically mixed in with native vegetation.

The area of the CLP stand from 2012 was .21 acres, the area of CLP stands in 2018 is 22.29 acres. This means there is now 106 times increase in the amount of CLP stands in Pearl Lake since 2012. CLP has spread around the lake and was found in other locations, but not in a high enough density for PRWD to consider it a stand.

This survey was only indicating the presence or absence of CLP. In a future study we have considered using a scale of 0-4 (Zero meaning no CLP on a rake to 4 meaning the only plant that was found was CLP) to have better information of where a CLP treatment could be most effective.

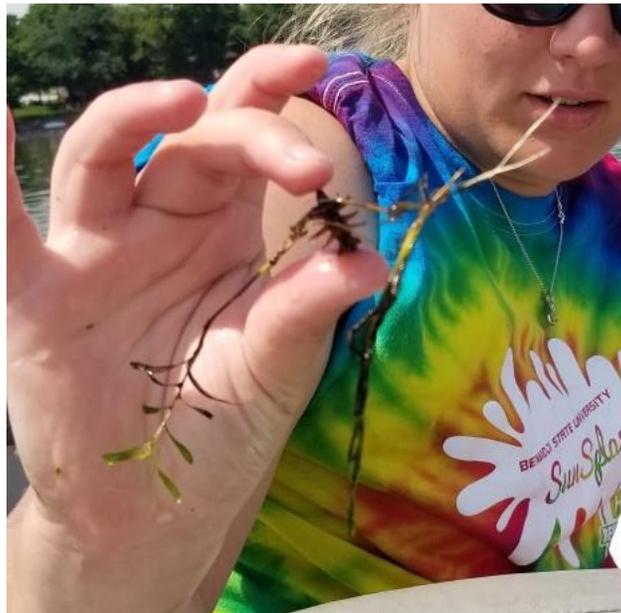
Above is an example of a CLP turion that was collected on Pearl Lake during the survey.
