Pelican River Watershed District
Aquatic Vegetation Survey Report

Munson Lake
Becker County

August 15, 2018

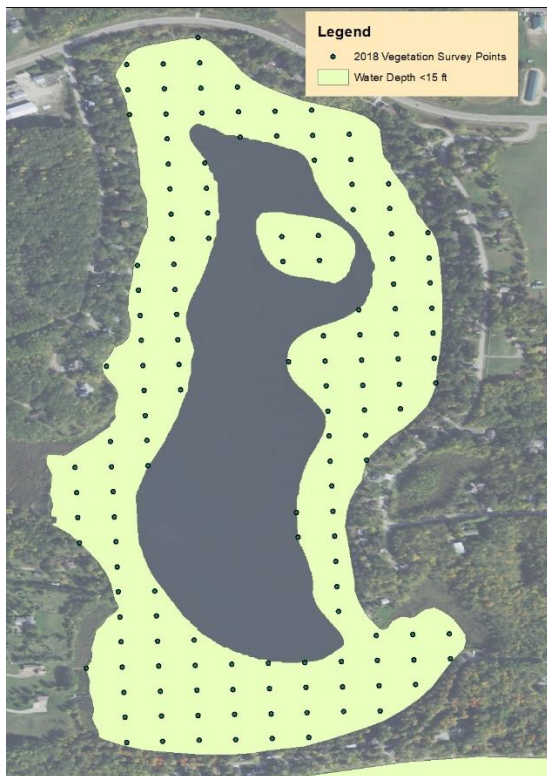
Figure 1. Vegetation point intercept survey point on Munson Lake

Pelican River Watershed District staff, interns Alissa Chalberg and Eli Disse, conducted a survey of aquatic vegetation on August 15, 2018. The point-intercept survey followed the methods described by Madsen (1999). Geographic Information System (GIS) software was used to create grid of points across the littoral zone (≥ 15 ft.) of Munson Lake at 50-meter intervals for a total of 145 survey points (Figure 1). A Global Positioning System (GPS) was used to navigate to each point where the water depth was recorded at 1-foot increments using an electronic depth finder.

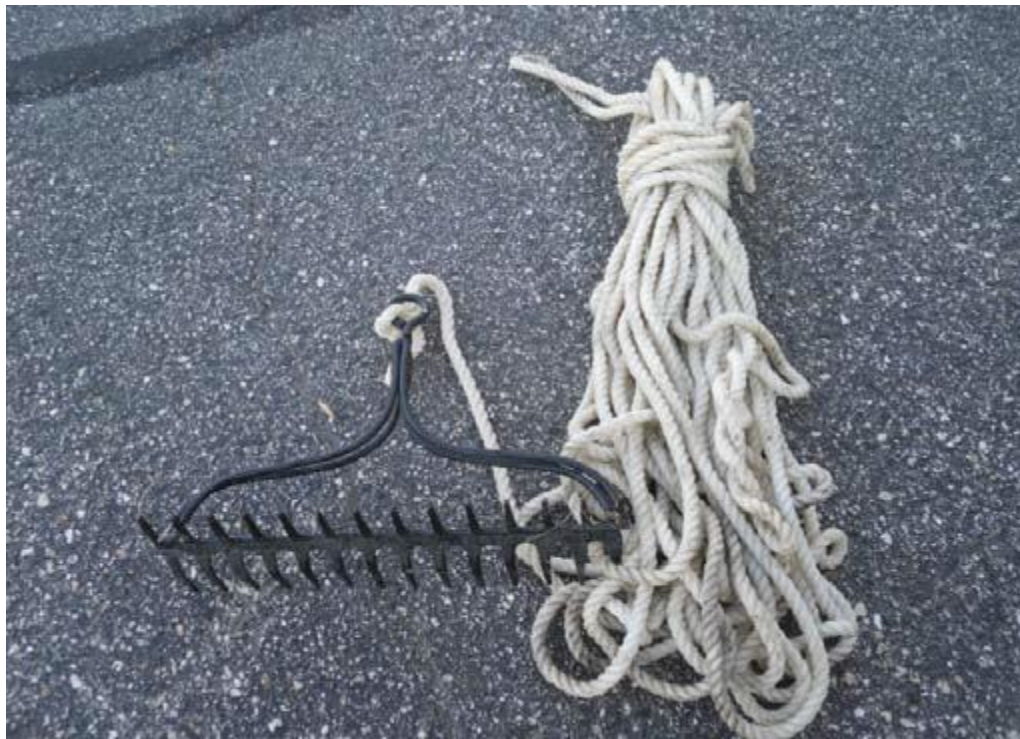
Surveyors recorded all plant species found in a one meter squared sample site at the pre-designated side of the boat. A double-headed garden rake attached to a rope was used to survey vegetation not visible from the surface(Figure 2). Each plant occurrence and relative abundance water recorded at survey points. Relative abundance was documented on a scale of 0-3 (Table 1). Plant identification followed Skawinski (2018). Data was entered in an Excel database. Frequency of occurrence was calculated for each species.

Figure 2: Double headed garden rake attached to rope

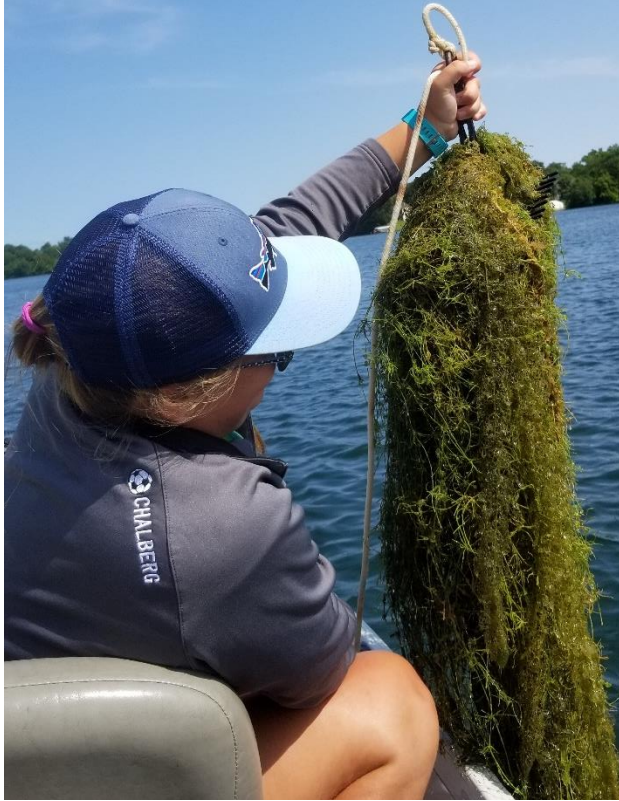
Figure 3: Double headed garden rake holding and Muskgrass sample, an abundance indicator of 3.

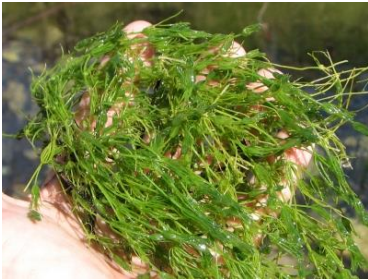
Northern Milfoil (*Myriophyllum sibiricum*) was the most frequently found plant on Munson Lake at 33% of the survey sites (Table 1, Figure X). It is a submerged plant that is characterized with five to 11 pairs of thread-like leaflets on each leaf. The leaves are arranged with four to five whorls around the stem. Stems emerge in the spring and produce flower spikes by mid-summer. Winter buds are produced in early fall and remain dormant until spring. Leaves and fruit of northern milfoil are consumed by a variety of waterfowl. The feathery foliage traps detritus and provide habitat for invertebrates. Beds of the plant also provide shade, shelter, and foraging opportunities for fish.

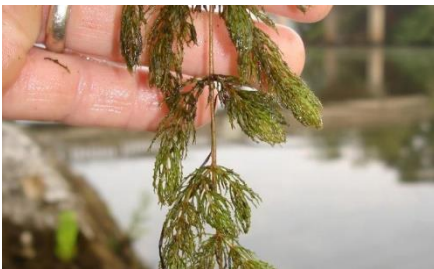
Illinois pondweed (*Potamogeton illioensis*) has stout stems that emerge from thick rhizomes and was observed at 28% of the sample sites (Table 1, Figure 10). They are usually found in water that has a high pH and has good water clarity and can grow in shallow water up to 3 meters (10 ft) deep. It can overwinter by winter-hardy rhizomes and, in some cases, may survive green below ice cover. The fruit is an important food source for waterfowl and is often grazed by muskrat, deer, and beaver. Illinois pondweed offers excellent shade and cover for fish and good
