2020 Pelican River Watershed District Monitoring Report

1 Executive Summary

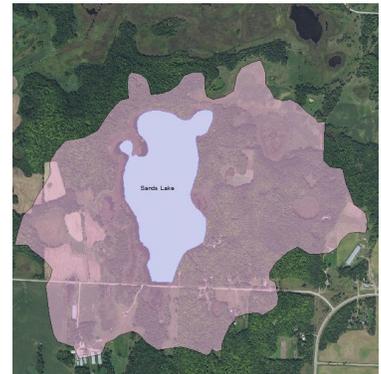
Figure 5.15. Sands Lake.

Sands Lake is small (104 acres) natural environment lake to the North of the Floyd Chain of Lakes (Figure 5.15). Sands is a shallow lake, with a maximum depth of 11 feet and a natural wetland fringe around the edge. The lake is land locked, with no significant surface inlets or outlets. Water quality in Sands lake is marginal, with a summer average phosphorous concentration of 30 ppb and a secchi depth of 9.5ft. Aquatic plant growth is dense throughout, but especially so in depths less than 5ft.

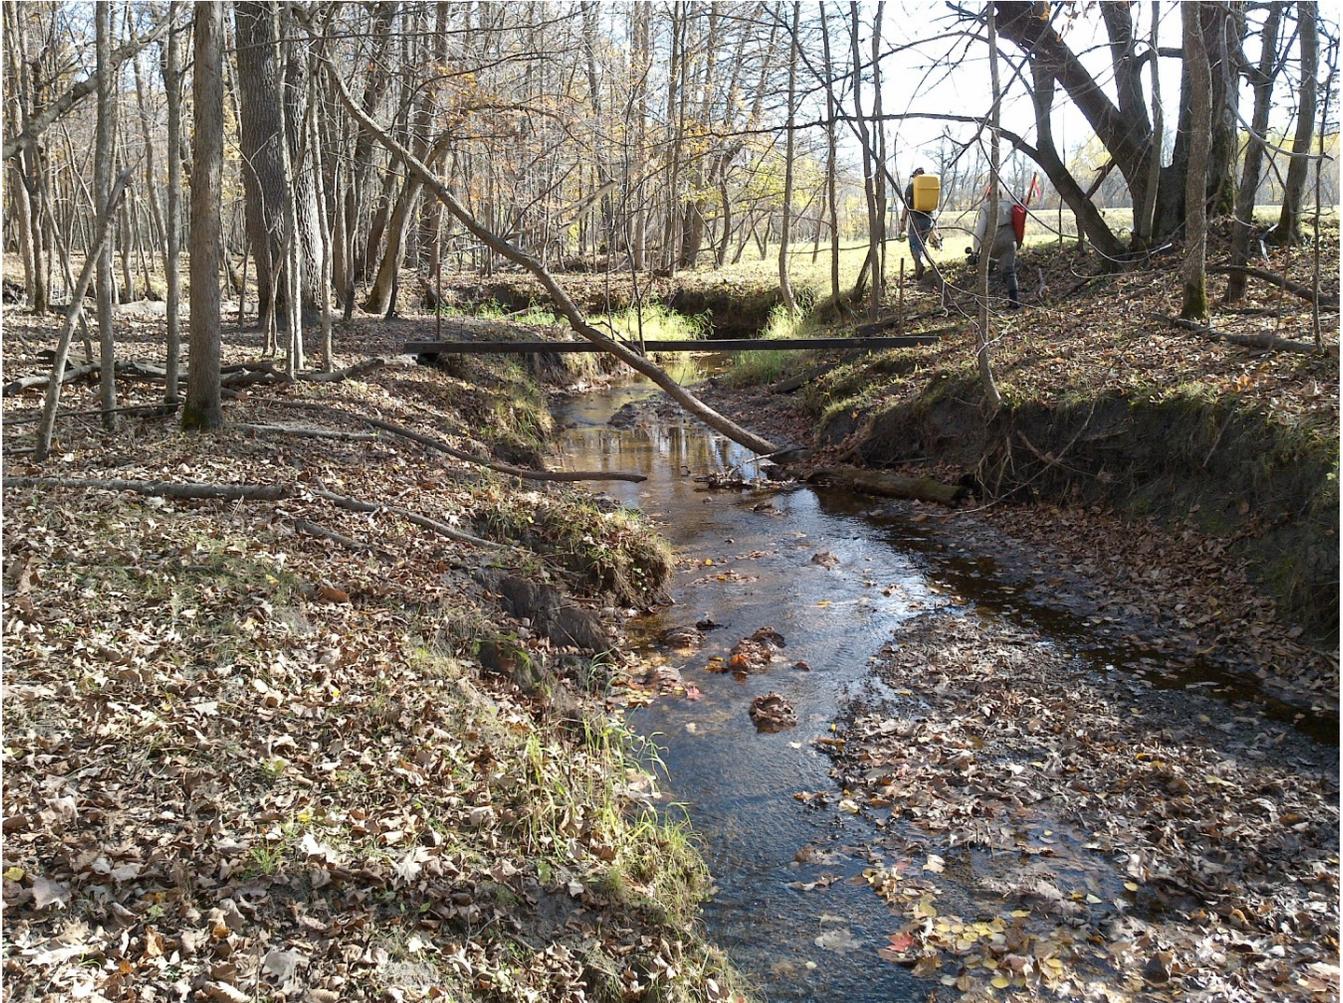
Figure 5.19. Example of bank erosion on Campbell Creek. North of CSAH 149.

In 2020 the District continued its cooperative partnership with the MN DNR to study stream channel erosion on Campbell Creek from Campbell Lake to Floyd Lake. District Staff joined MN DNR Staff for three days of survey in October. Staff noted downcutting of the channel bed, undercut banks, and extensive erosion to outer stream banks. The area North of CSAH 149 is seasonally grazed by livestock, and no exclusion fence is present. Livestock have been destabilizing stream banks and stream riffles. Staff also suspect high stream velocity is to blame. (Insert Picture of example of cross section)

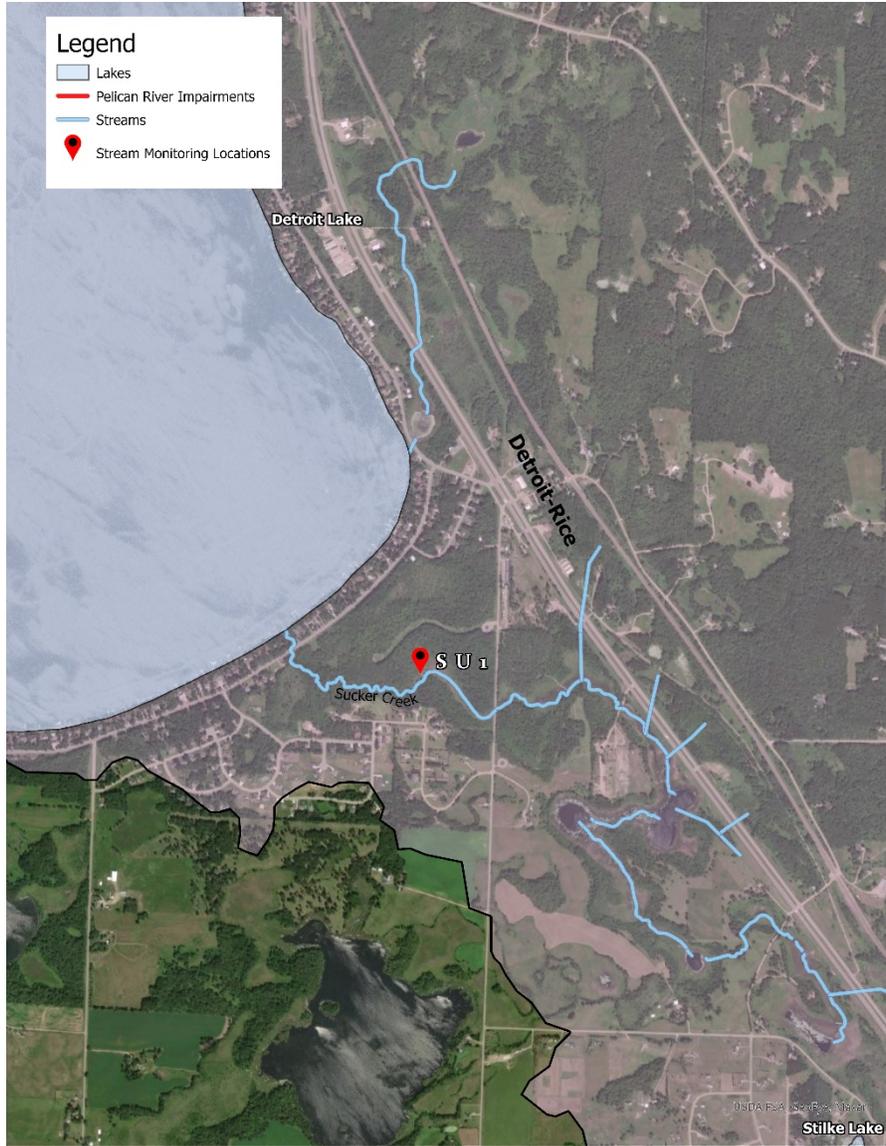
Figure 6.17. Sucker Creek sampling location.

The District sampled 1 location on Sucker Creek in 2020 to judge the health of the system (Figure 6.17). Staff visited the location SU1 a total of 27 times to collect water quality samples. DO readings averaged 7.8 mg/l, sufficient for trout to use the stream for spawning. Average TP, OP, and TSS were at 35 ppb, 15 ppb, and 4.6 ppb.

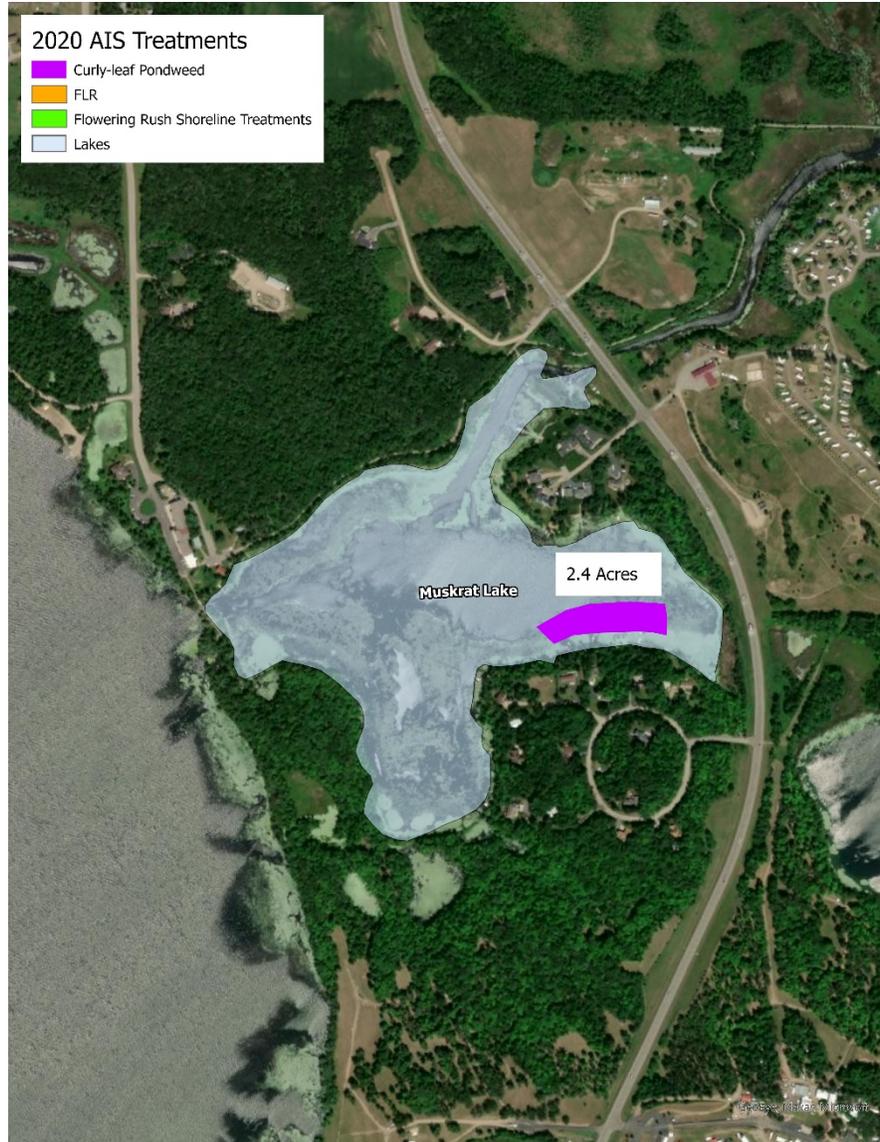
Figure 7.6. Curly-leaf pondweed treatment on Muskrat Lake in 2020.

The District treated a total of 2.4 acres of curly-leaf pondweed on Muskrat Lake in 2020 (Figure 7.6). A mixture of Endothall and Diquat were used to treat this bed. Unfortunately, the treatment was not effective, and the bed persisted after the treatment. Since Muskrat Lake is a small reservoir, water flow through the system is faster than other lakes, limiting the chemical’s contact time. The District has tried treating AIS in Muskrat Lake several times with little success. The District needs to explore new methods to increase chemical contact time in this system.

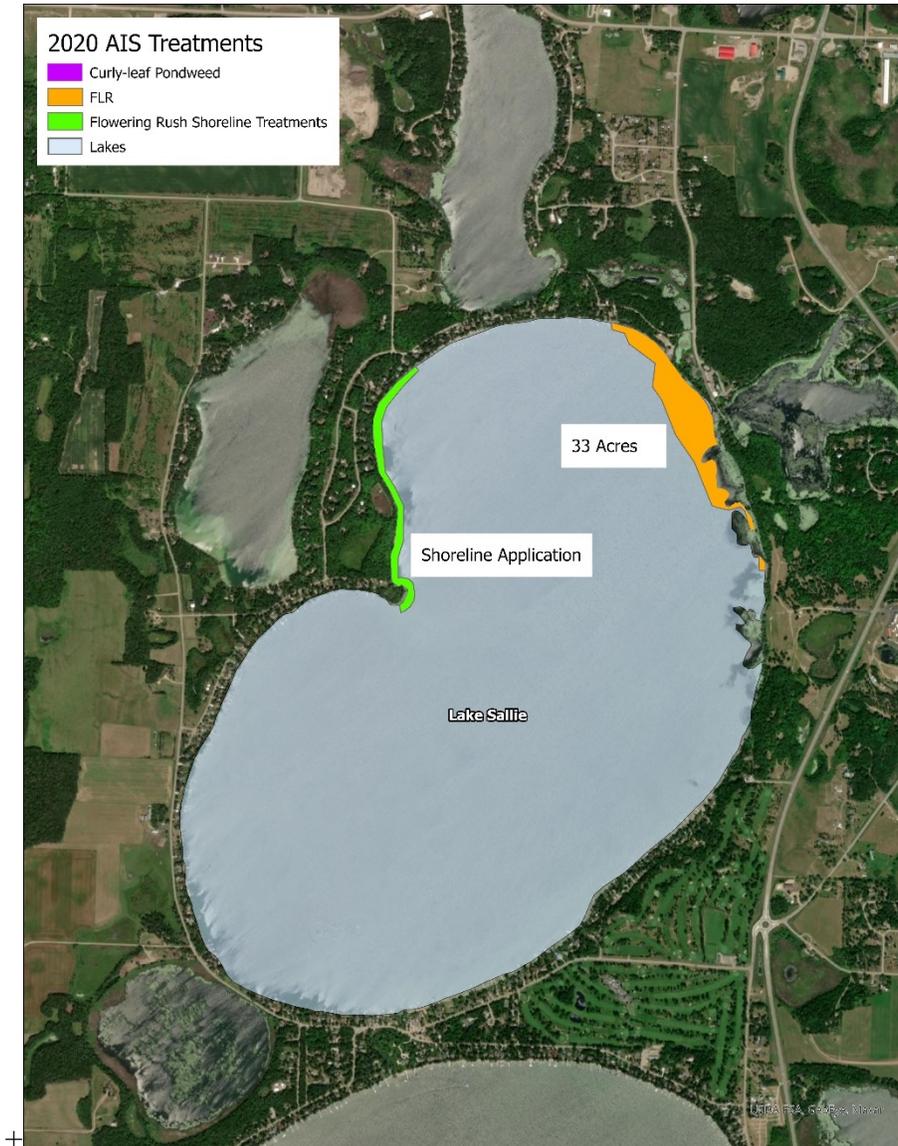
Figure 7.12. Aquatic invasive species treatments on Lake Sallie in 2020.

The District performed reduced chemical treatments of flowering rush, and no treatments of curly leaf pondweed on Lake Sallie in 2020 (Figure 7.12). For the 33-acre bed on the East shore of Lake Sallie, 2 treatments with Diquat were performed (July 7th and August 11th). This stand is intermixed with hardstem bullrush, making it difficult to access. There is also a flowing water problem associated with

where the Pelican River drains into Lake Sallie. The next step to effectively control this patch is to control the flow of water and increase contact time between the chemical and the plant. The District will begin investigating methods to achieve this in 2021. Possible methods include using a silt curtain or a “bubble curtain”, a device that inhibit water flow by producing a wall of air bubbles from the bottom to the surface.

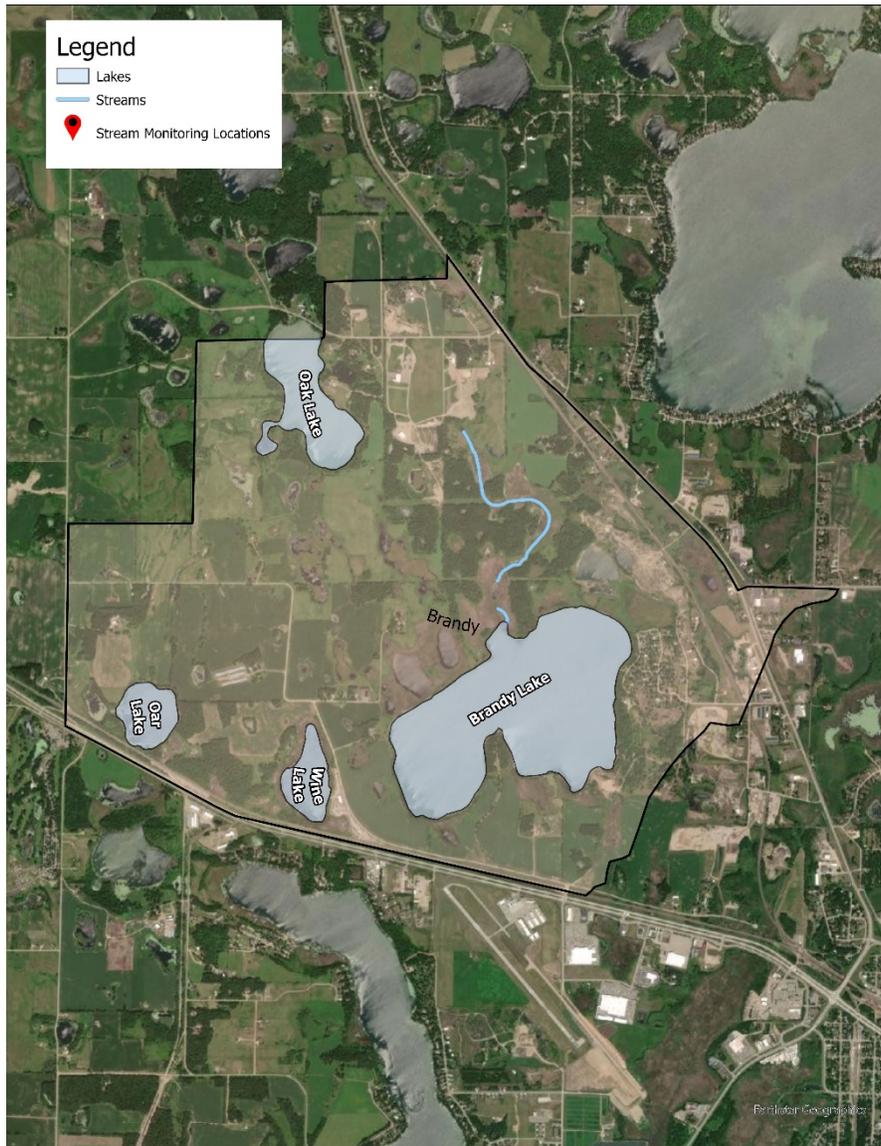
Figure 8.1. The Brandy Water Management Area.

The Brandy WMA contains about 3,000 acres (Figure 8.1). Four named lakes exist within this area; Brandy, Wine, Oak and Oar, however several small unnamed lakes and wetlands also dot the WMA. Brandy Lake is the largest lake, at 323 acres. The other lakes are smaller and have small watersheds. Land in the Brandy WMA is mostly used for cultivated crops or pasture, and shoreline along the lakes is mostly undeveloped. This is partly because the shallow nature of these lakes makes them ill-suited for recreation. Approximately 10 percent of the WMA is owned by the U.S. Fish and Wildlife Service. Brandy Lake historically suffered from poor water quality from the former Becker County Landfill but has improved through remediation. Wine Lake is impaired due to excess nutrients, and the District will work with MPCA to develop a TMDL. Oak lake was sampled in 2020 for water quality.

Oak Lake is an 86-acre, natural environment lake with a maximum depth of 16ft (Figure 8.1). The lake is boarded by United States Fish and Wildlife Service property on the Northwest and Southeast sides of the lake, with some private land ownership. Little is known about Oak lake other than a vegetation survey performed by the MN DNR in 2018. The survey found plants only in area less than 8ft deep, indicating poor water clarity. A nearby landowner indicated water levels had increased in last 50 years, and livestock were previously kept in an area currently flooded, possibly causing internal loading.

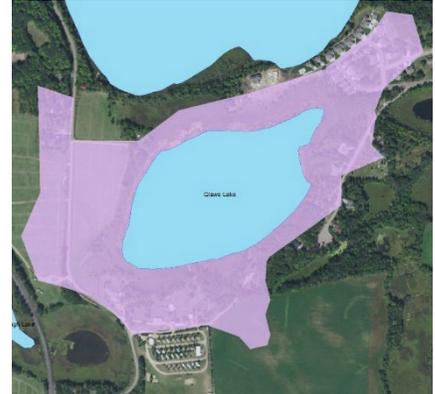
Figure 10.2. Glawe Lake.

Glawe is a small natural environment lake totaling about 40 acres and reaching a depth of 20 feet (Figure 10.2). It is separated from Curfman Lake by a 250-foot-wide land bridge along its northern shoreline. Water quality on Lake Glawe has remained stable and the lake is classified as mesotrophic. Development around the lake has increased in recent years with the construction of the Golden Bay Shores development along the NE shoreline. Stormwater from the development is treated via stormwater ponds on the north side of the lake prior to discharge to Glawe. A new single family residential development is also under construction on the east side of the lake. Shoreline vegetation removal from residential home construction should be minimized to avoid negative impacts to these small, sensitive lakes.

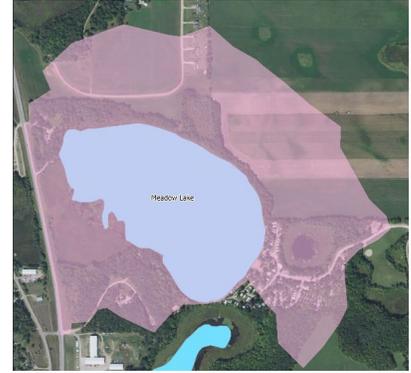
Figure 10.6. Meadow Lake

Meadow is a 71-acre natural environment lake located approximately 4.5-miles SW of the City of Detroit Lakes (Figure 10.6). Despite its relatively small size, the lake is quite deep, reaching a maximum depth of 72 feet. Meadow has no surface water inlet and is recharged primarily by groundwater interaction and some surface water runoff. There is no true outlet to the lake, however, there is a culvert below HWY 59 that connects Meadow to a wetland and another culvert below CSAH 17 that connects the wetland to Lake Melissa.

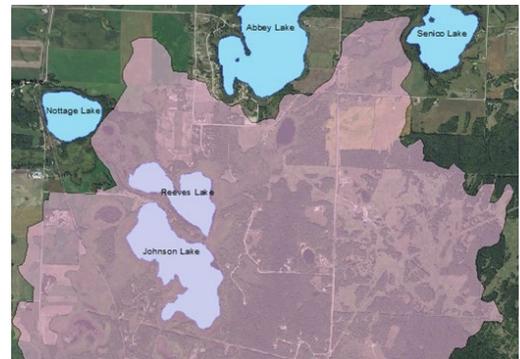
Figure 10.11. Johnson Lake.

Johnson Lake is a moderately developed, natural environment lake located south of the City of Detroit Lakes (Figure 10.11). Johnson lake is connected to Reeves Lake via a small natural channel on the Northeast shore of the lake. A prominent wetland fringe surrounds the lake, uprooted portions of wetland vegetation often detach and move around the lakes by wind and water currents. The channel between the two lakes sometimes becomes blocked by floating bogs, making watercraft passage between the two impossible. Johnson lake lies to the south of Reeves, totaling 219.6 acres in size and reaching a depth of 30 feet.

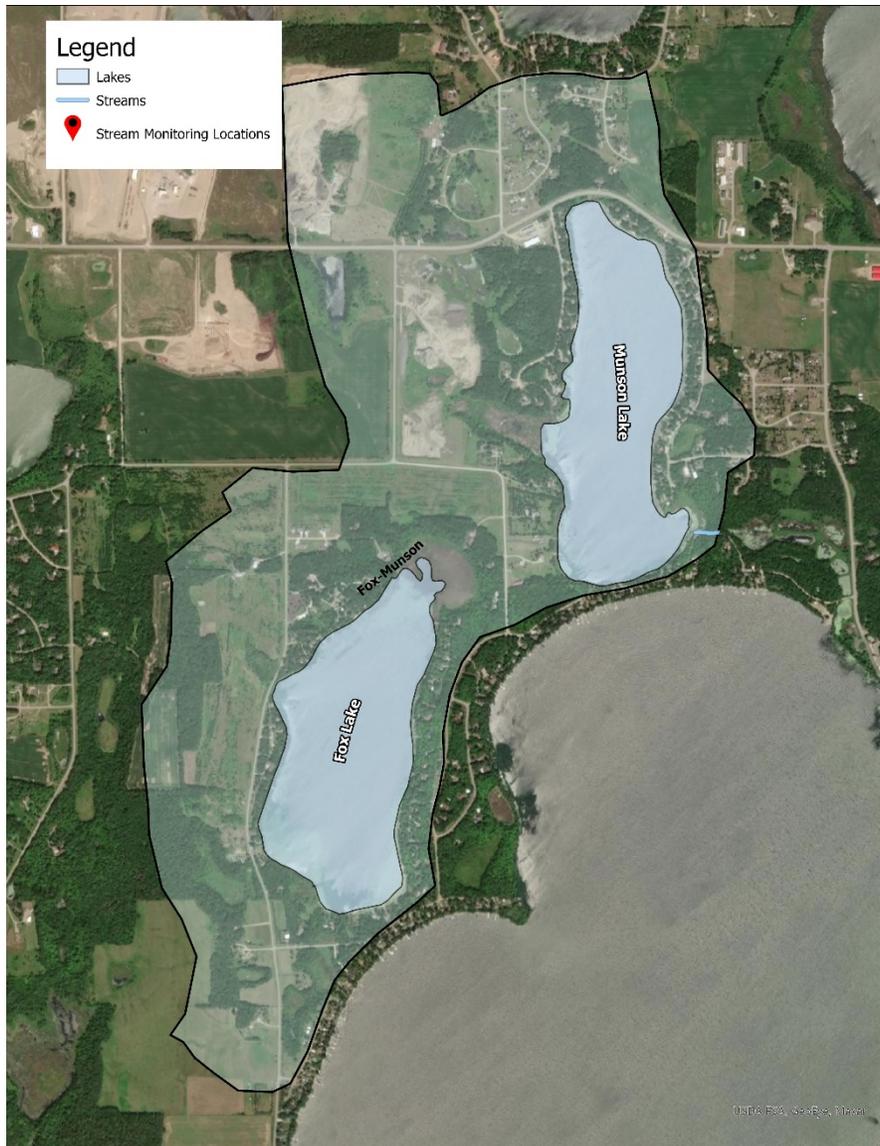
Figure 11.1. The Munson/Fox Water Management Area.

The Munson-Fox WMA contains about 1,350 acres (Figure 11.1). The only lakes in this WMA are Munson and Fox Lakes. Both are small lakes, at 129 and 138 acres, respectively, but both are also elongated, giving them good amounts of shoreline. Both lakes are fed by groundwater and have adjacent wetlands and some shoreline runoff, but neither has a significant inlet stream. Both lakes have small outlets. Munson and Fox lakes have relatively small watersheds. Land within these watersheds is a little more than 25 percent forested, 23 percent water, 50 percent cultivated, grassland or pastureland, and less than 2 percent impervious surface. Some major gravel mining operations are found in the area.
