PELICAN RIVER

watershed district

2021 Annual Monitoring Report

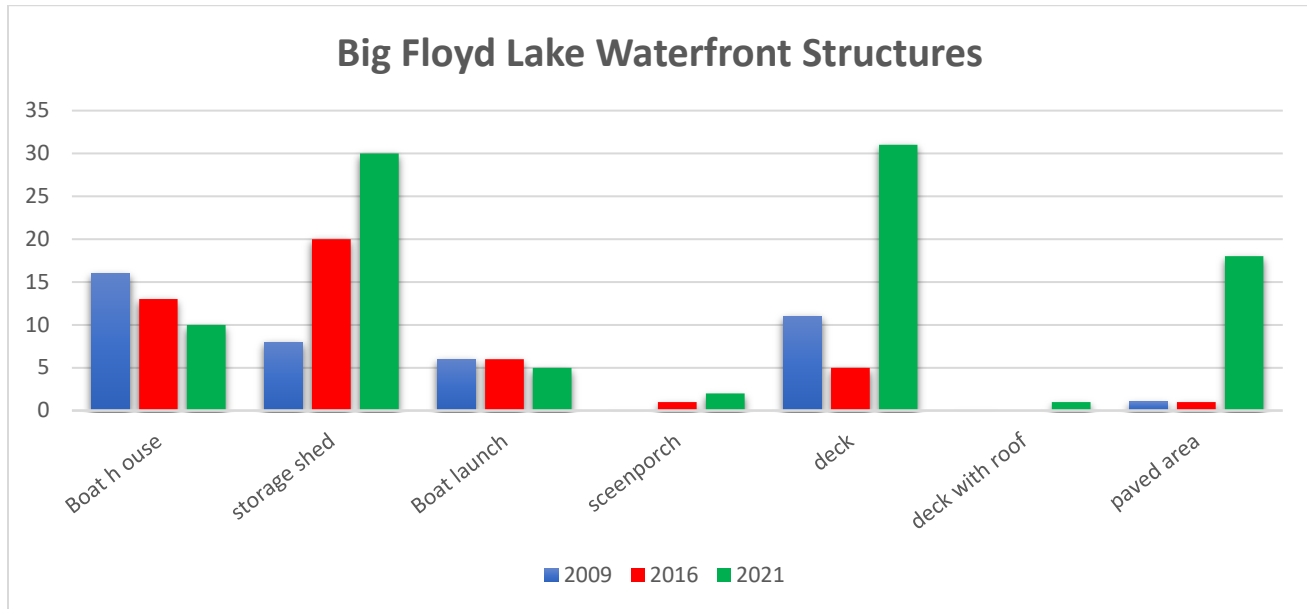
Figure 5.8. Waterfront structures on Big Floyd.

Waterfront Structures: Since 2009 the number of boathouses has decreased from 16 (2009) to 10 in 2021, however there is a marked increase in storage sheds from 8 (2009) to 30 in 2021. Decks have also greatly increased from 11 (2009) to 31 in 2021 and patio areas increased from 1 (2009) to 18 in 2021.

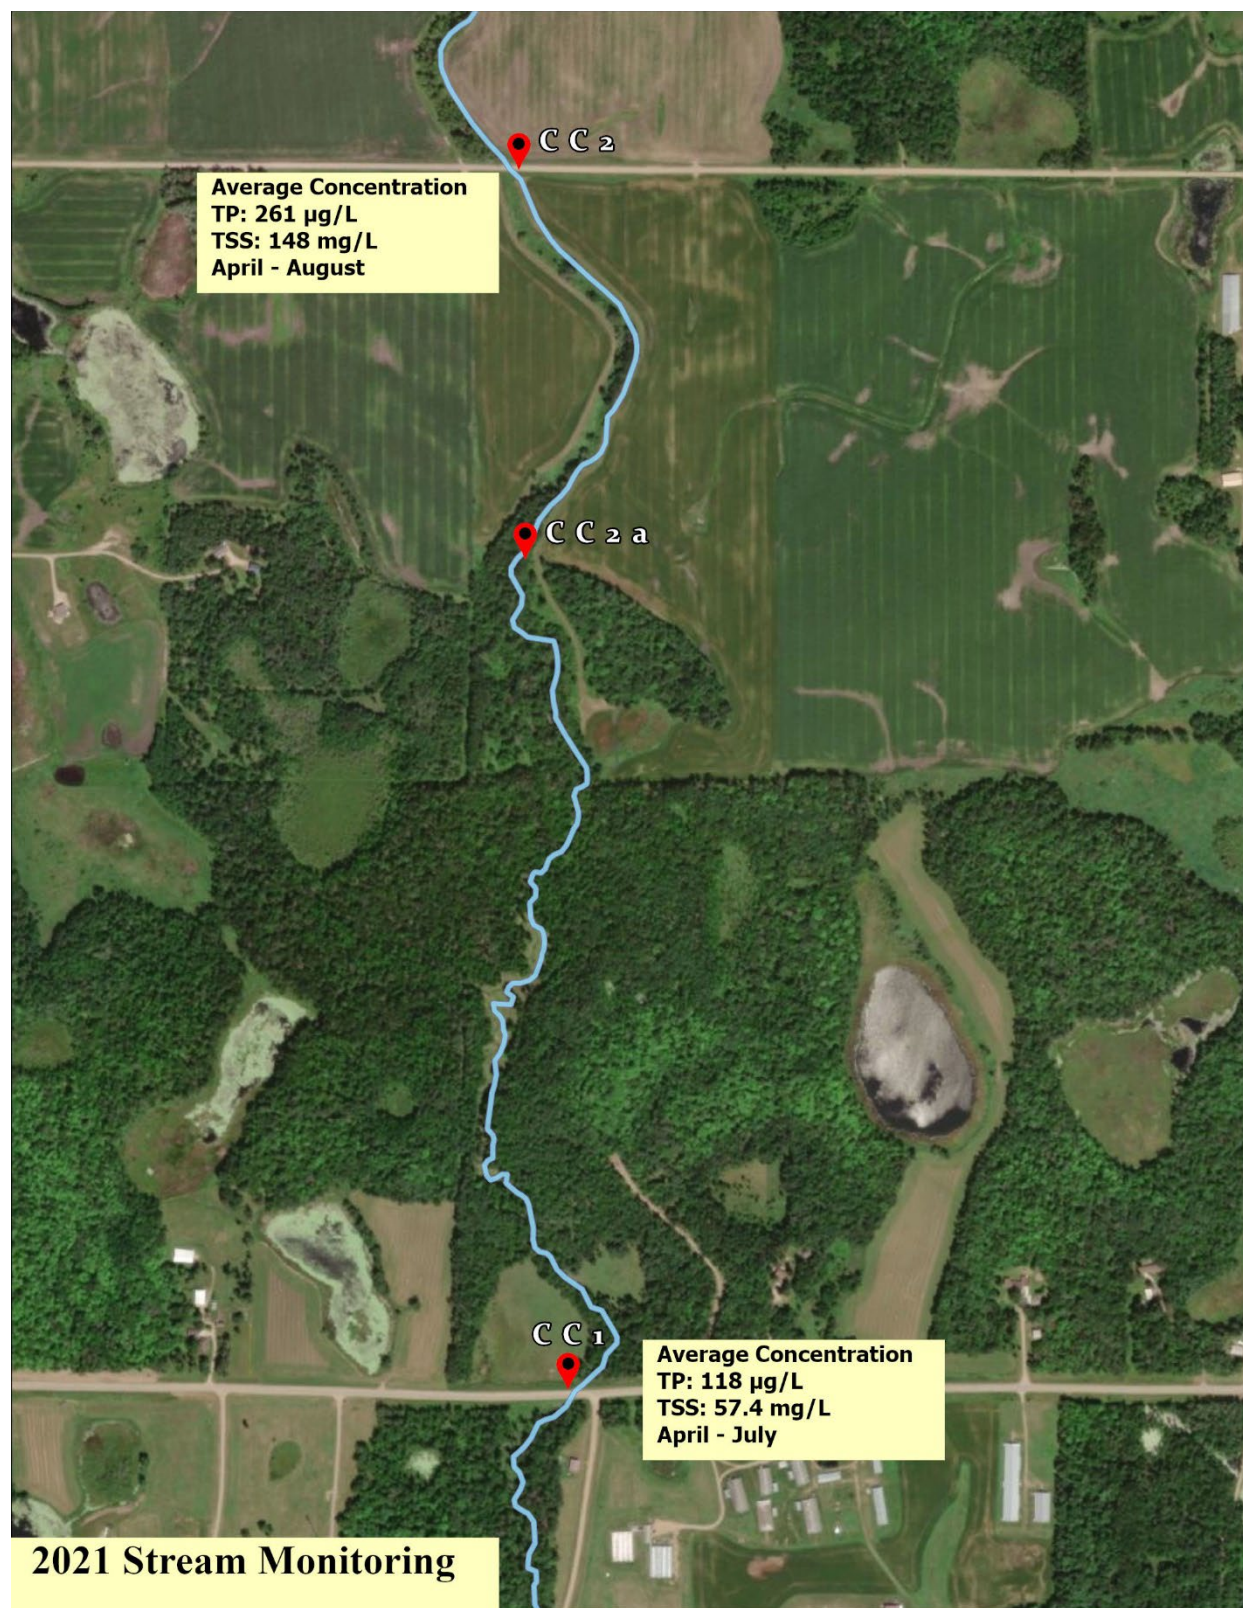
Figure 5.19. Pollutant loading on Campbell Creek.

In 2021, Campbell Creek experienced one of its best years of water quality, due to the extended drought conditions from July through September. Since there was no stormwater runoff to carry sediment downstream North Floyd Lake had water quality benefits as well. By mid-July there was no stream flow and the last sample taken was on July 12th at CC1, and on August 20th at CC2 after a rainfall event. Even with a few minor rainfall events in July and August, Campbell Creek remained dry with no flow. The average concentrations at CC2 (April – mid-August) was 261 µg/L TP and 148 mg/L TSS. The average concentrations (April – mid-July) at CC1 was 118 µg/L TP and 57.4 mg/L TSS.

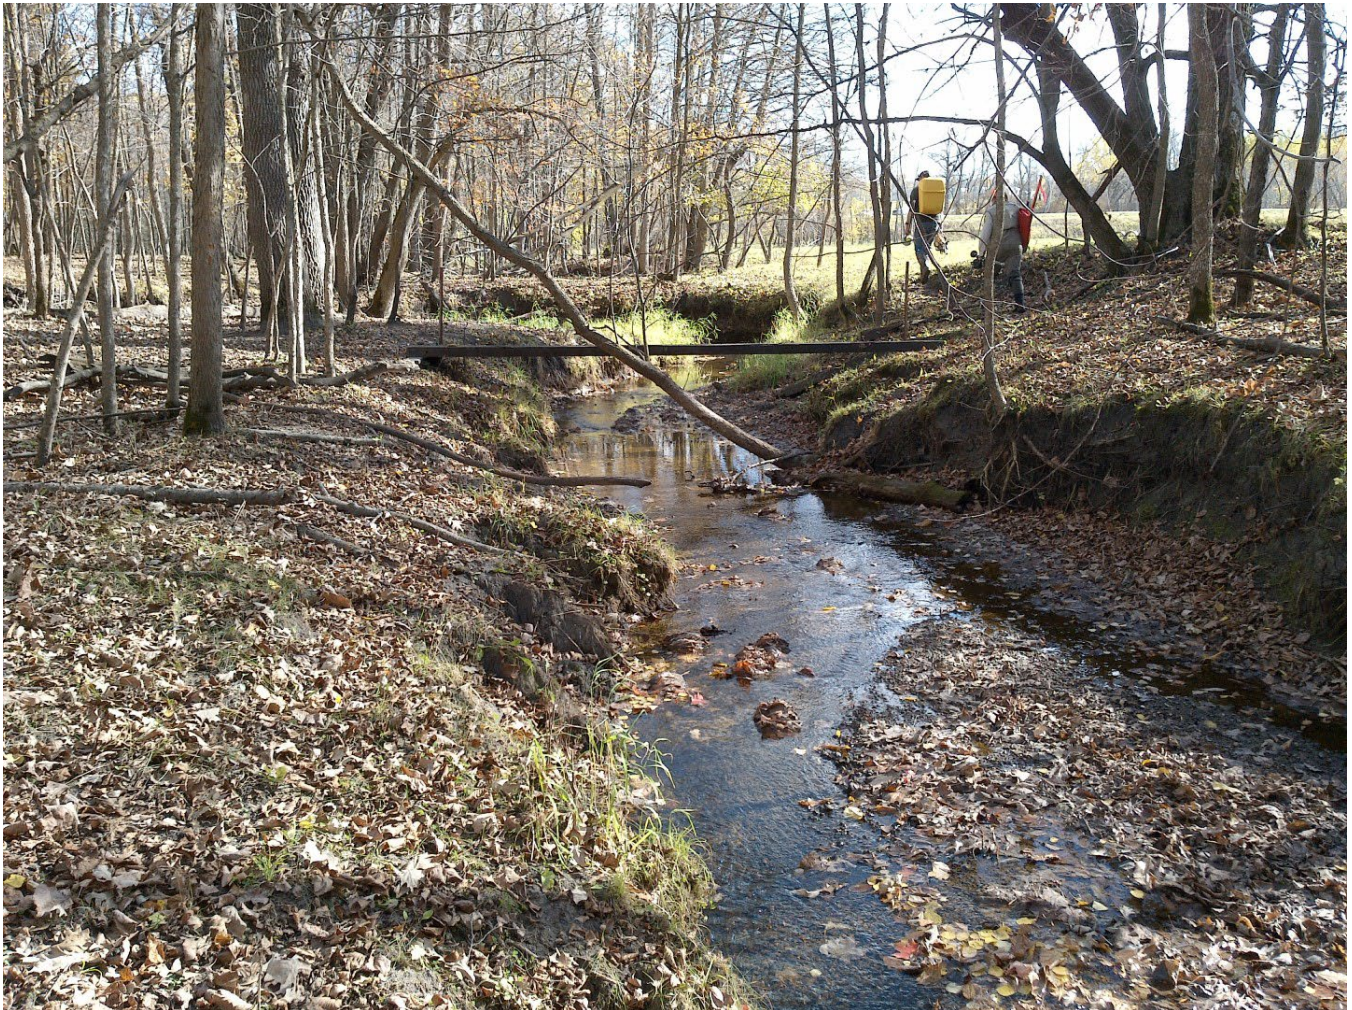
Figure 5.21. Example of bank erosion on Campbell Creek. North of CSAH 149.

In 2021 the District continues its cooperative partnership with the MN DNR to study stream channel erosion on Campbell Creek from Campbell Lake to Floyd Lake. District Staff has obtained some funding through the 319 Grant to help get started on the construction for the much-needed improvements to this area. Staff noted downcutting of the channel bed, undercut banks, and extensive erosion to outer stream banks. The area North of CSAH 149 is seasonally grazed by livestock, and no exclusion fence is present. Livestock have been destabilizing stream banks and stream riffles. Staff also suspect high stream velocity is to blame. With the planned improvements we have high hopes that this will improve these impairments.

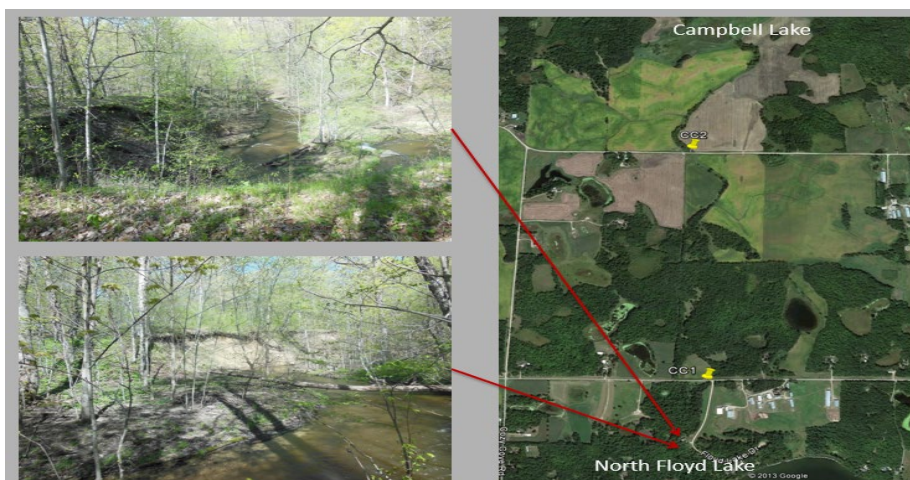
Figure 5.22 Targeted areas of stream channel erosion

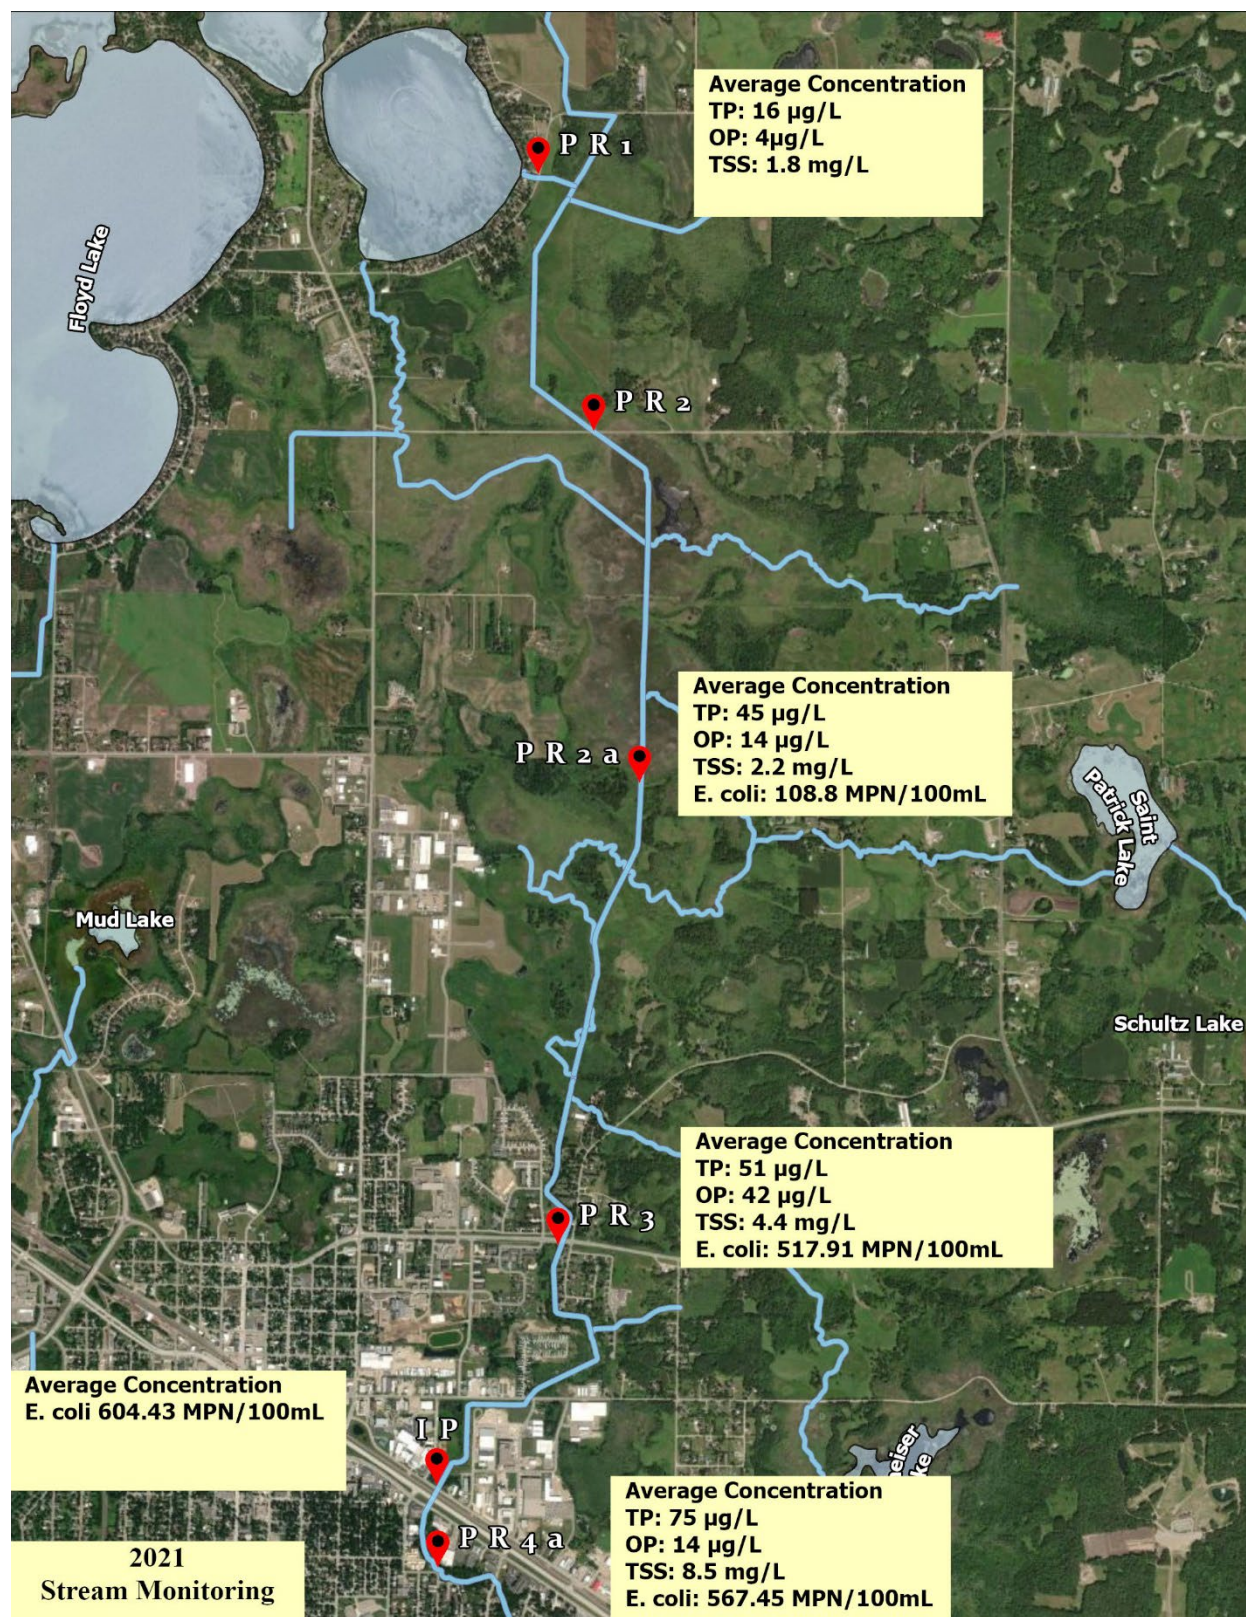
Figure 6.11. Pelican River sampling in the Detroit/Rice WMA.

The Pelican River experienced an average water quality year in 2021 (Figure 6.11). Concentrations at Site PR1 (outlet of Little Floyd Lake) was 16 µg/L TP and 4 µg/L OP; Site PR2A was 45 µg/L TP and 14 µg/L OP; Site PR3 (HWY 34/PR) was 51 µg/L TP, and 42 µg/L OP; and PR4a was 75 µg/L TP and 14 µg/L OP. Staff noted the presence of beaver dams between the PR2A and PR3. Upper structure of the Rice Lake wetland restoration project went on-line in fall of 2021.

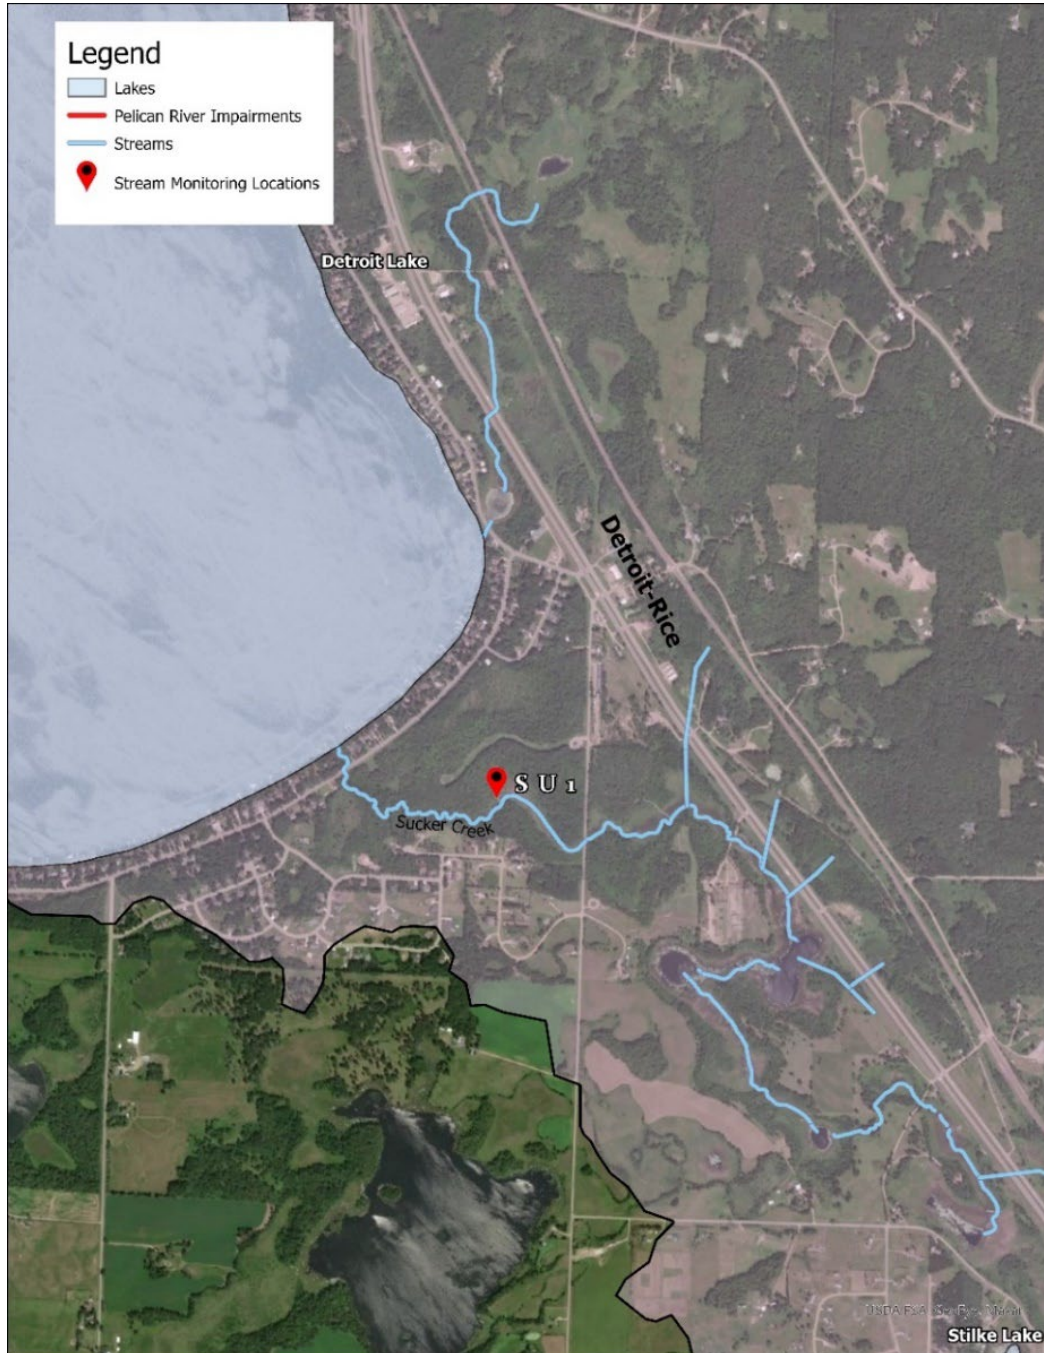
Figure 6.17. Sucker Creek sampling location.

Sucker Creek is a natural creek that flows into the Southeast shore of Big Detroit Lake. Sucker Creek is protected by the Sucker Creek Nature Preserve, a protection area aimed to preserve the natural state of Sucker Creek and educate people about the benefits of natural systems. Sucker Creek is the District's only designated trout stream. Because of its unique natural state, the District monitors water quality at one point on the creek

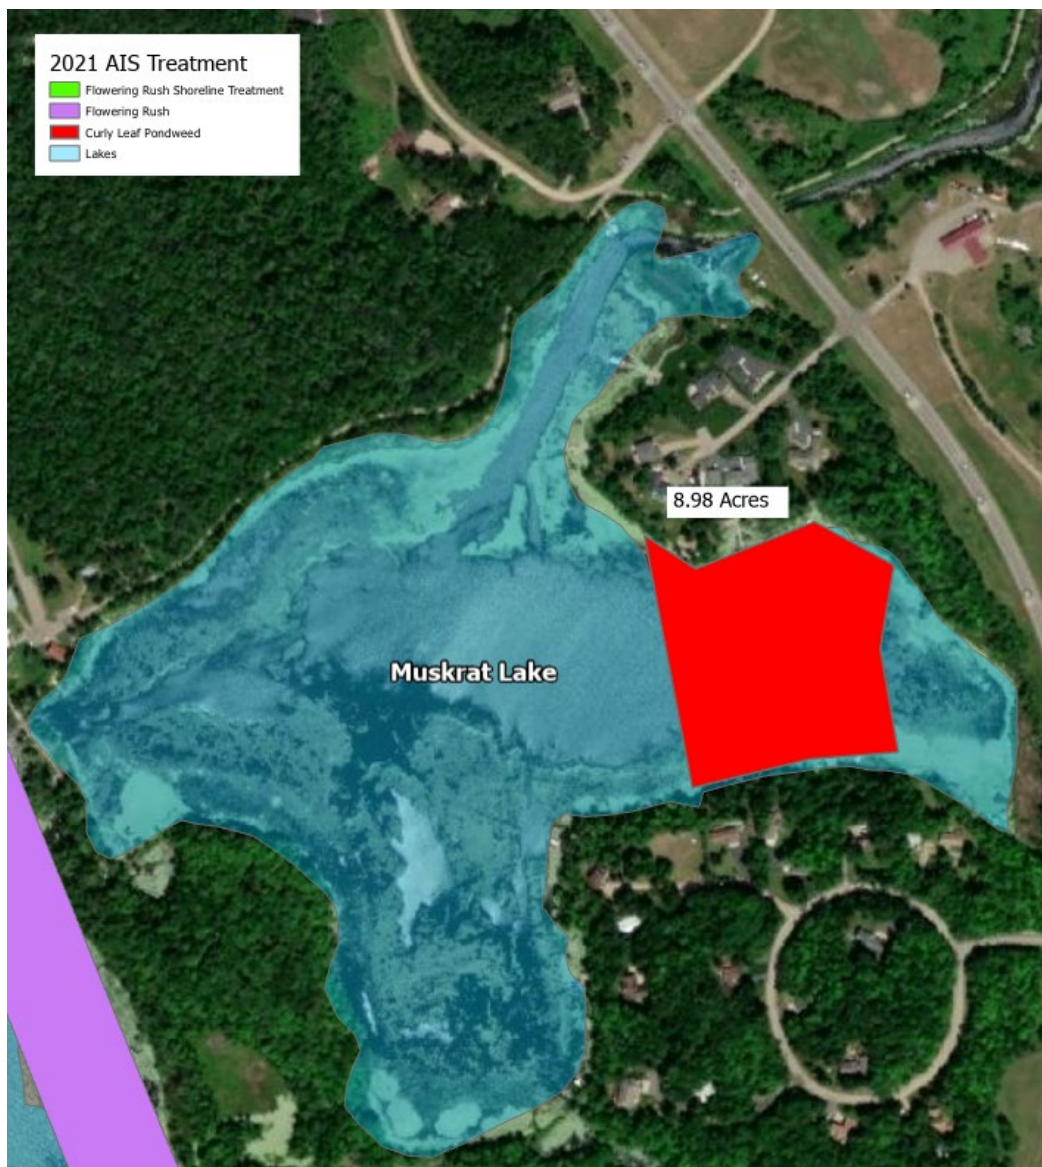
Figure 7.8. Curly-leaf Pondweed treatment on Muskrat Lake 2021.

The District treated a total of 8.98 acres of curly-leaf pondweed on Muskrat Lake in 2021 (Figure 7.6). A mixture of Endothall and Diquat were used to treat this bed. Unfortunately, the treatment was not effective, and the bed persisted after the treatment. Since Muskrat Lake is a small reservoir, water flow through the system is faster than other lakes, limiting the chemical's contact time. The District has tried treating AIS in Muskrat Lake several times with little success. The District needs to explore new methods to increase chemical contact time in this system, perhaps diverting water flow away from the treatment area.

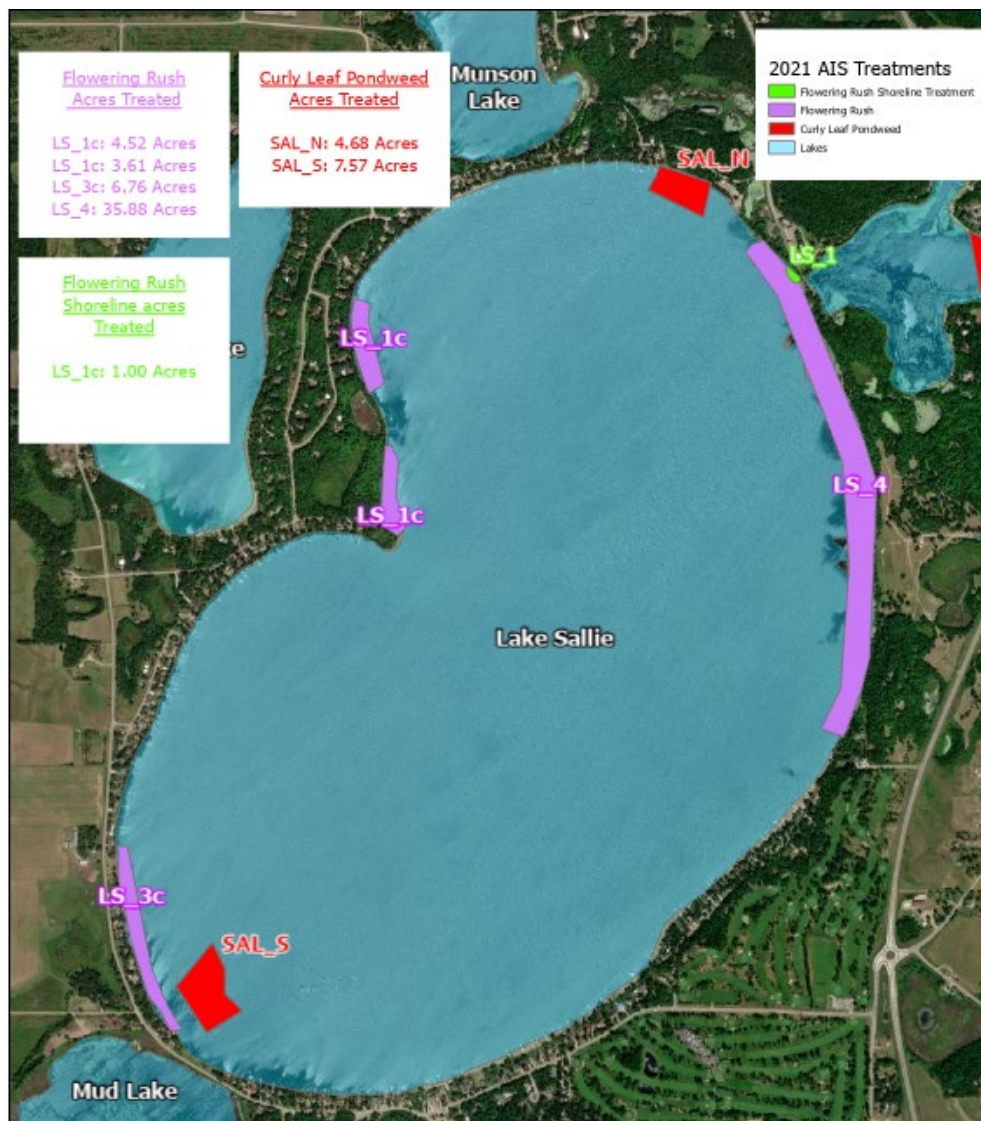
Figure 7.74. Aquatic invasive species treatments on Lake Sallie in 2021.

The District performed reduced chemical treatments of flowering rush, and no treatments of curly leaf pondweed on Lake Sallie in 2021 (Figure 7.12). For the 35.88-acre bed on the East shore of Lake Sallie, 2 treatments with Diquat were performed (June 28th and August 9th). This stand is intermixed with hardstem bullrush, making it difficult to access. There is also a flowing water problem associated with where the Pelican River drains into Lake Sallie. The next step to effectively control this patch is to control the flow of water and increase contact time between the chemical and the plant. A possible method to look into would include using a silt curtain or a “bubble curtain”, a device that inhibit water flow by producing a wall of air bubbles from the bottom to the surface.

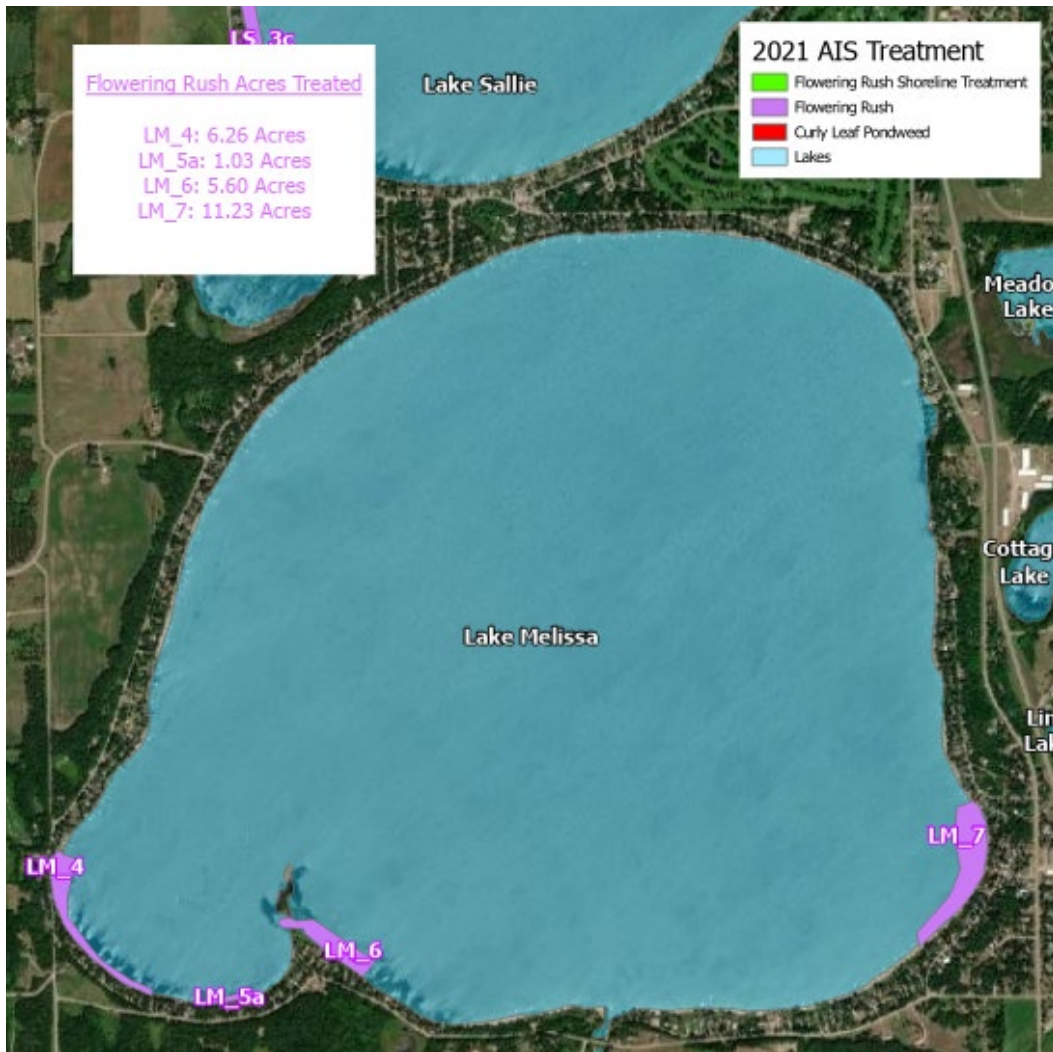
Figure 7.22. Aquatic invasive species treatments on Lake Melissa in 2021.

No chemical treatments for Curly Leaf Pondweed were required in 2021. The only treatments the District performed were for Flowering Rush, a total of 24.12 acres were treated twice (June 28th and August 9th). (Figure 7.18). The District will continue to assess the lake for Flowering Rush and Curly Leaf Pondweed in 2022.
