PELICAN RIVER

2022 Annual Monitoring Report

Gina Kemper
Water Resource Coordinator
Pelican River Watershed District

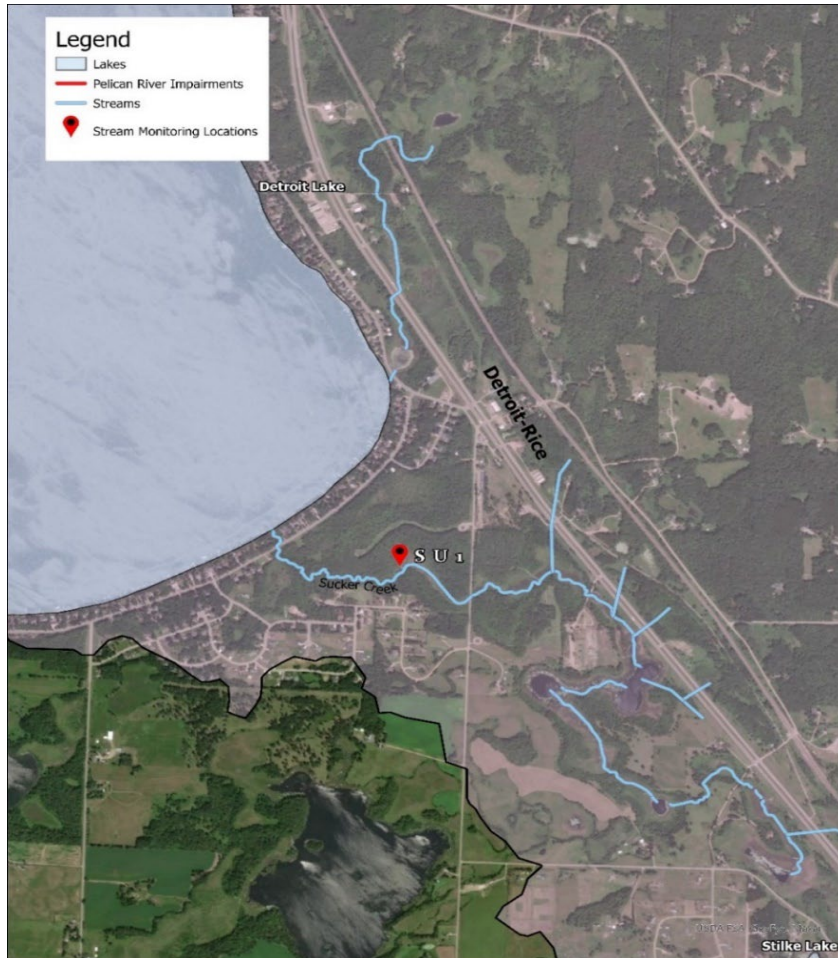
Figure 6.17 Sucker Creek sampling location

Sucker Creek is the District's only designated trout stream. Sucker Creek is a natural creek that flows into the Southeast shore of Big Detroit Lake. The Sucker Creek Nature Preserve serves as a protection area for Sucker Creek and provides educational kiosks to help educate people about the benefits of natural stream and forest area eco-systems. The District has one monitoring station within the preserve.

Staff collected 11 samples from May – mid August, until the creek stopped flowing. Average TP was at 35 $\mu\text{g/L}$ and OP was at 14 $\mu\text{g/L}$. TP concentrations consistently spiked during storm events, affecting the annual average concentrations. Dissolved Oxygen (DO) readings averaged 8.5 mg/l, sufficient for trout to use the stream for spawning (Figure 6.17).

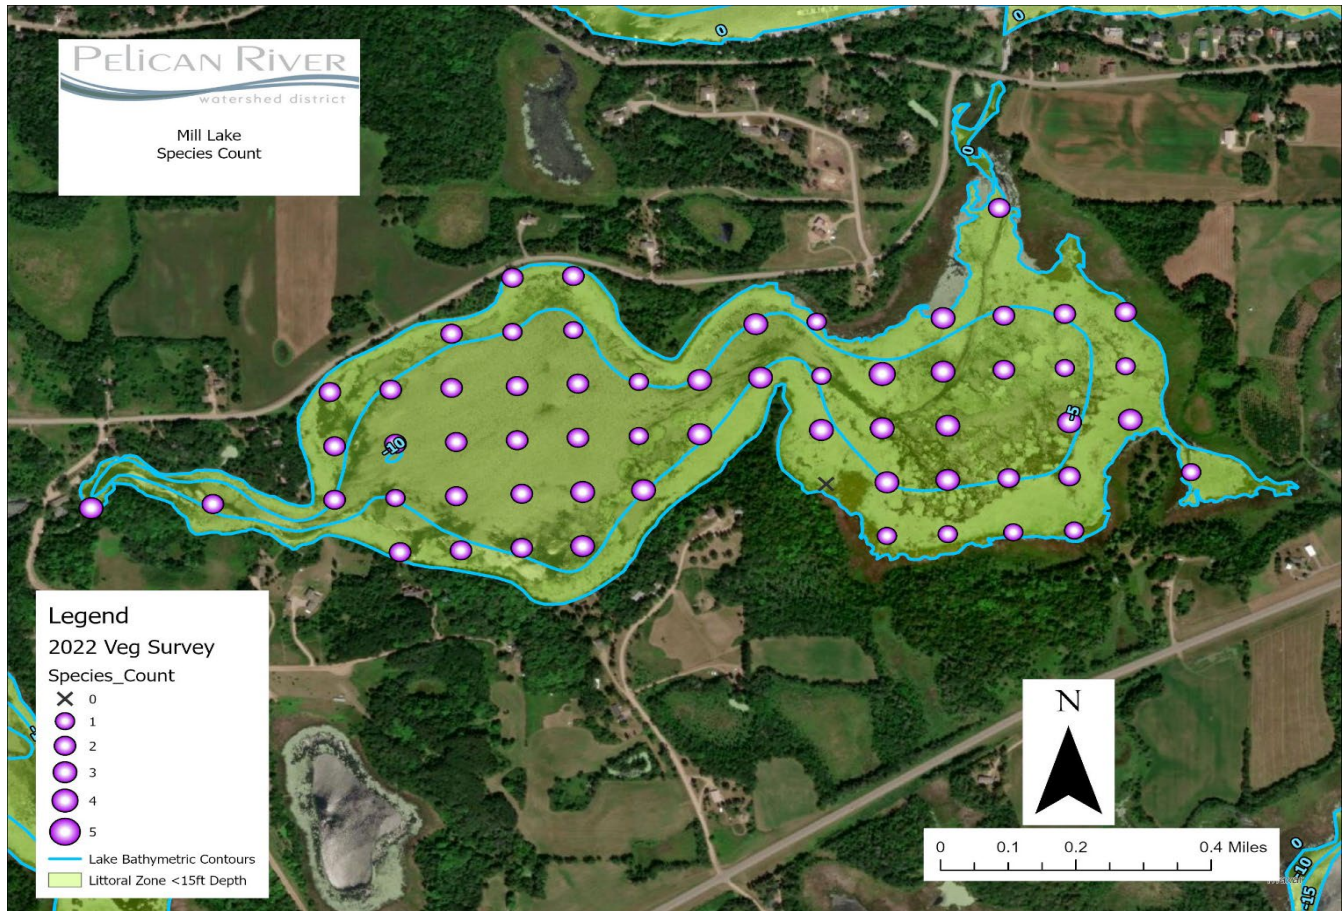
Figure 7.20 Number of species at each site from the 2022 point-intercept survey on Mill Pond Lake.

Mill Pond Lake has an average of ten species per sampling site. Figure 7.20 displays the spatial distribution and species richness (# of species per sample point) of all native species from the 2022 point-intercept survey.
