PELICAN RIVER

watershed district

2023 Annual Monitoring Report

Gina Kemper
Water Resource Coordinator
Pelican River Watershed District

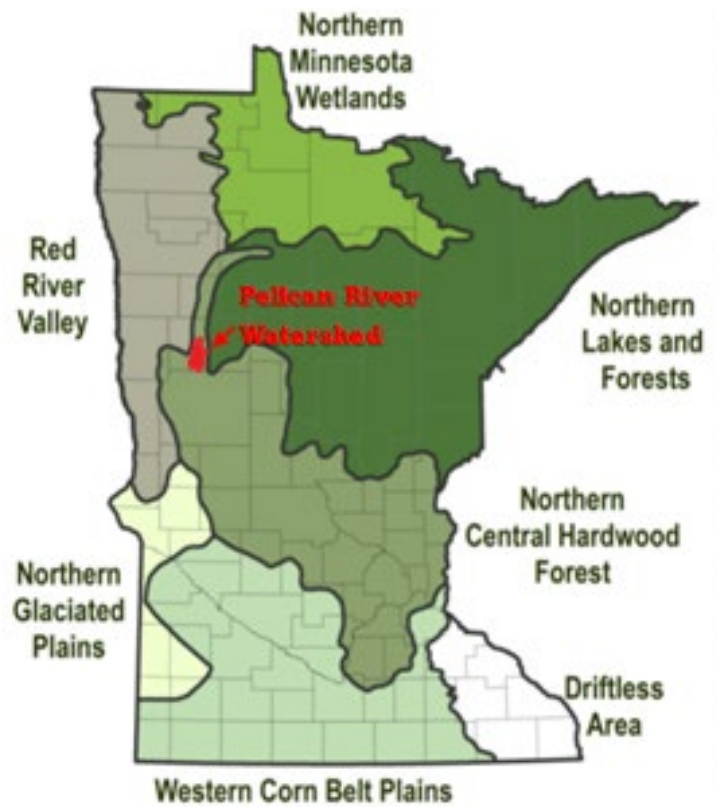
Figure 2. 2 PRWD within the MN Ecoregions

The Pelican River Watershed District is located within the North-Central Hardwood Forest Ecoregion (Figure 2.2). This region is an area of transition between the forested areas to the north and east, and the agricultural areas to the south and west. The terrain varies from rolling hills to smaller plains and is abundant with glacial lakes, wetlands, and remnant hardwood forests. The plains areas of the region are a mix of row crops, livestock grazing, and native prairie land. Much of the land surrounding the lakes has been developed for housing and recreation, resulting in an increase of the nutrient runoff associated with the lawns and impervious surfaces. The lakes in this region are typically found to be mesotrophic but are occasionally found to be slightly eutrophic, especially during mid-late summer, in shallower systems, and in more highly developed areas.

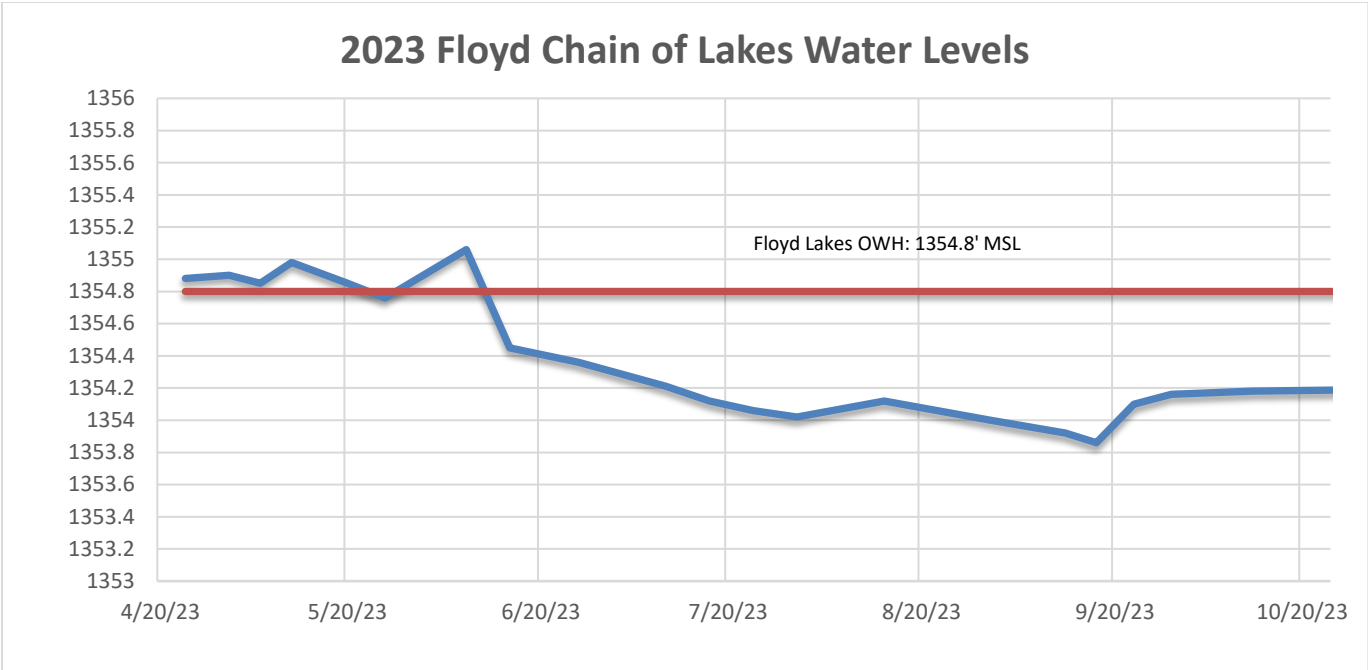
Figure 5.3 Floyd chain of lakes water levels 2023.

Big Floyd, Little Floyd, and North Floyd maintain similar water levels. The OHW for all 3 basins is set at the same elevation (1354.8’ NVGD 29) by the MN DNR. There is a fixed crest weir (1354.8 NVGD 29) on the outlet of Little Floyd Lake. Surprisingly with the late spring and snow conditions water levels were barely above the OHWL (1354.88’ NVGD 29), however by June to late September, water levels continued to drop until the much-needed rain in late September helped to start bringing the water levels back up (Figures 5.2 & 5.3).

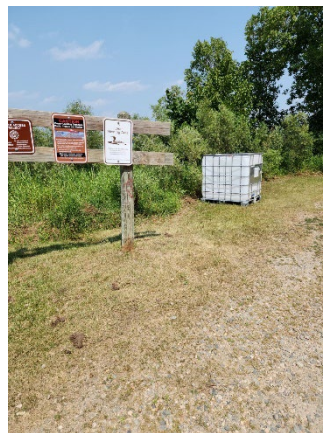
Property owners from Little Floyd Lake called in with some concern about Blue-green algae around the public launch around mid to late July so we took a TP and E. coli sample on July 24th to see what might be causing it. If you notice in Figure 5.10 those levels are indicated by the green and red stars. It did not appear to be from E. coli, but TP was higher at the boat launch than at the routine sampling location. With shallower water, heat, and the higher TP levels this would be the right combination so have some blue green algae show up. Also noted that there was a very large empty 300-gallon chemical container of AquaBlue that was left at the access (Figure 5.10 & 5.11). PRWD staff is unsure if this was used as an in-lake treatment for aquatic vegetation by local property owners, but we did report it to DNR. This could also be part of the reason why Blue-green algae was present or what appeared as Blue-green algae.

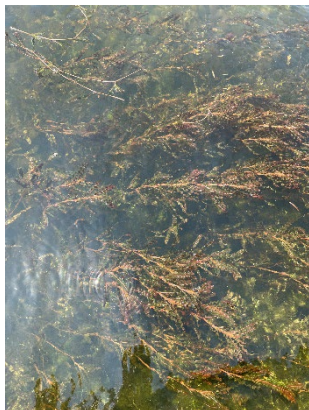
Figure 5.16 photo of CLP on North Floyd Lake

AIS Curly-leaf Pondweed (CLP) was discovered in the Northwest bay of North Floyd Lake Figure 5.16 & 5.17). It was delineated and 3.17 acres are proposed to be treated in 2024 (Figure 5.15).

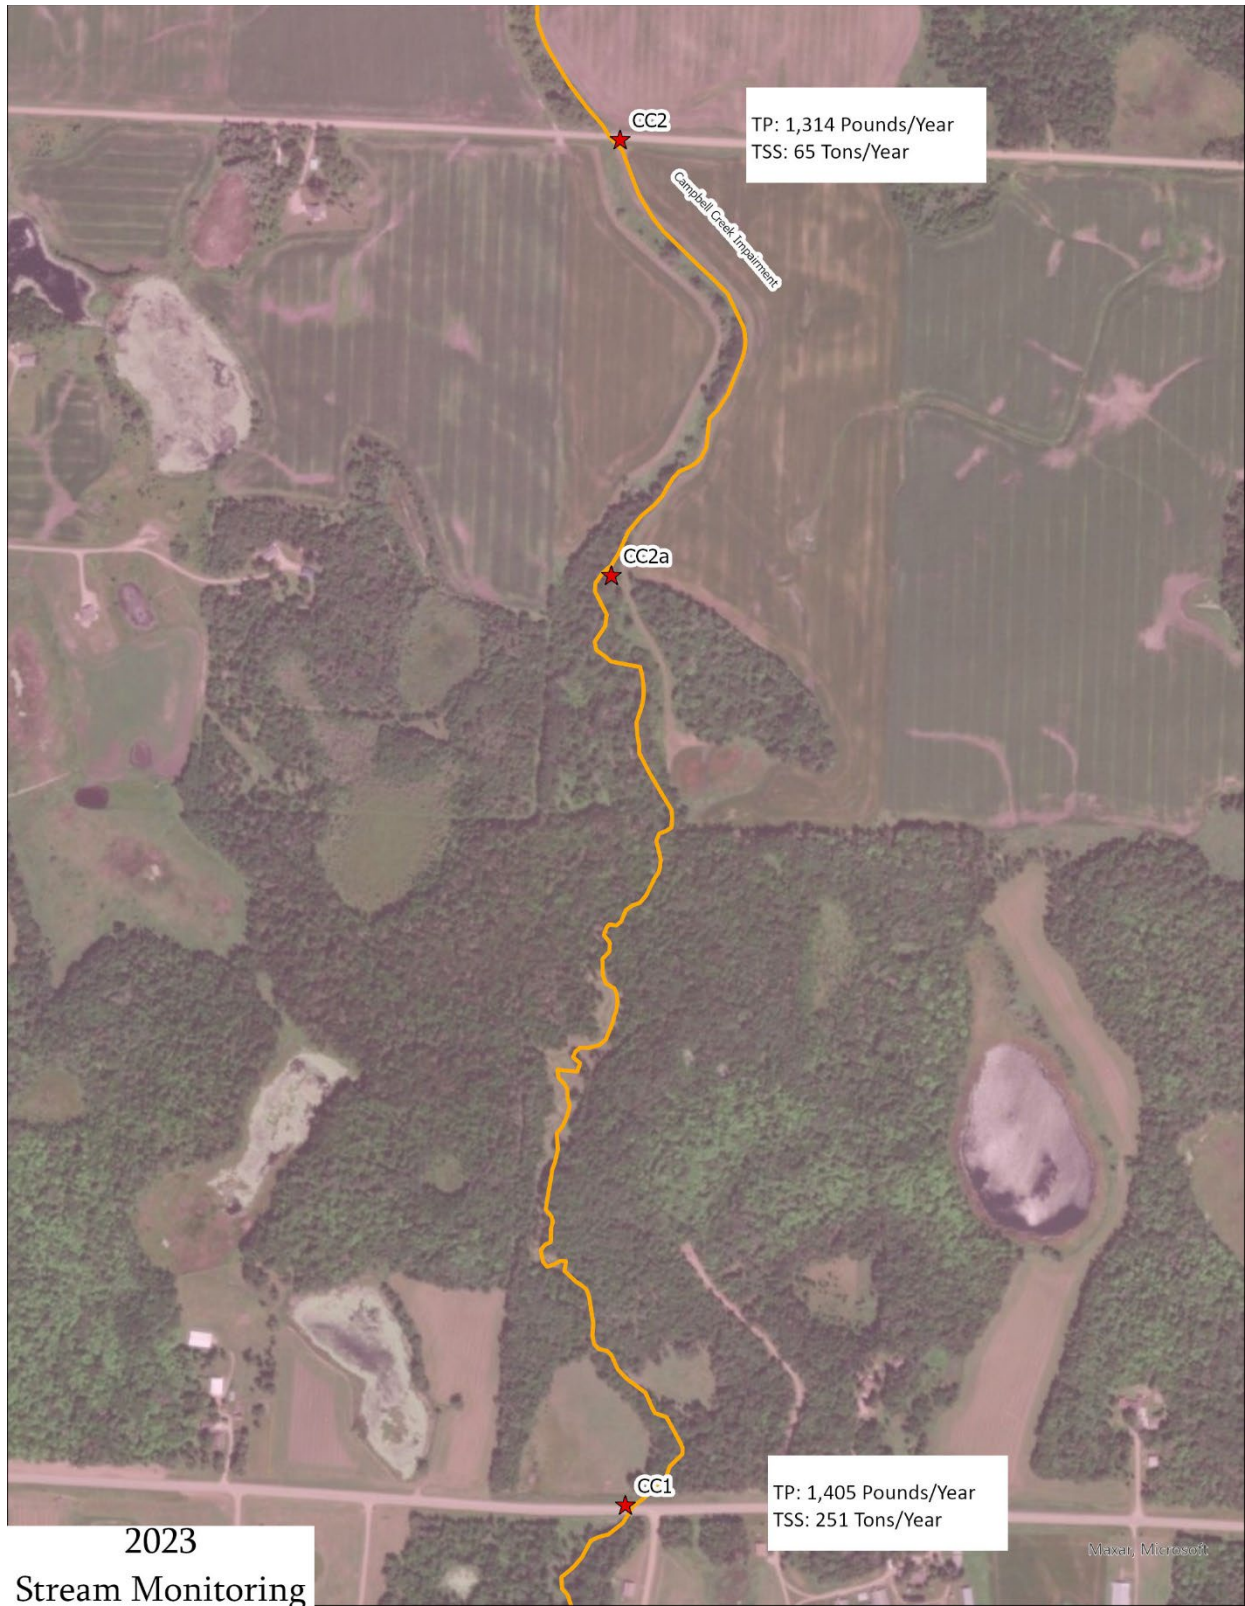
Figure 5.21 Pollutant loading on Campbell Creek.

With a drought year, the District saw improved water quality as this causes very little flushing of sediments and nutrients through our stream systems. s saw 40-year high record water elevations. The District will be attempting to repair this situation in the upcoming years by implementing best management practices in Campbell Creek and in the surrounding uplands with the help of local entities such as the MN DNR and Becker County Soil and Water District.

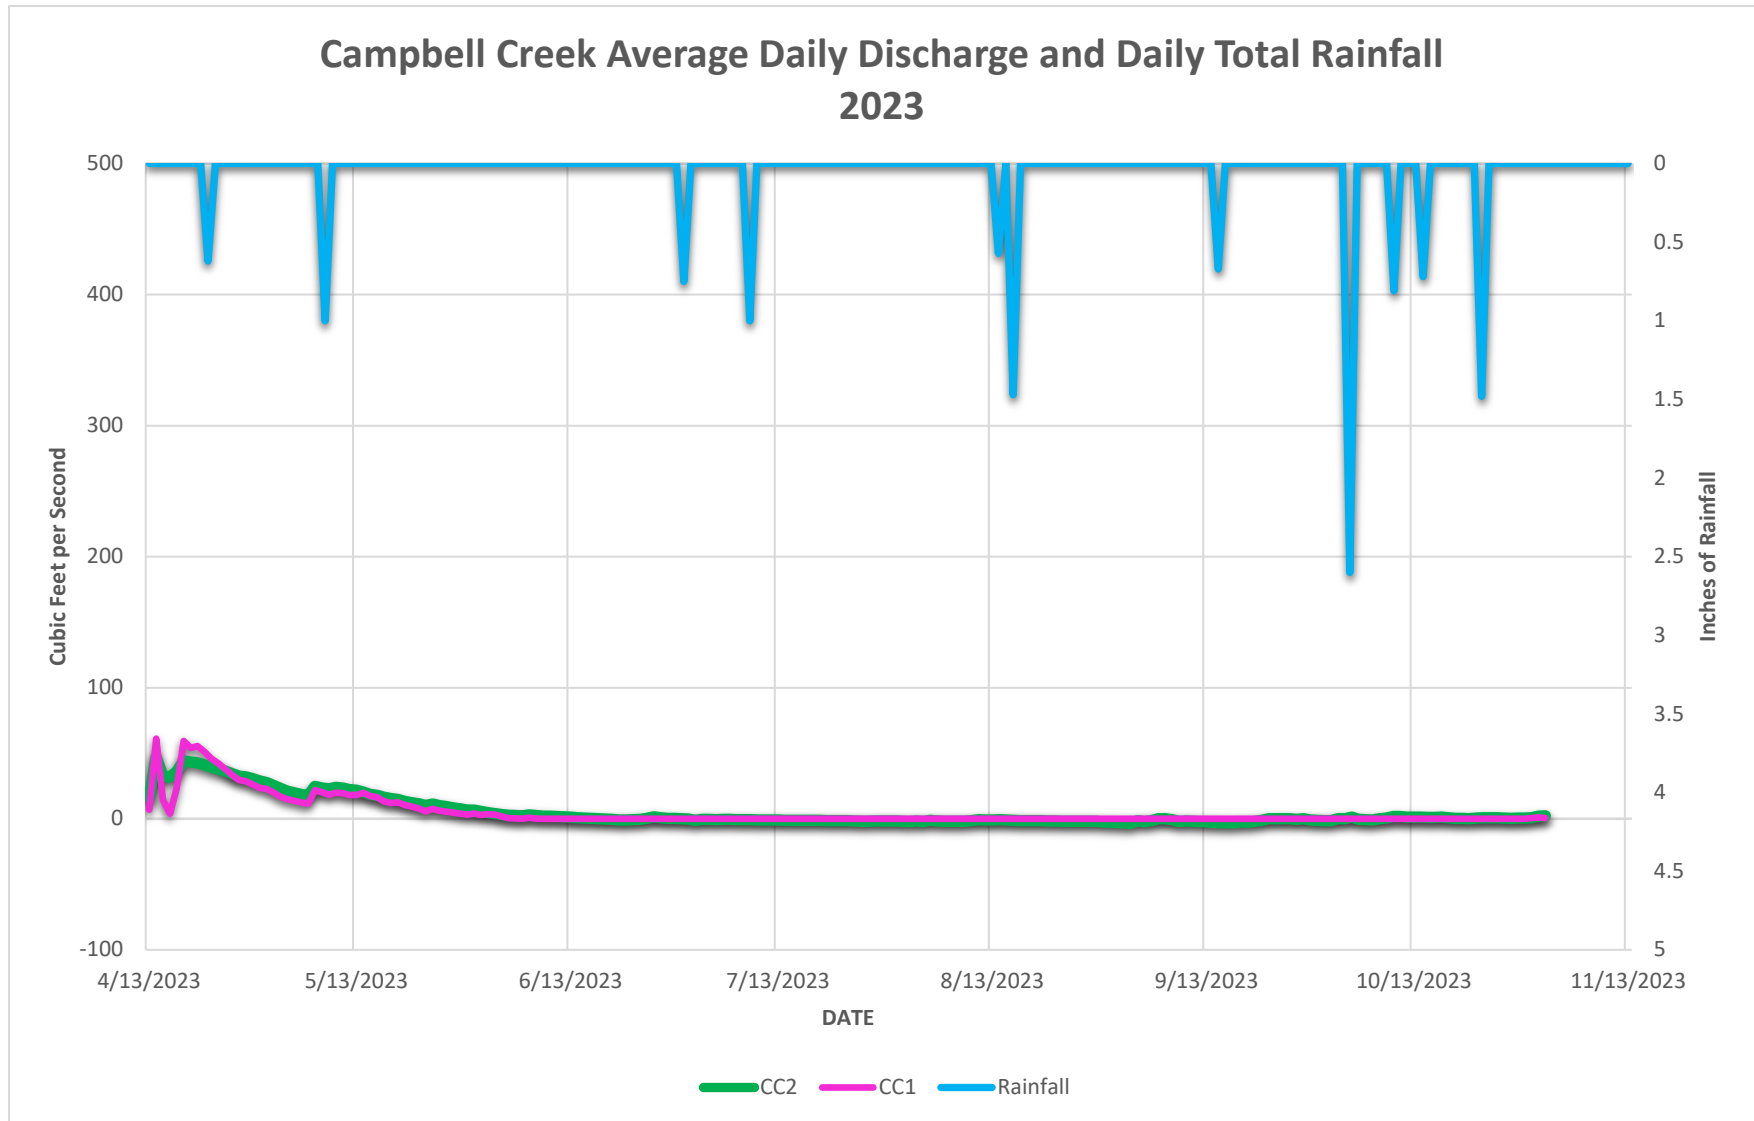
Figure 5.22 2023 Average daily flows in Campbell Creek and Daily Total Rainfall. Data from Campbell Creek at 230th St (CC2) and CSAH 149 (CC1).

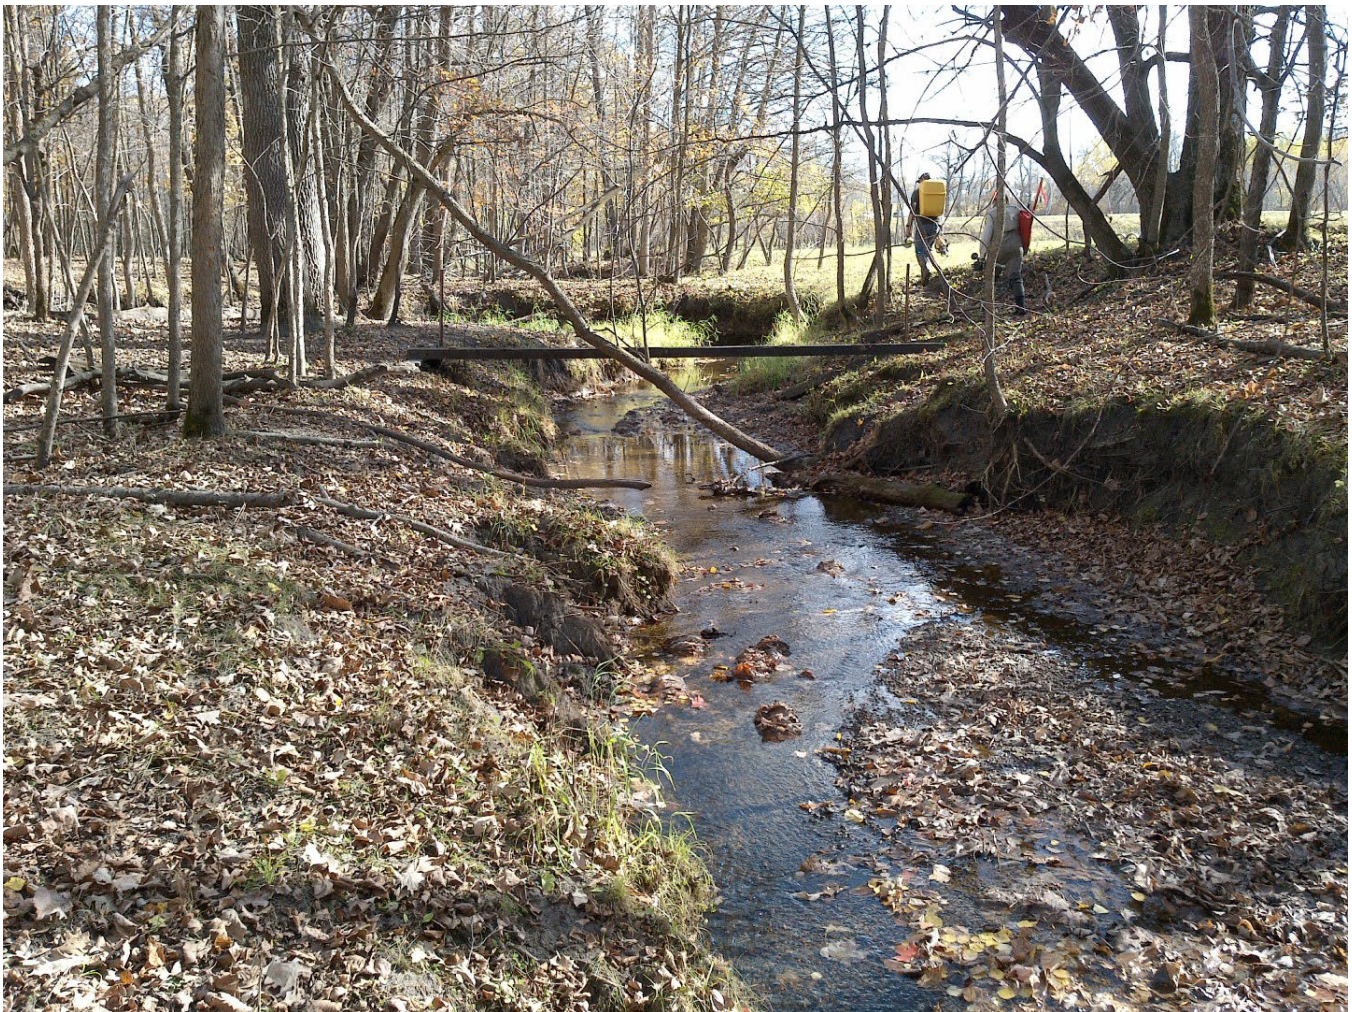
Figure 5.23. Example of bank erosion on Campbell Creek. North of CSAH 149.

The District continues its cooperative partnership with the MN DNR to study stream channel erosion on Campbell Creek from Campbell Lake to Floyd Lake. District Staff has obtained some funding through the 319 Grant to help get started on the construction for the much-needed improvements to this area. Staff noted downcutting of the channel bed, undercut banks, and extensive erosion to outer stream banks (Figures 23, 24, 25, 26 and 27). The area North of CSAH 149 is seasonally grazed by livestock, and no exclusion fence is present. Livestock have been destabilizing stream banks and stream riffles. Staff also suspect high stream velocity is to blame. With the planned improvements we have high hopes that this will improve these impairments.

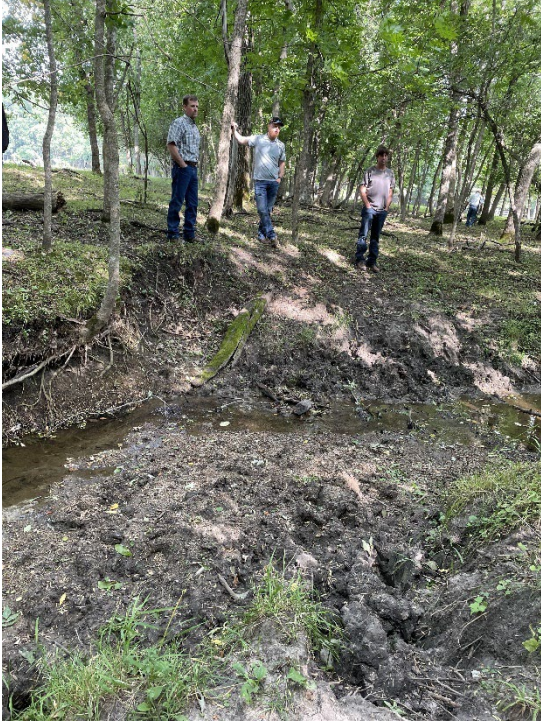
Figure 5.24 Targeted areas of stream channel erosion

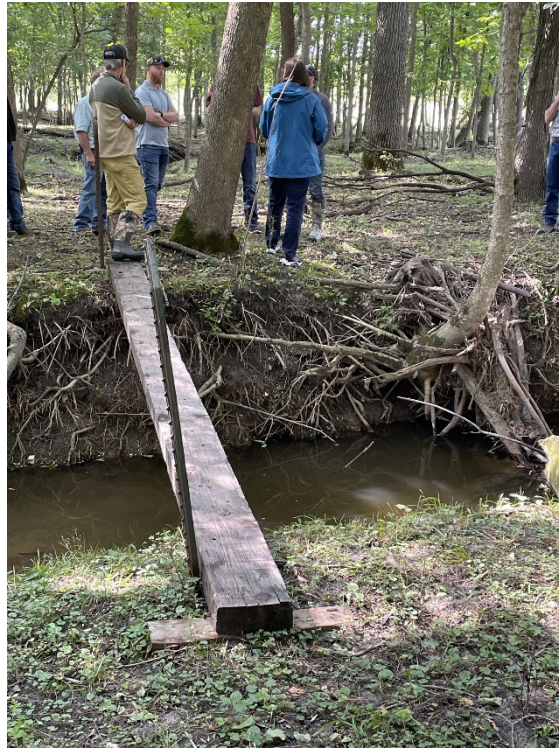
Figure 5.26 Targeted areas of stream channel erosion

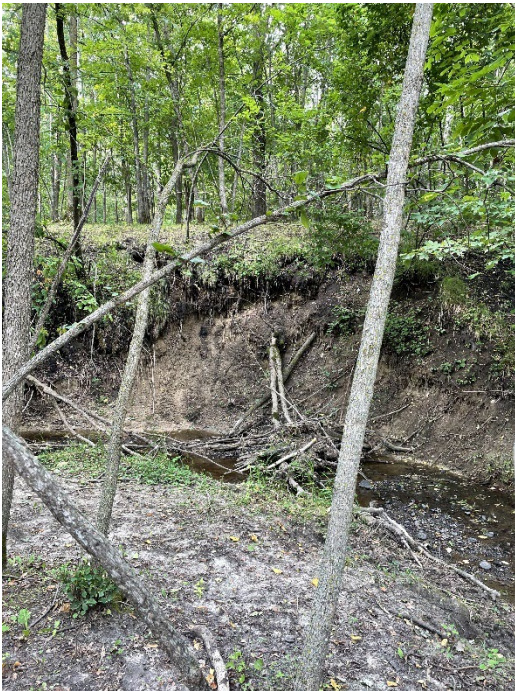
Figure 5.25 Targeted areas of stream channel erosion

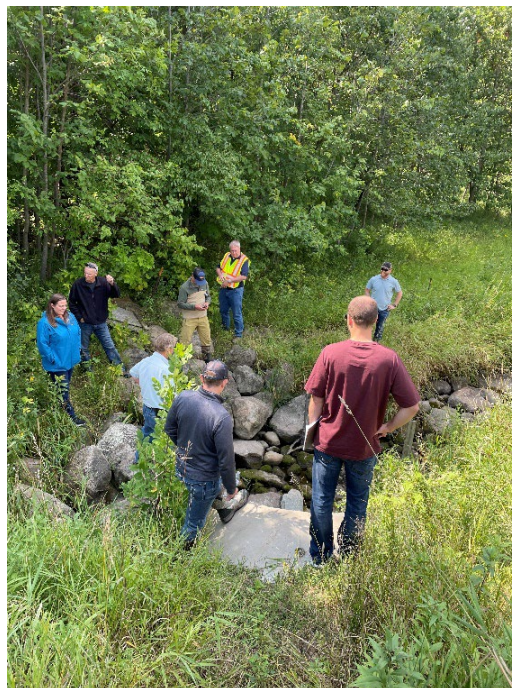
Figure 5.27 Targeted areas of stream channel erosion

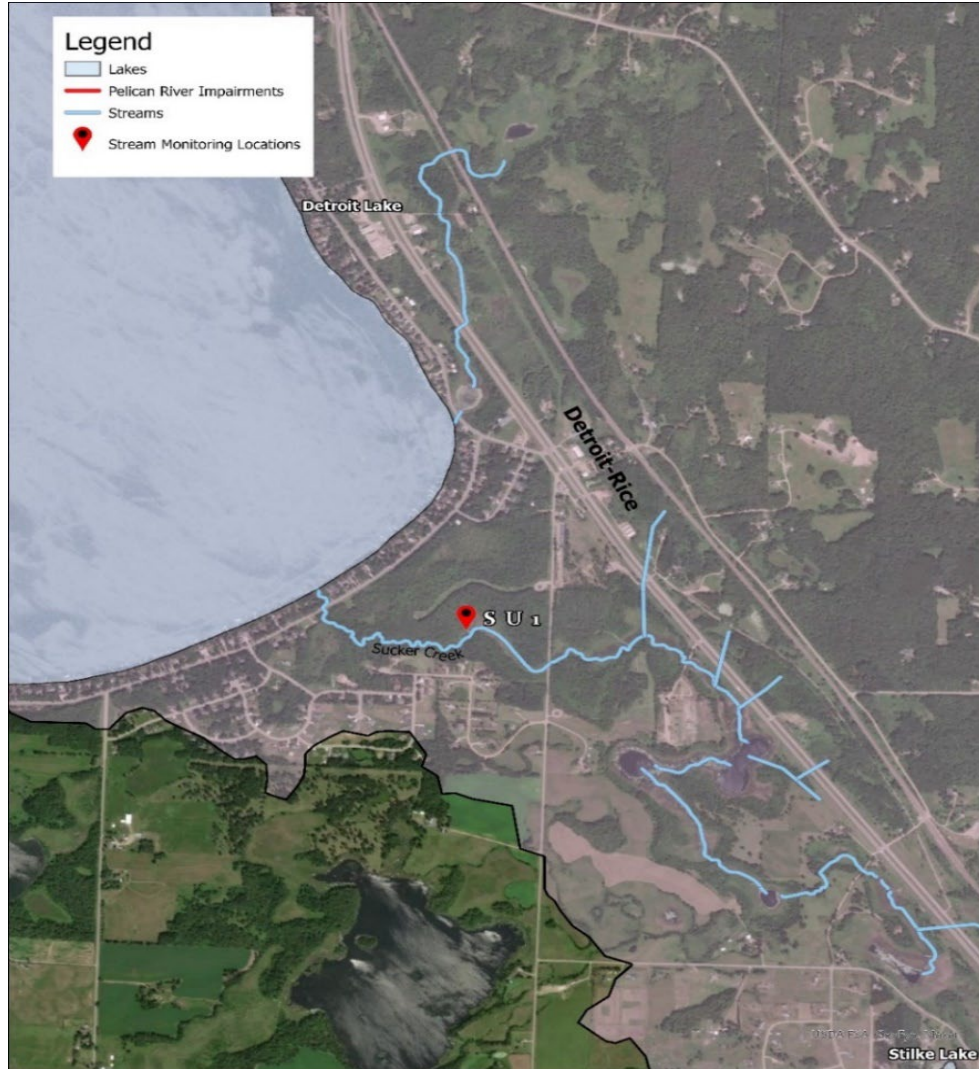
Sucker Creek is the District’s only designated trout stream. Sucker Creek is a natural creek that flows into the Southeast shore of Big Detroit Lake. The Sucker Creek Nature Preserve serves as a protection area for Sucker Creek and provides educational kiosks to help educate people about the benefits of natural stream and forest area eco-systems. The District has one monitoring station within the preserve.

Figure 6.16 Sucker Creek sampling location

Staff collected 15 samples from May – mid August, until the creek stopped flowing. Average TP was at 34 $\mu\text{g/L}$ and OP was at 19 $\mu\text{g/L}$. TP concentrations consistently spiked during storm events, affecting the annual average concentrations. Dissolved Oxygen (DO) readings averaged 8.1 mg/l, sufficient for trout to use the stream for spawning (Figure 6.16).

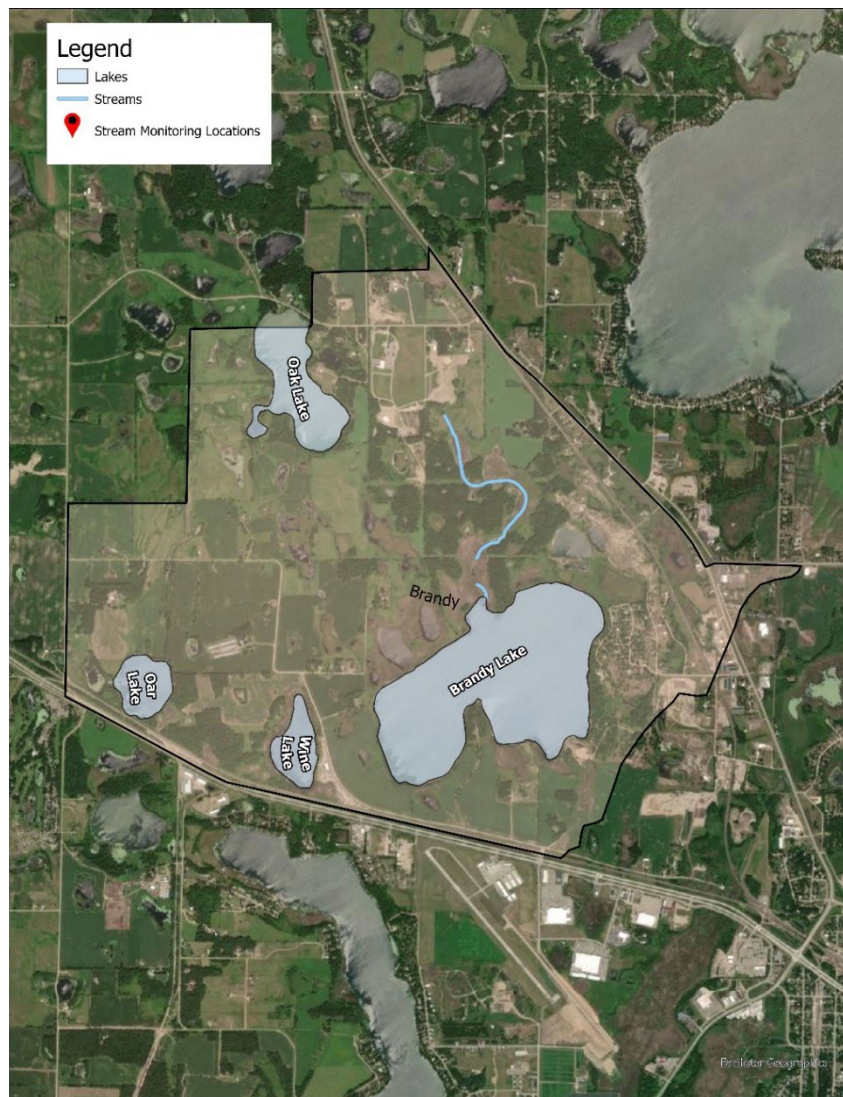
The Brandy/Wine WMA contains about 3,000 acres (Figure 8.1). Four named lakes exist within this area; Brandy, Wine, Oak, and Oar, however several small unnamed lakes and wetlands also dot the WMA. Brandy Lake is the largest lake, at 323 acres. The other lakes are smaller and have small watersheds. Land in the Brandy WMA is mostly used for cultivated crops or pasture, and shoreline along the lakes is mostly undeveloped. This is partly because the shallow nature of these lakes makes them ill-suited for recreation. Approximately 10 percent of the WMA is owned by the U.S. Fish and Wildlife Service. Brandy Lake historically suffered from poor water quality from the former Becker County Landfill but has improved through remediation. Wine Lake is impaired due to excess nutrients, and the District will work with MPCA to develop a TMDL. Oak lake was sampled in 2020 for water quality.

Figure 8.1 The Brandy/Wine Water Management Area.

Oak Lake is an 86-acre, natural environment lake with a maximum depth of 16ft (Figure 8.1). The lake is boarded by United States Fish and Wildlife Service property on the Northwest and Southeast sides of the lake, with some private land ownership. Little is known about Oak Lake other than a vegetation survey performed by the MN DNR in 2018. The survey found plants only in areas less than 8ft deep, indicating poor water clarity. A nearby landowner indicated water levels had increased in the last 50 years, and livestock were previously kept in an area currently flooded, possibly causing internal loading.

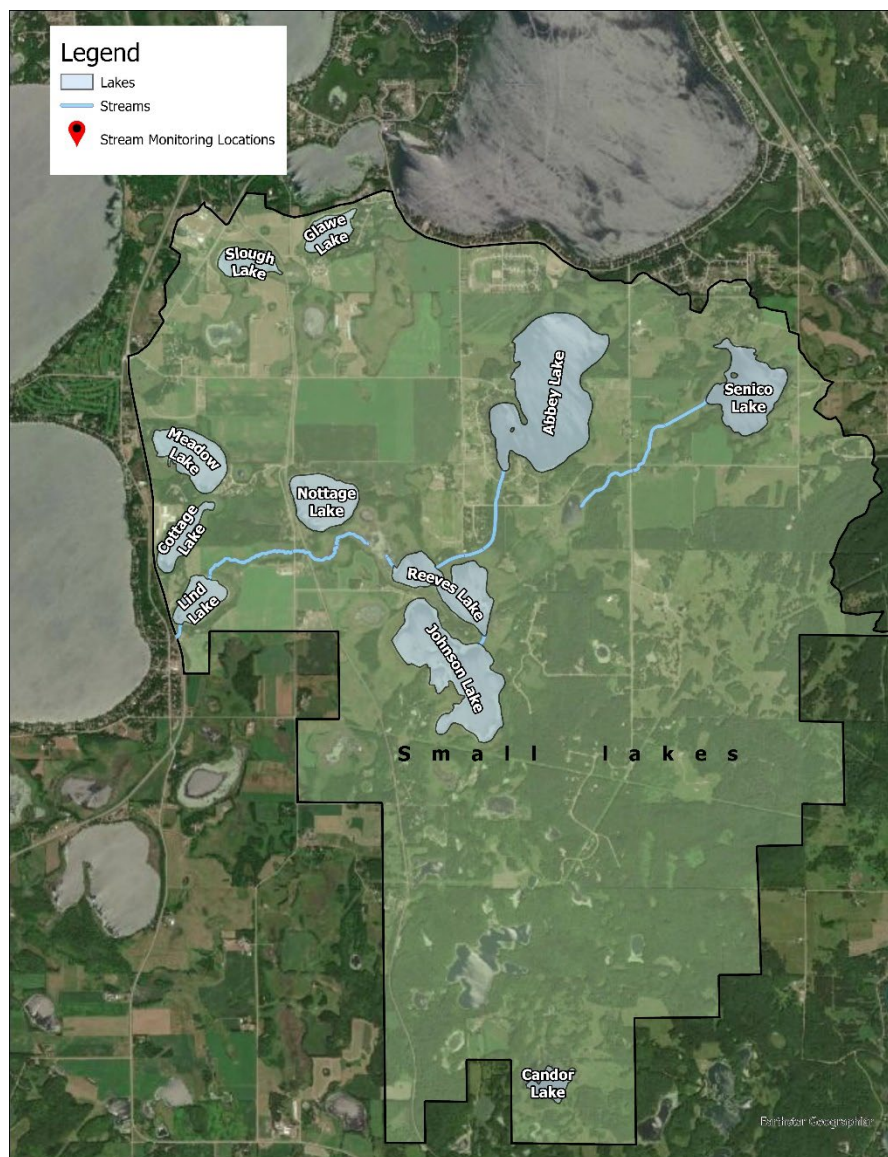
The Small Lakes WMA consists of about 11,000 acres in the southeastern corner of the District (Figure 11.1). This WMA extends into Ottertail County and contains numerous small lakes and wetland areas. Many of the lakes are connected by means of wetlands, and the overall drainage of the area is indistinct. Land use in this WMA can be roughly divided into the northwest half and the southeast half. The northwest half of the WMA contains significant agricultural areas, as well as most of the lakes and wetlands in the WMA. The southeast half of the WMA is mostly forested with steep slopes. Less than 2 percent of the WMA is covered by impervious surface. The shorelines of the lakes in this WMA are sparsely settled but have recently seen more development interest, Johnson and Reeves Lakes in particular. Water quality data has been collected for Abbey, Meadow, Johnson, Reeves, Lind, and Glawe. Lind drains into Melissa Lake in the Sallie-Melissa WMA, making it the last lake in the WMA.

Figure 11.1 The Small Lakes Water Management Area.
