## **Wetland Aeration for Phosphorus Reduction: Results of Ditch 14 Summer Projects**

December 1999

Dr. Richard Hecock  
Pelican River Watershed District  
Detroit Lakes, MN

Steve McComas  
Blue Water Science  
St. Paul, MN 55116  
(651) 690.9602

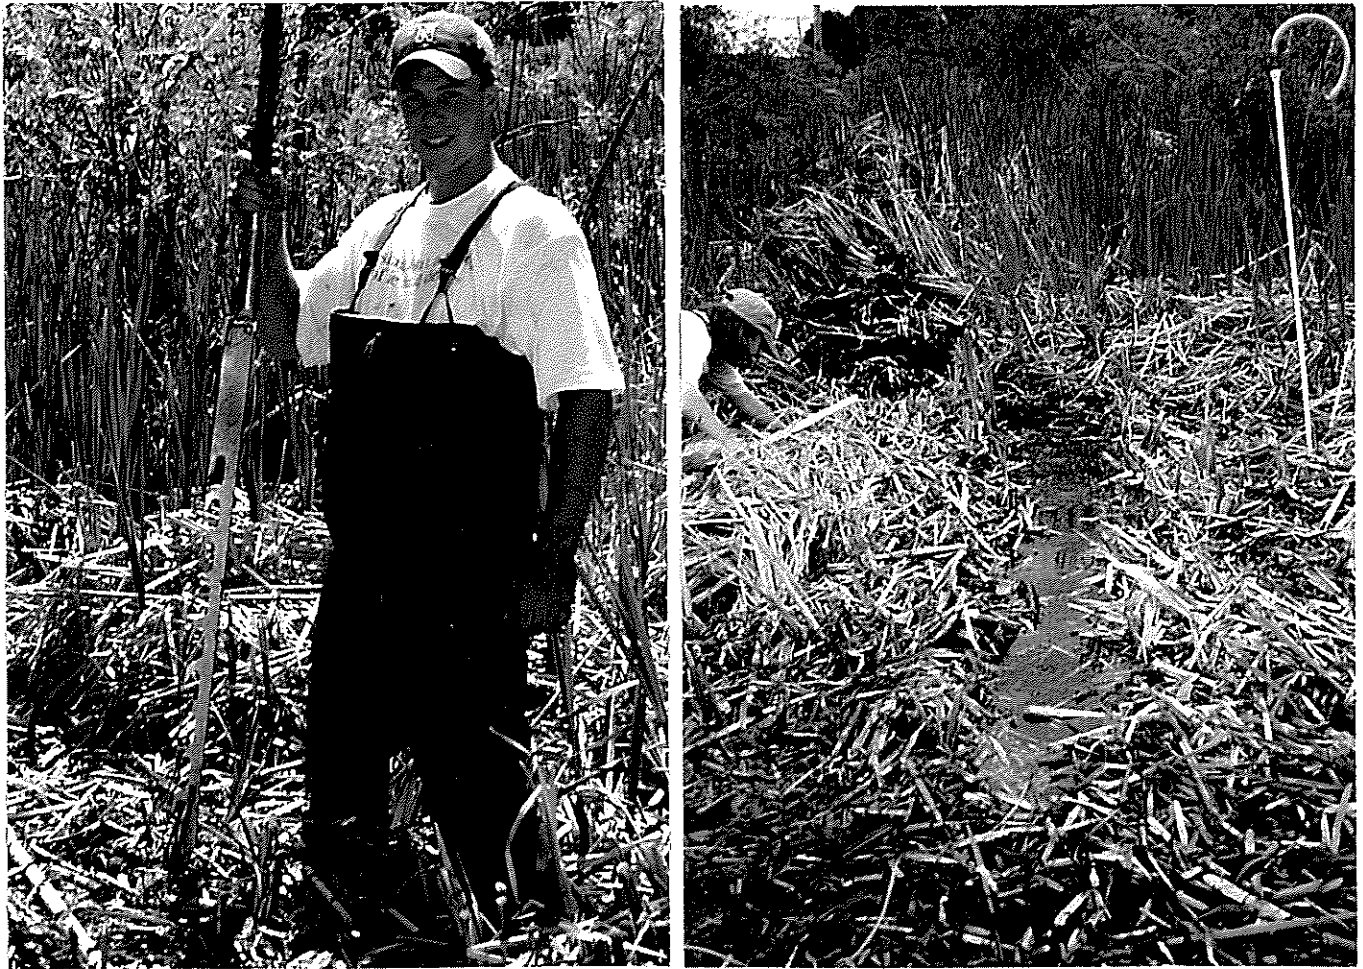
Figure 1. [left] An ice saw was used to cut the peat in the wetland. [right] The trench was 10 feet long, 0.5 feet wide and about 3 feet deep. In this area the peat mat was about 1.5 feet thick and was floating on top of about 2.0 feet of peaty water.

A short wetland trench about 10 feet long was cut into a wetland using an ice saw (Figure 1). The wetland trench was located in the SC 4 area (Figure 2). An airline along the bottom of the trench injected compressed air from a nearby solar powered aerator at a rate of 0.18 cfm. The configuration of the sampling wells are shown in Figure 2. The intent was to sample phosphorus and iron 1 meter up gradient of the aerated trench, then sample the trench, and sample down gradient from the trench in wells 3, 4, 5, 6, and 7. Wells 8 and 9 were to be used as background wells.

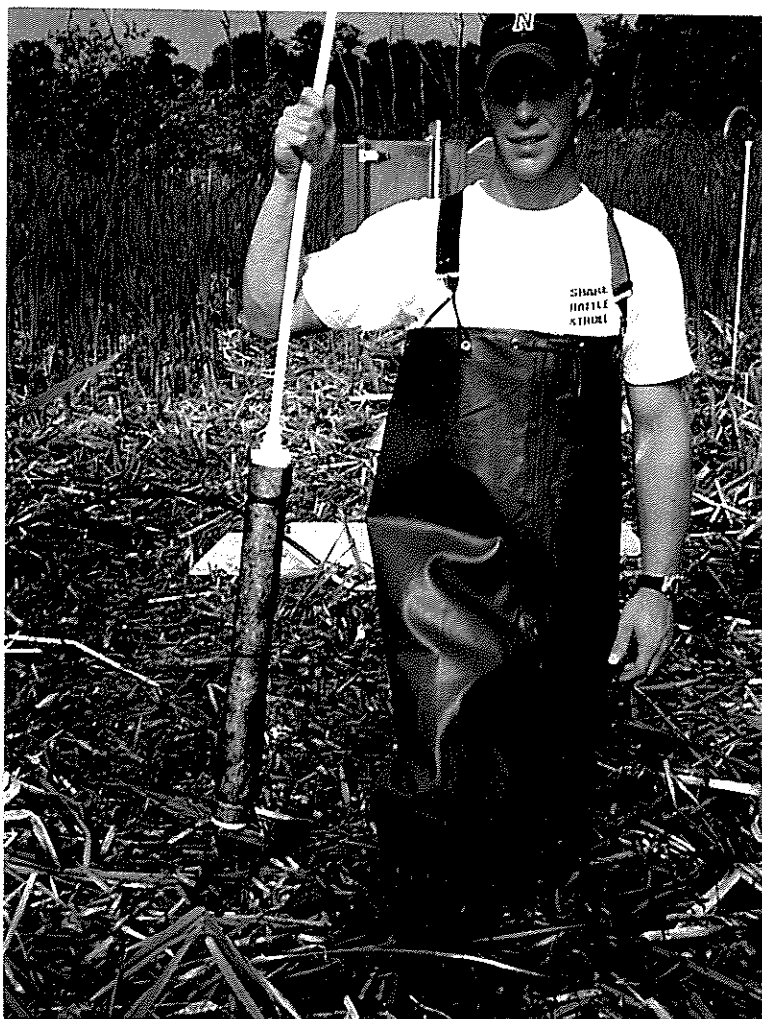
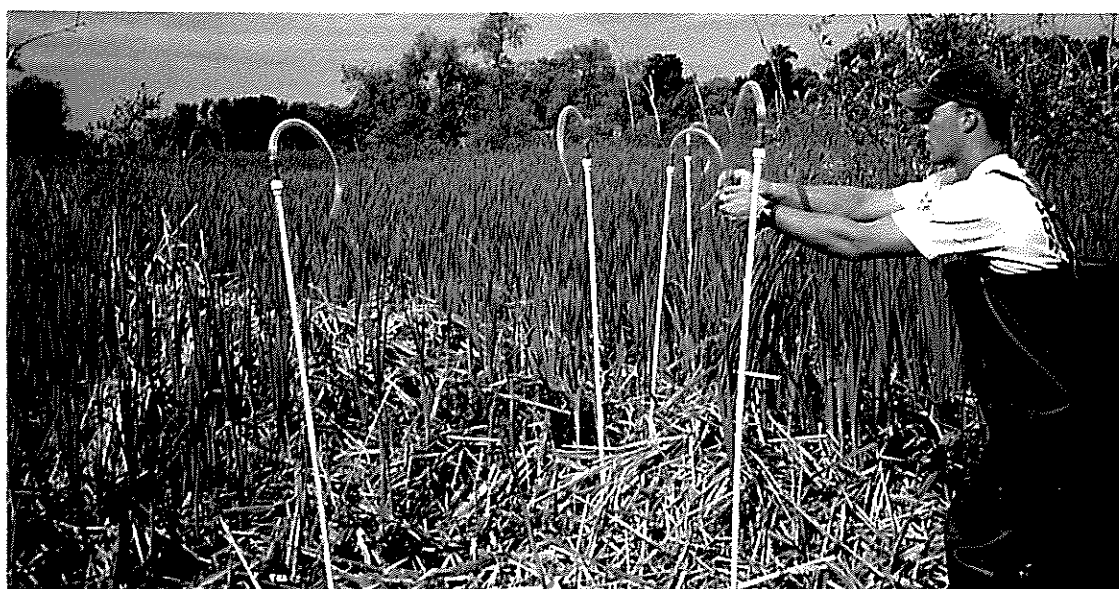
Figure 3. [top] Example of a water sampling well used in the wetland.  
[bottom] Wetland interstitial pore water was collected from this array of wells to monitor impacts of trench aeration.

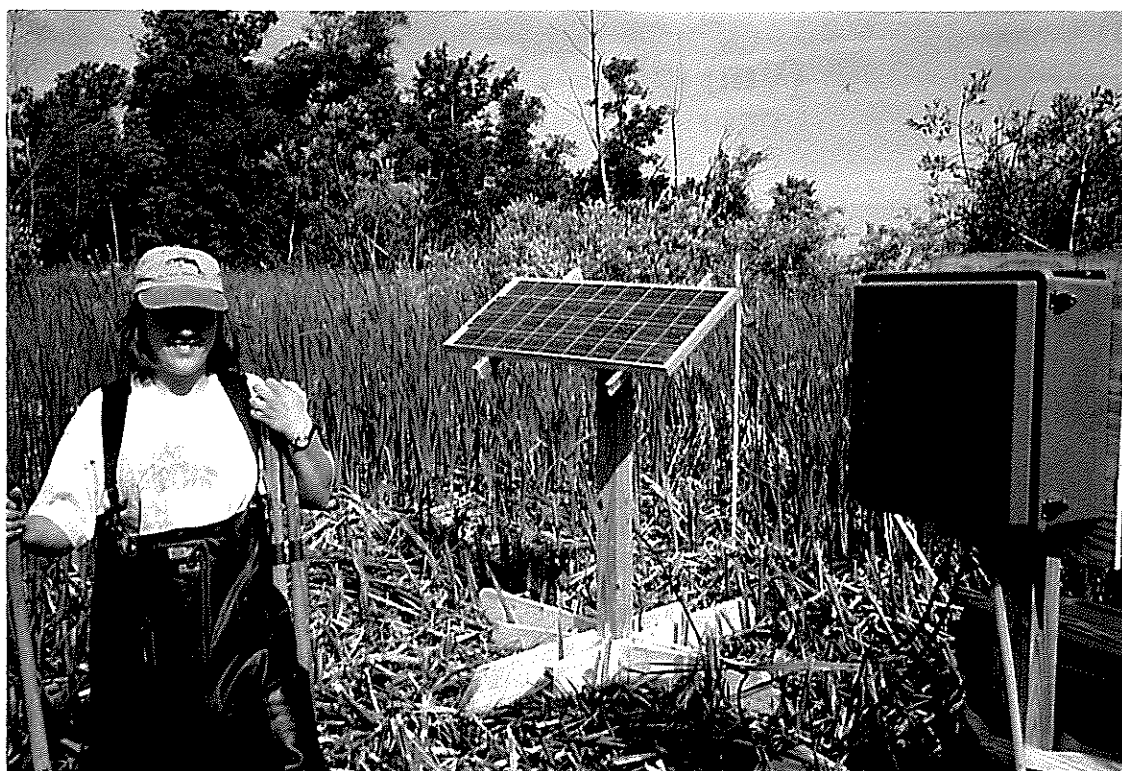
Figure 4. The solar powered aeration system ran off of one solar panel and the air compressor delivered 0.18 cubic feet of air per minute.

Solar powered aerators can work in Minnesota (Figure 4). Air bubbles were visible in the groundwater in the trench (Figure 5) throughout the project duration except for a one-week period when holes appeared in the feeder line and air was not delivered to the trench. The feeder line was repaired and air flow was restored to the trench.

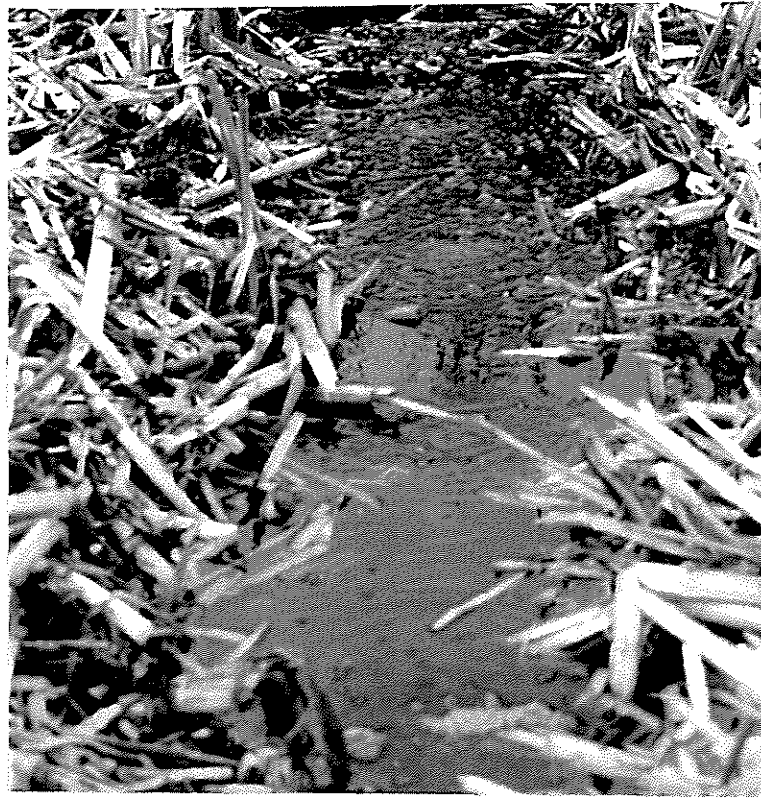
Figure 5. Air bubbles in the wetland trench originate from the submerged air line which comes from the solar powered aerator. The trench had a positive redox reading in July and August.

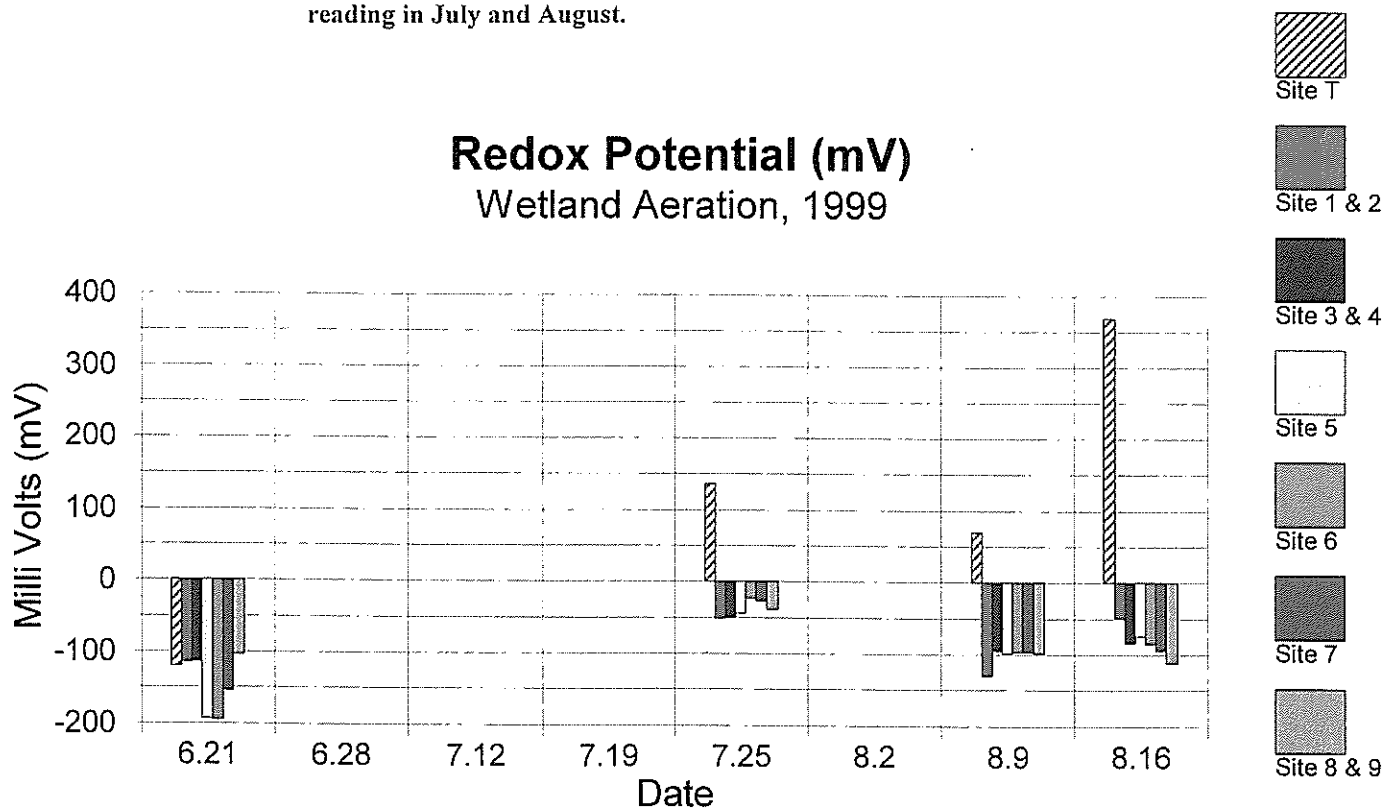
Figure 6. Redox readings (in milliVolts) were taken in June, July, and August from the sample wells. June represents initial conditions. The trench had positive readings in July and August. Sites 1-7 had higher readings compared to initial conditions. Sites 8 and 9 were impacted in July but not in August.

Dissolved oxygen was found at low levels in all the monitoring wells (Appendix A). Redox measurements (in millivolts) measure the oxidizing or reducing potential in the groundwater. Water in the trench was oxidized based on redox measurements, whereas redox in the monitoring wells, both up gradient and down gradient had reducing conditions (Figure 6). However, redox conditions in the up gradient and down gradient wells were higher (more oxidizing) in July and August compared to initial conditions in June (Figure 6).

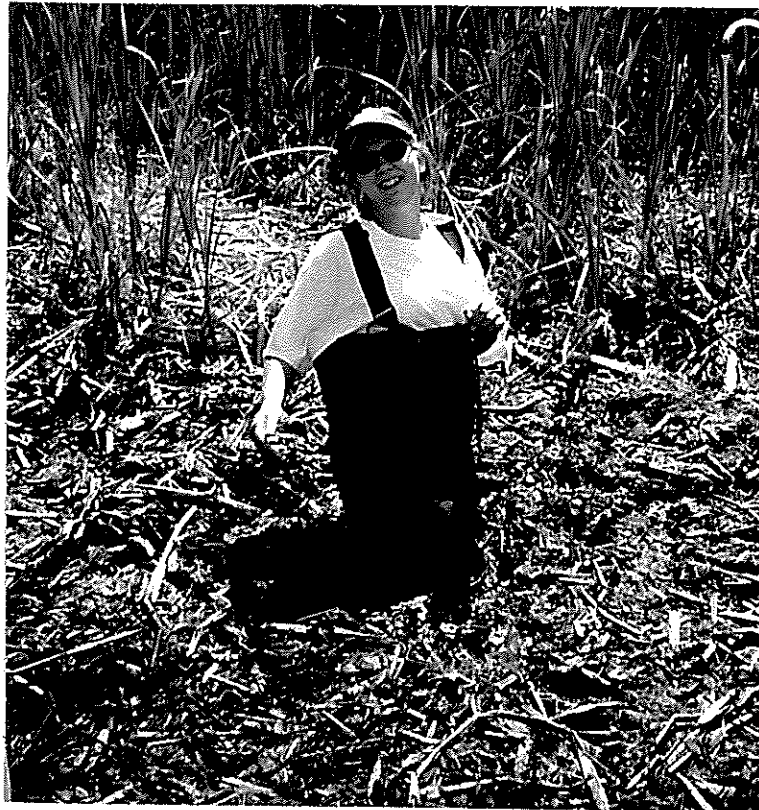
**Figure 13.** Rochelle Nustad, PRWD summer staff, has punched through the floating cattail mat and is standing/floating in the peat slurry. We have referred to this type of wetland setting as a semi-solid wetland.

Wetlands that export phosphorus can have different peat structures. Some wetlands are packed with solid peat while others, like cattail marshes, may not be solid peat but rather their root mat may float on top of a semi-solid peat slurry. These could be characterized as semi-solid wetlands. Trenches would probably hold up in solid wetlands, but not in semi-solid wetlands. The Ditch 14 wetland test site is located in a semi-solid wetland.

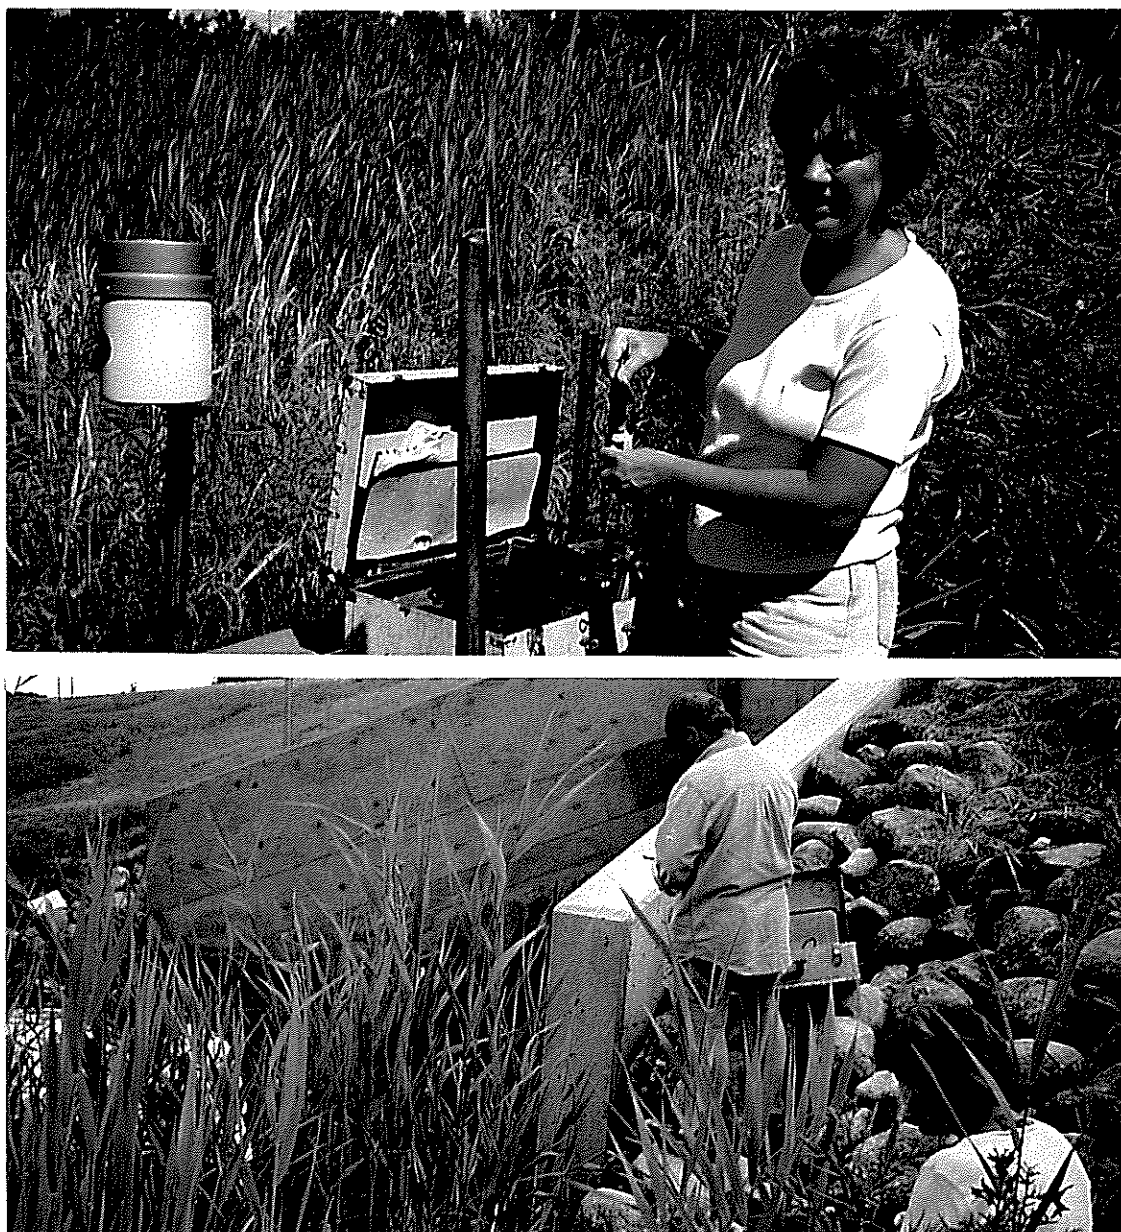
Figure 14. [top] Tera Guetter, PRWD staff, is downloading data from SC4 a station on Ditch 14. [bottom] Tim James, MPCA, is collecting water samples in the Pelican River downstream from where Ditch 14 discharges into it.

By midsummer we realized the wetland trench technique might be unnecessary if we could accomplish the same objectives by just aerating the shallow Ditch 14. Information on Ditch 14 was collected in July and August at several locations (Figure 14).

The outlet of Ditch 14 is the established monitoring site SC 4 that has been sampled for at least 10 years by the PRWD. We did additional monitoring in Ditch 14 in July and August.
