Pearl Lake Diagnostic Study Clean Water Partnership

Becker County, MN

Prepared by Jonathan Staldine
Pelican River Watershed District

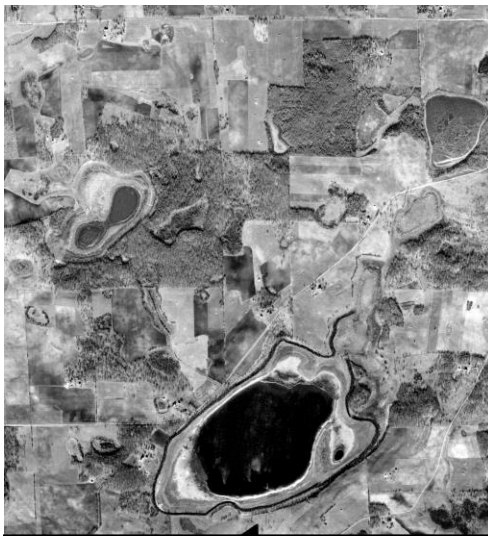
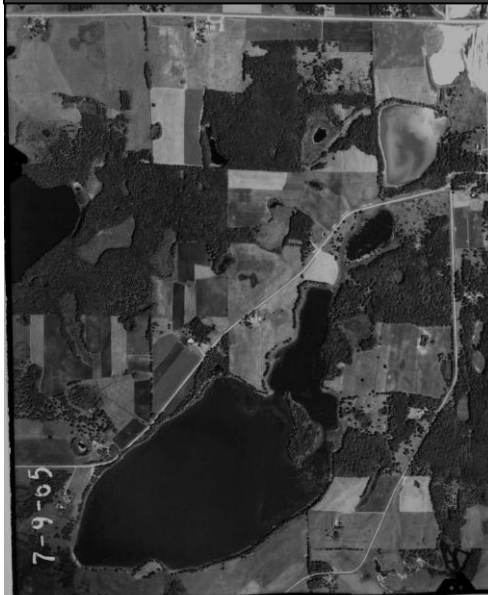
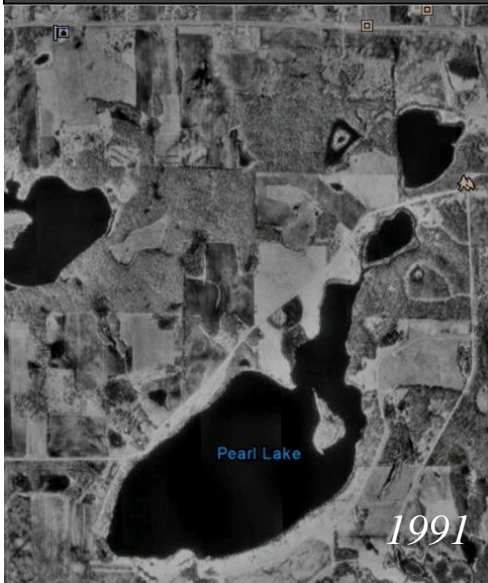
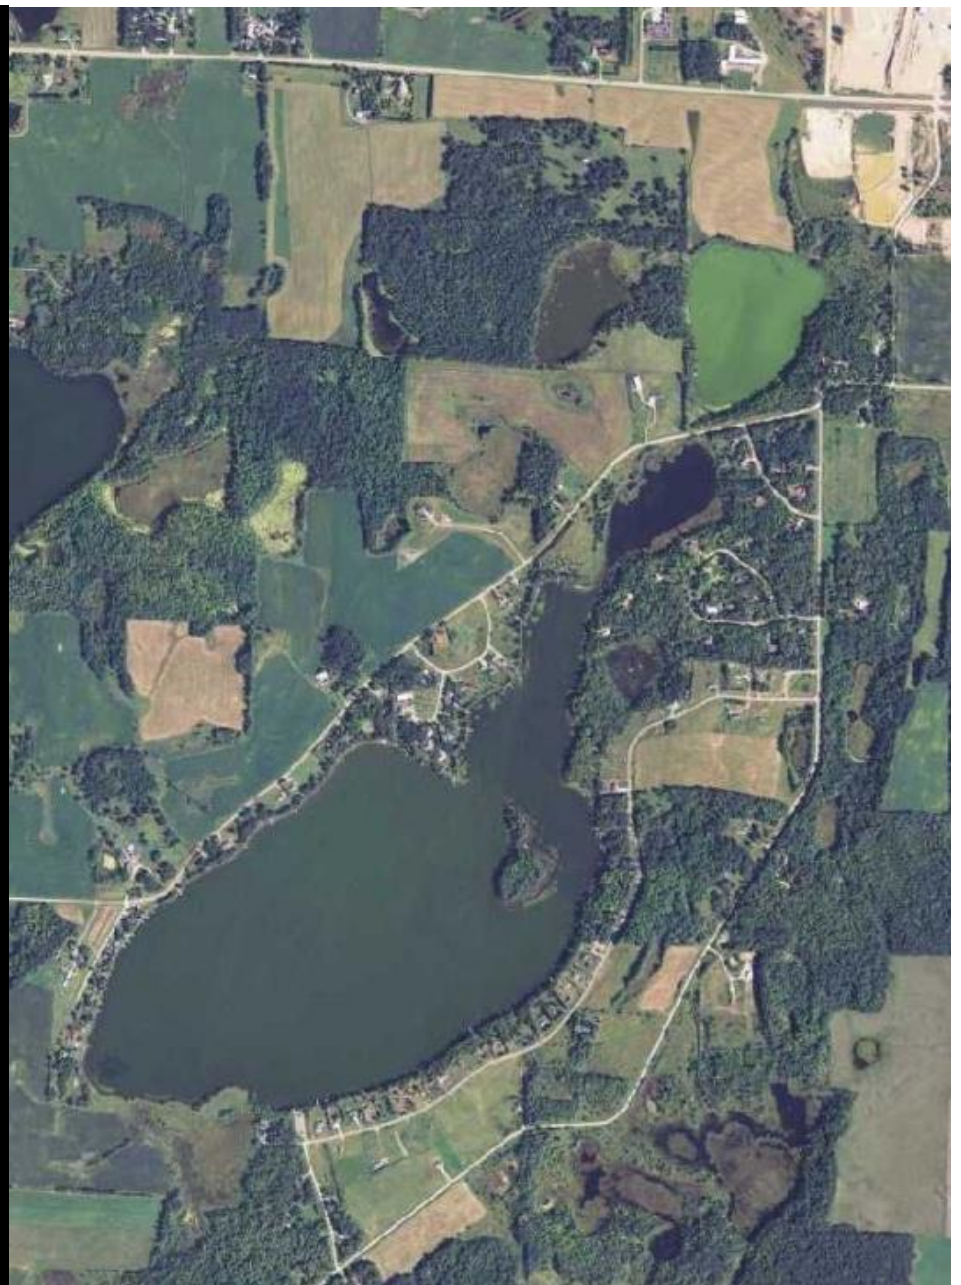
Like other areas in Lake Eunice Township, the Pearl lake area has witnessed rapid conversion of agricultural uses to development in lake-oriented second homes and primary residences. In 1983 a very large part of the riparian shoreline was either cultivated or grazed; there were only 2 riparian residences. By 2003 the riparian agricultural practices were gone, and approximately 32 riparian residences were present. In 2013, there are 57 such residences and an additional 21 second tier residences (in the Shoreland District, within 1000 feet of the shoreline). There remain approximately 12 acres of cultivated land within Pearl's Shoreland District. 16% of the shoreline remains undeveloped in several large tracts, though some of this area is not suitable for development by virtue of poor drainage. Figure 2.4.1 compares aerial photos from 1939, 1965, 1991, and 2003 to demonstrate this succession.

Pearl Lake has dramatically changed over time in terms of lake morphology as well as developmental character. In the past two decades Pearl Lake has rapidly gained shoreline residential development and stabilized into the profile observed today. Historically, Pearl Lake lacked a well defined outlet, which has led to variable water levels. Within the time frame of 2000 to 2010, a well defined outlet was created setting the run-out elevation at 1356.50' above mean seal level.

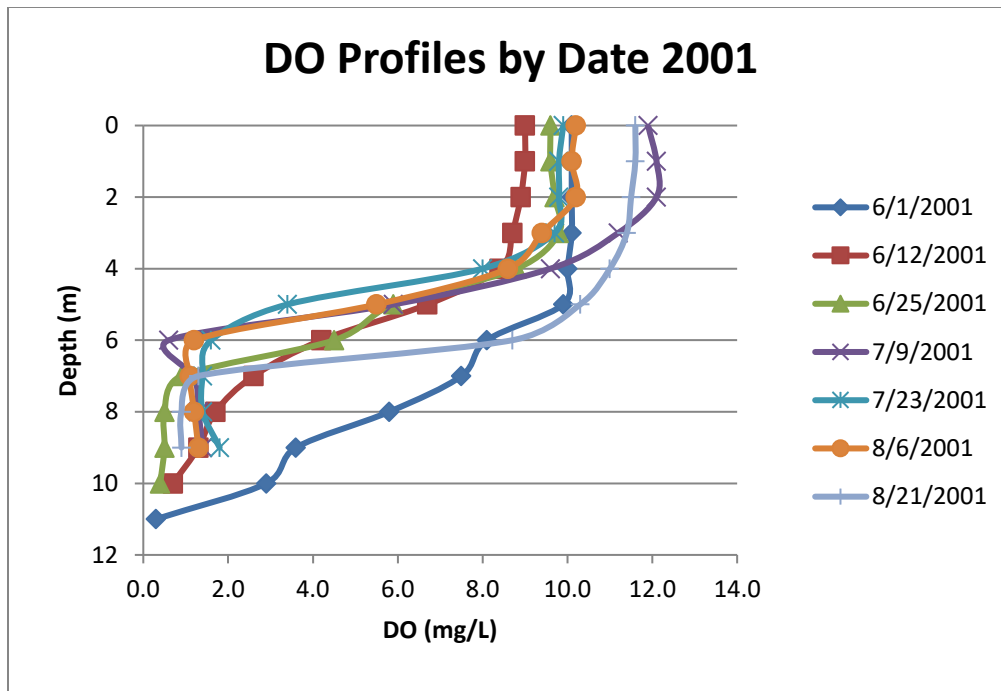
Figure 2.9.1b. DO concentration by depth, 2001.

Background Data on Pearl Lake for Dissolved Oxygen for the 2001, 2005, 2008 & 2009 seasons are presented below (Figures 2.9.1b-d). Data from the 2010-2012 monitoring period for the Diagnostic Study fit squarely within this trend. At depths of 6 meters or more, Pearl Lake typically displays anoxic conditions.

Anoxic conditions affect the release of phosphates from sediment accumulations, distribution of fish habitat, and organic material decomposition rates. Sudden drops in dissolved oxygen may indicate collapses of algal blooms that lead to fish kills. Pearl Lake exhibits consistent mixing to a depth of around 6 meters (approximately 20 feet), where conditions are most suitable for fish habitat.

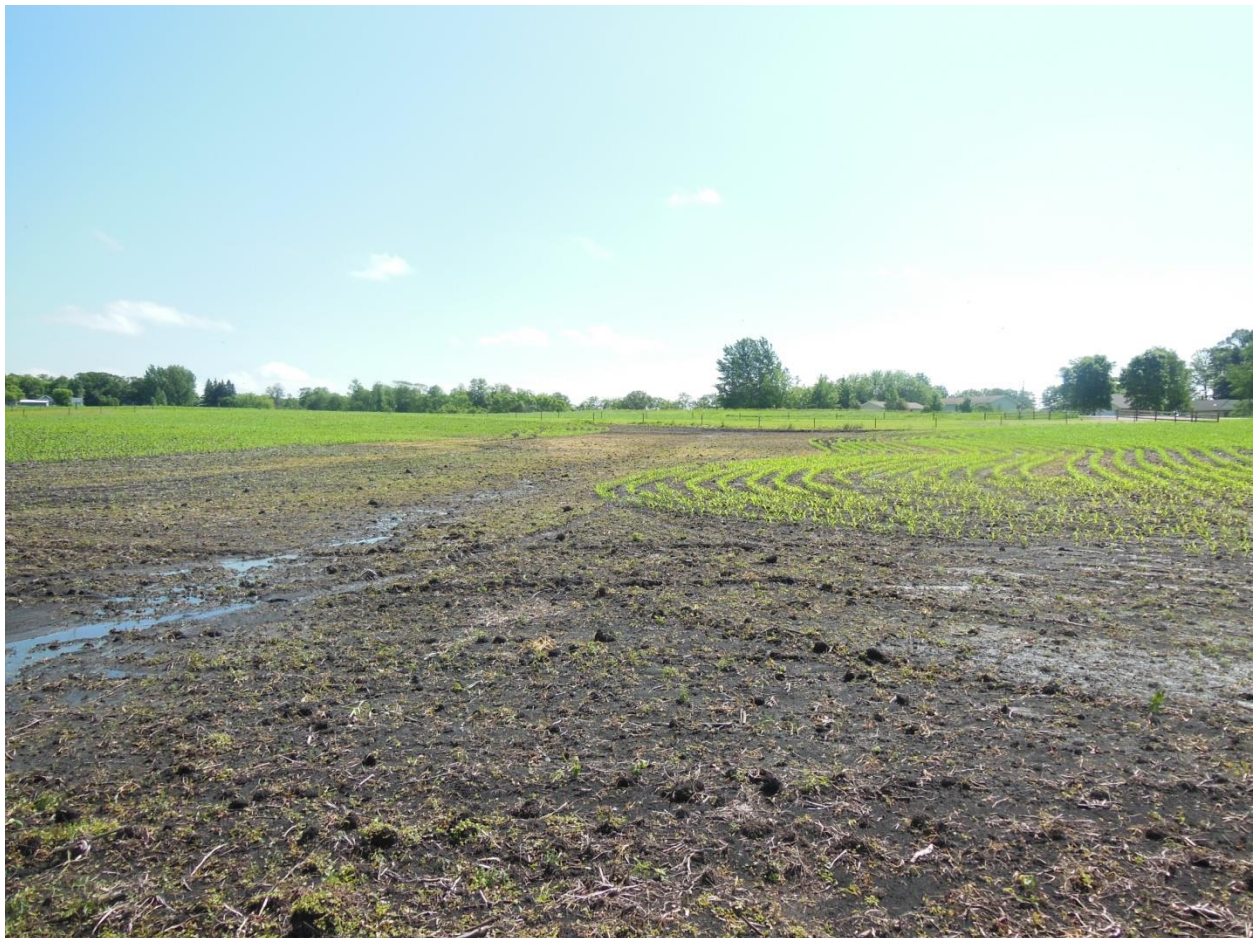
Figure 5.3.2a Linear drainage, Possible Grassed Waterway

However, there is still room for improvement within the 199 acre agricultural area draining into Pearl Lake from the West. This basin was found to contribute 17lbs of phosphorus annually. Figure 5.3.2a shows an area where a small grass waterway might be appropriate, and Figure 5.3.2b demonstrates an ideal placement for a native buffer strip planting. Effectively capturing the sediment may mean up to an 80% reduction in phosphorus loading, as phosphorus is primarily sediment bound.

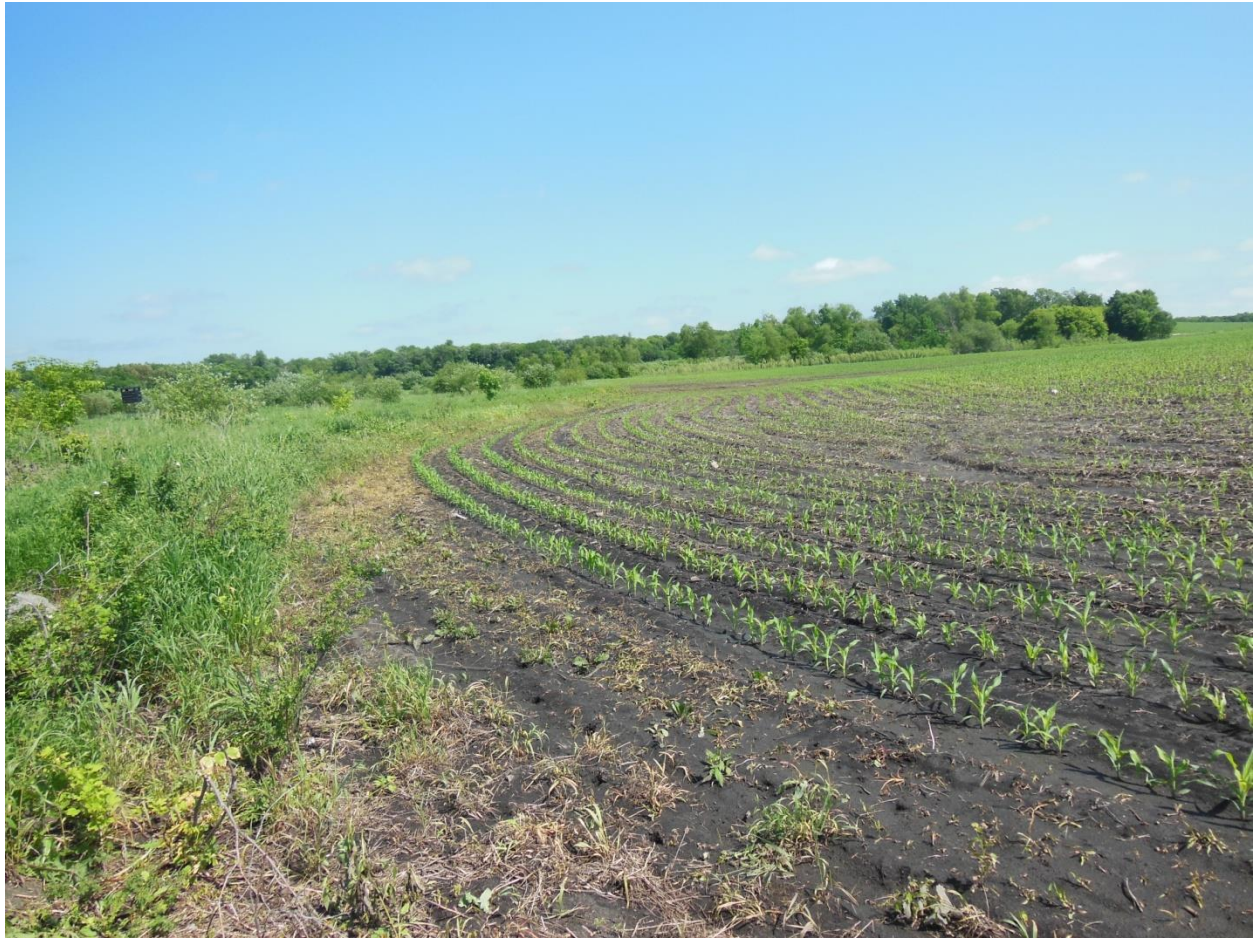
Figure 5.3.2b Corn planted in close proximity to ditch
