Stream Name	Campbell Creek	
Nearest Road	County Road 149	
Nearby MPCA Biological Site	None	
Drainage Area	12.6 square miles	
Stream Type - Existing	E5	
Stream Type - Potential	E4	
Valley Type	Unconfined Glacial (U-GL-TP)	
Entrenchment Ratio	2.53	
Width-to-Depth Ratio	7.67	
Sinuosity	1.3	
Slope	0.0015	
Particle Size (D50)	SAND (2 mm)

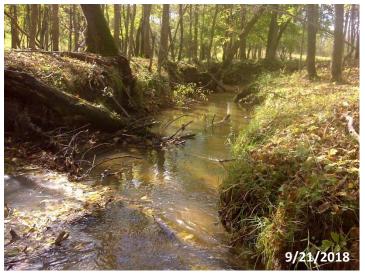
Campbell Creek originates near Richwood. It is considered an altered, public watercourse at 260<sup>TH</sup> Street and transitions to a public watercourse at 230<sup>th</sup> Street. It flows into Mud Lake north of Detroit Lakes. Campbell Creek was assessed upstream of CR 149. The channel flows through outwash glacial deposits (unsorted sand and gravel) and a stagnation moraine. The soil types within the riparian zone are silty clay loams (Soil Survey Staff NRCS, 2018).

The channel was narrow and deep, with a width-to-depth ratio of 7.67, and the substrate was predominantly sand-sized particles (E5 stream type). The total Pfankuch score was 101, which is unstable for E4 and E5 stream types. The channel was incised and did not have access to its adjacent floodplain during minor flood events. The bank-height ratio was 1.3. At two times the maximum depth of the riffle, the flood-prone width was approximately 25 feet wide.

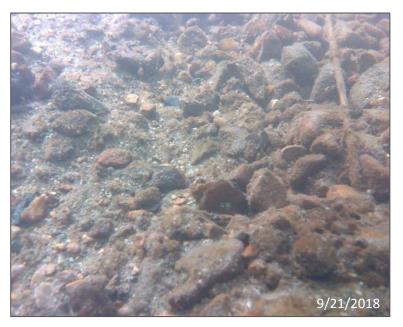
Campbell Creek was in an unstable condition at this site. The channel was incised, but it did have access to its adjacent floodplain during larger flood events. The channel bottom was inundated with excessive fine sediment, likely coming from the streambanks. It would be beneficial to correct the observed incision, reduce the loading of fine sediments to the stream, and evaluate any impacts that stream crossings are having on channel stability.

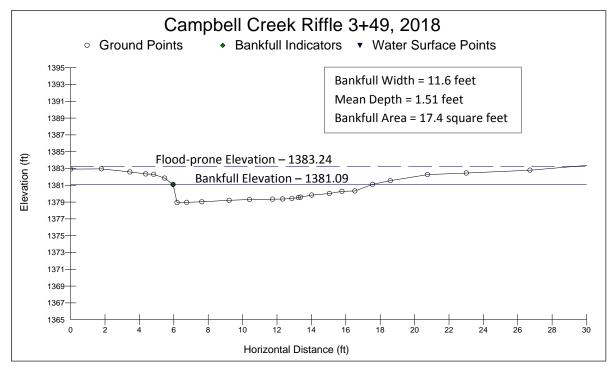
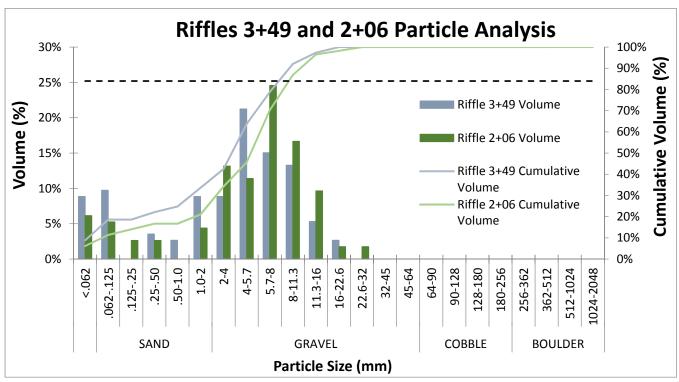
Channel Dimensions	Mean	Max		Mean	Max
Riffle Width (ft.)	12.1	12.6	Pool Width (ft.)	10.1	10.9
Mean Riffle Depth (ft.)	1.46	1.51	Mean Pool Depth (ft.)	2.31	2.35
Maximum Riffle Depth (ft.)	2	2.2	Maximum Pool Depth (ft.)	3.2	3.3
Riffle Cross-Sectional Area (sq. ft.)	17.5	17.6	Pool Cross-Sectional Area (sq. ft.)	23.3	24.6
Width of Flood-Prone Area (ft.)	25.5	29.3	Pool Width to Riffle Width	0.84	0.9
Riffle Width/Depth Ratio	8.3	9	Mean Pool Depth to Mean Riffle Depth	1.6	1.6
Entrenchment Ratio	2.1	2.5	Pool Area to Riffle Area	1.3	1.4
