# Upper Pelican River Subwatershed (HUC10 – 0902010307)

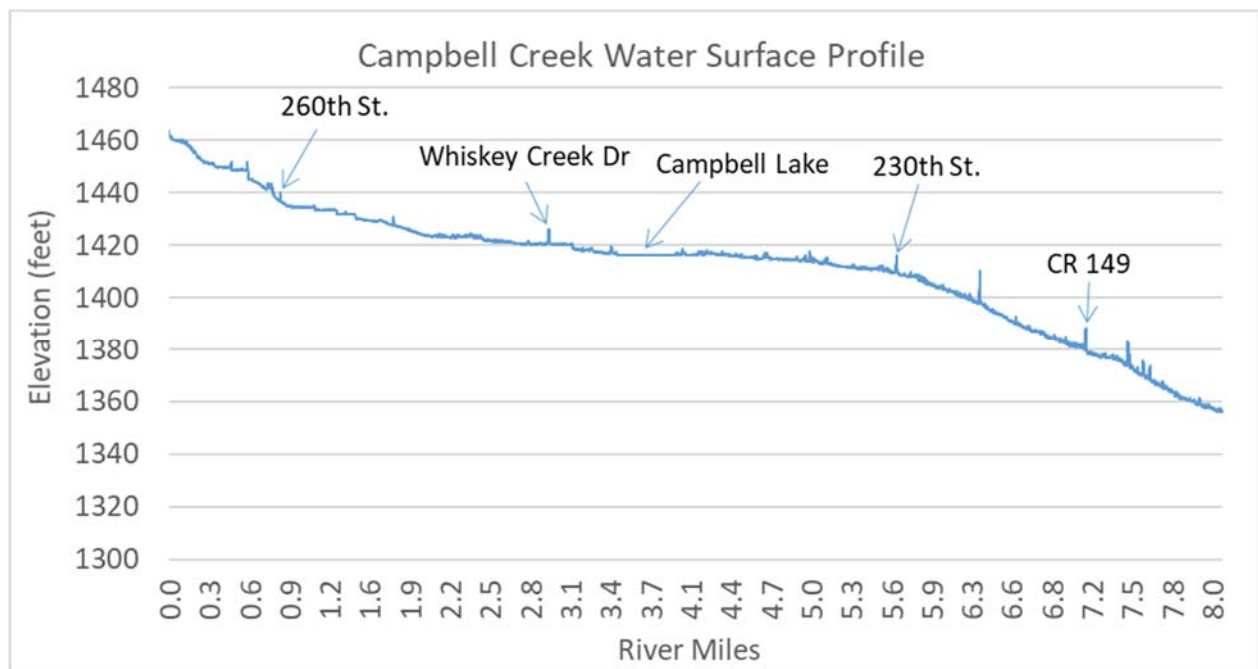
Figure 16. Campbell Creek LiDAR derived water surface profile.

Near the origination of Campbell Creek to around 260<sup>th</sup> Street the LiDAR derived water surface slope is 0.005 (Figure 16). From Whiskey Creek Dr. to 230<sup>th</sup> St. the slope is flatter (0.0006). The remaining length of the watercourse has a slope of 0.004. There are four water quality sample sites on Campbell Creek where total suspended solids (TSS) have been measured. The water quality TSS standard for this watercourse is 30 mg/L. From upstream to downstream the maximum TSS values collected were 31, 932, 76, and 1464 mg/L. The standard was exceeded 2%, 19%, 21%, and 21% of the time, respectively.
