Meadow Lake, Becker County, MN 2022 Aquatic Vegetation Management Report

G. L. Kemper. 2022. Meadow Lake, Becker County: 2022 Aquatic Vegetation Management Report.
Water Resource Coordinator Pelican River Watershed District, 211 Holmes Street W., Detroit Lakes, MN 56501. 16 pp.

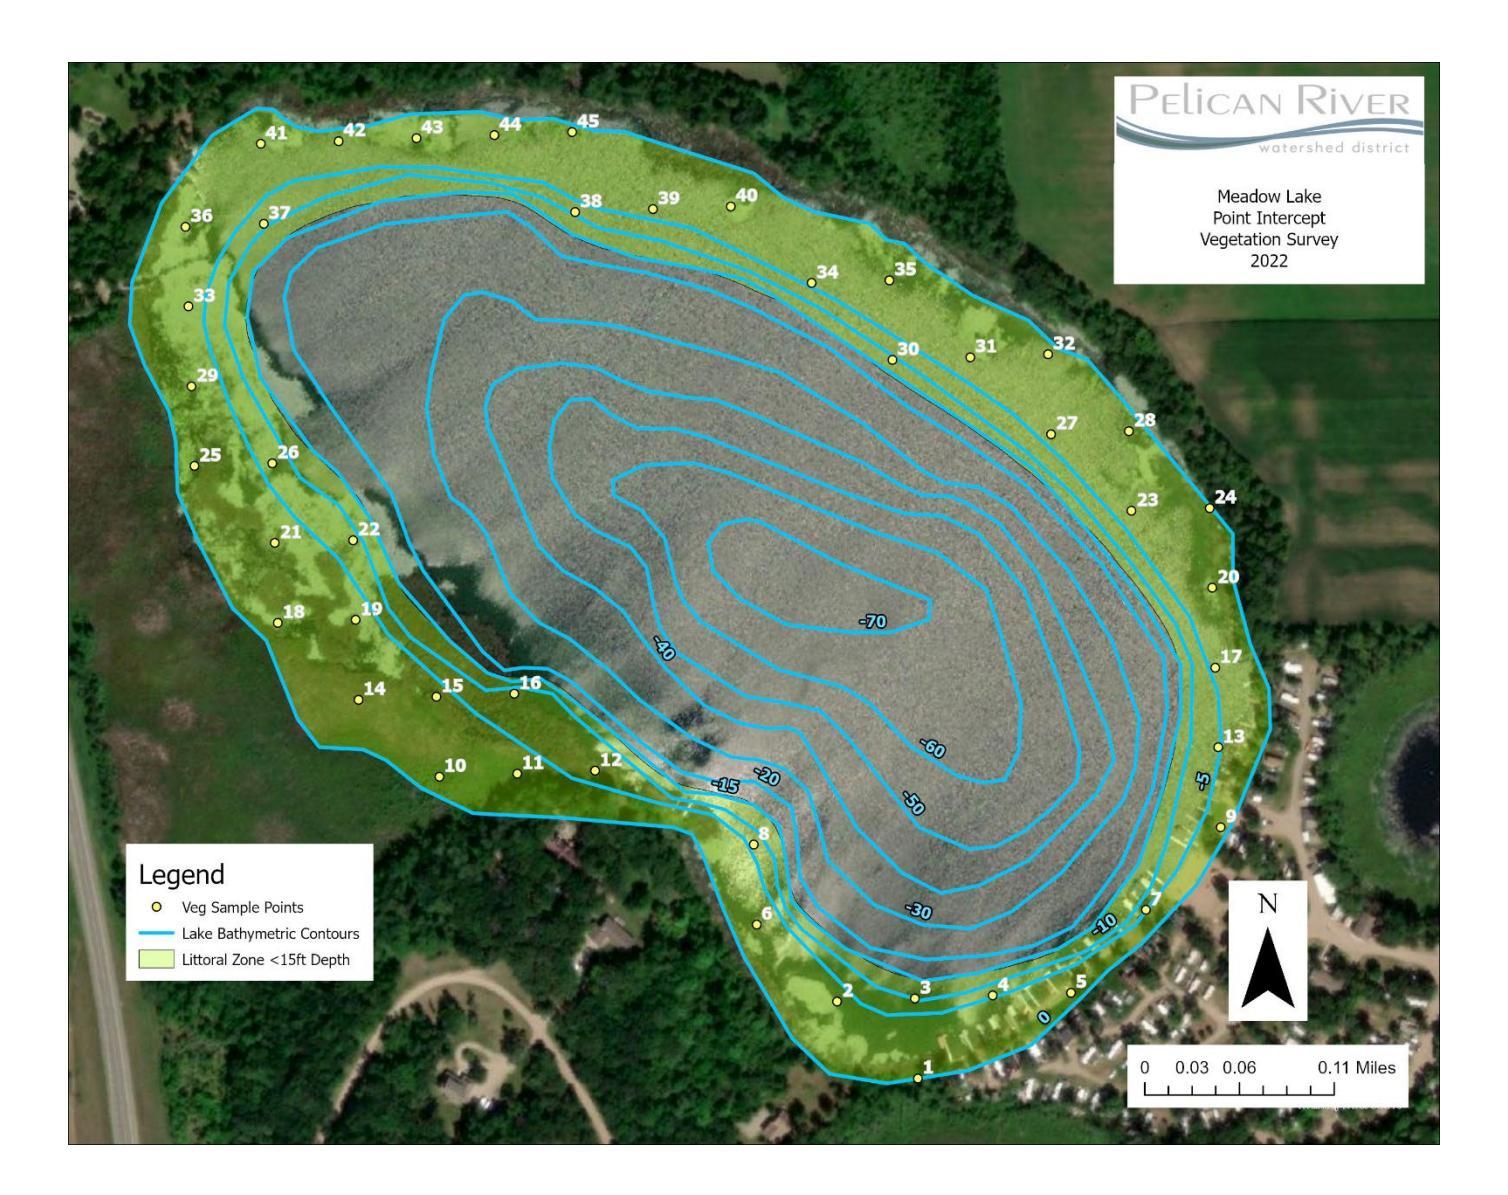
Figure 1 – Point-intercept Survey Grid. Point-intercept survey grid for Meadow Lake, Becker County (EQuIS# 03-0371-00-201). A total of 45 points were surveyed in 2022 at 72 meters apart.

PRWD surveyors used a point-intercept survey method developed by John Madsen in "Aquatic Plant Control Technical Note MI-02, 1999" during the 2022 Survey. Points were placed 72 meters apart using a Geographic Information System (GIS), comprising of 44 points on a grid (Figure 1). Plant samples were collected by throwing and dragging a double-sided rake along the lake bottom at each point. All plant taxa (submerged, floating-leaf, emergent and free floating) were recorded to species or genera during the survey following Skawinski (2018). Plant samples were assessed on the boat to determine species presence/absence and abundance. The abundance rake rating are as follows: 1: sparse, 2: common/ frequent/ occasional, and 3: abundant/matted (Table 3). Frequencies of occurrence percentages (i.e., how often a plant species was sampled in the lake) were calculated based on the littoral zone.

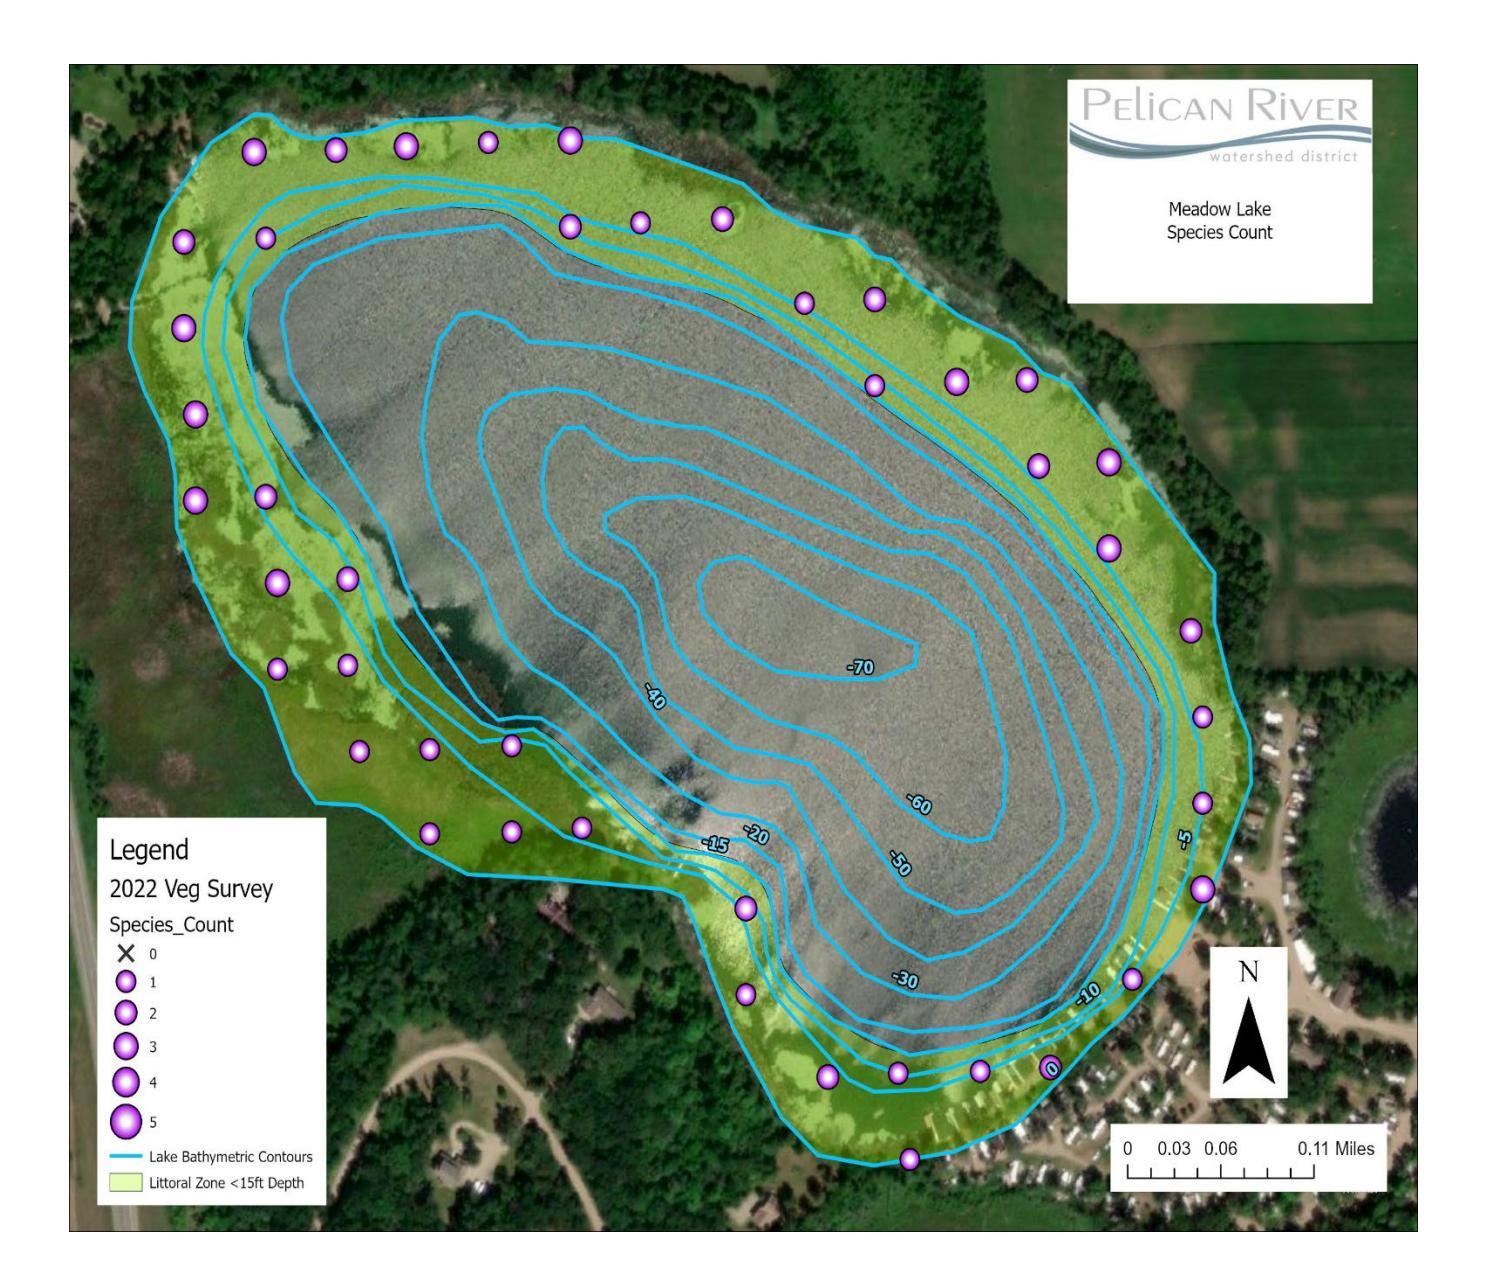
Figure 2 – Species Richness Distribution. Number of species at each site from the 2022 point-intercept survey in Meadow Lake, Becker County (EQuIS# 03-0371-00-201). Densities ranged from 0 to 5 at each point, with a 5 indicating the richness in species presence and 0 indicating no species.

Meadow Lake has an average of four species per sampling site. Figure 2 displays the spatial distribution and species richness (# of species per sample point) of all native species from the 2022 point-intercept survey.

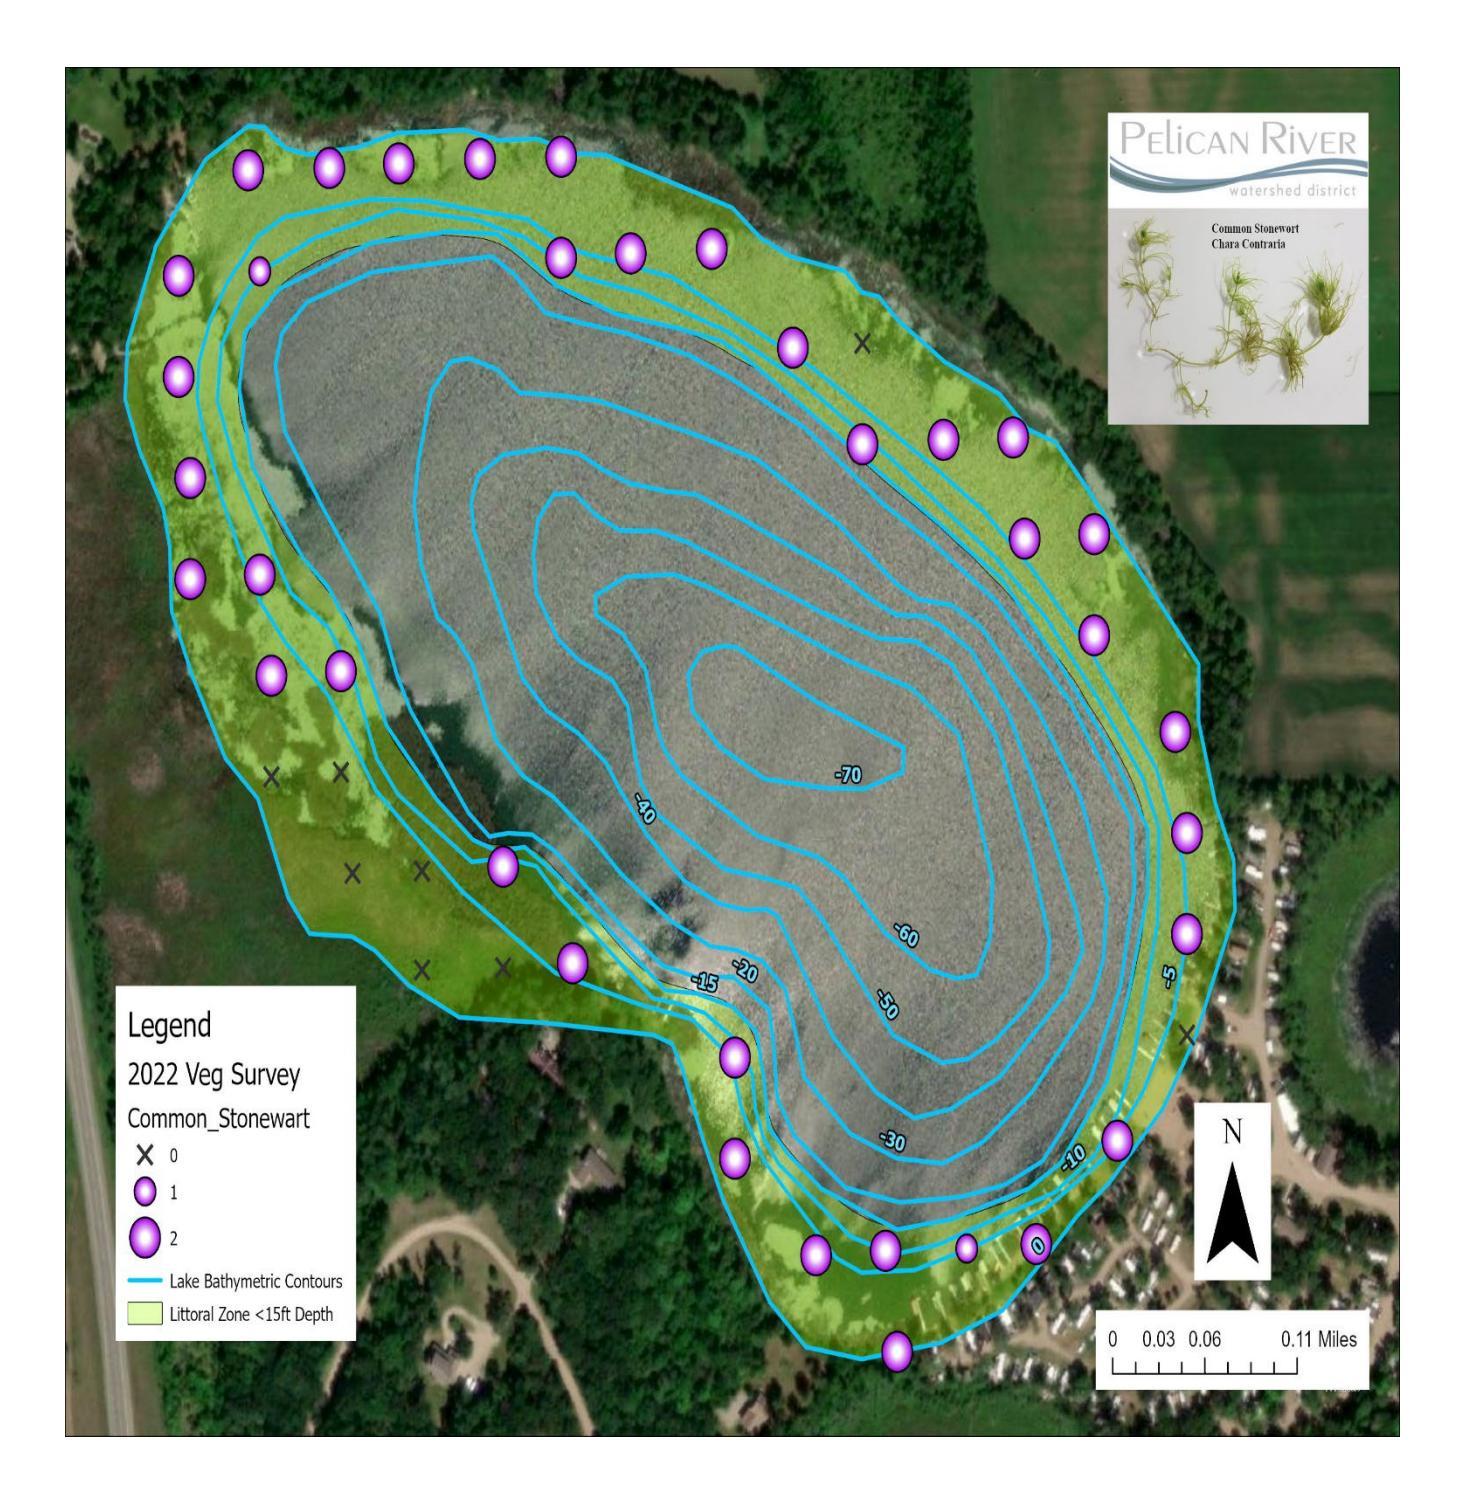
Figure 3 – Common Stonewort Distribution. Plant distribution from the 2022 point-intercept survey for Common Stonewort in intercepts Meadow Lake, Becker County (EQuIS# 03-0371-00-201). Densities ranged from 0 to 2 at each point, with a 2 indicating dense plant presence and 0 indicating no plants.

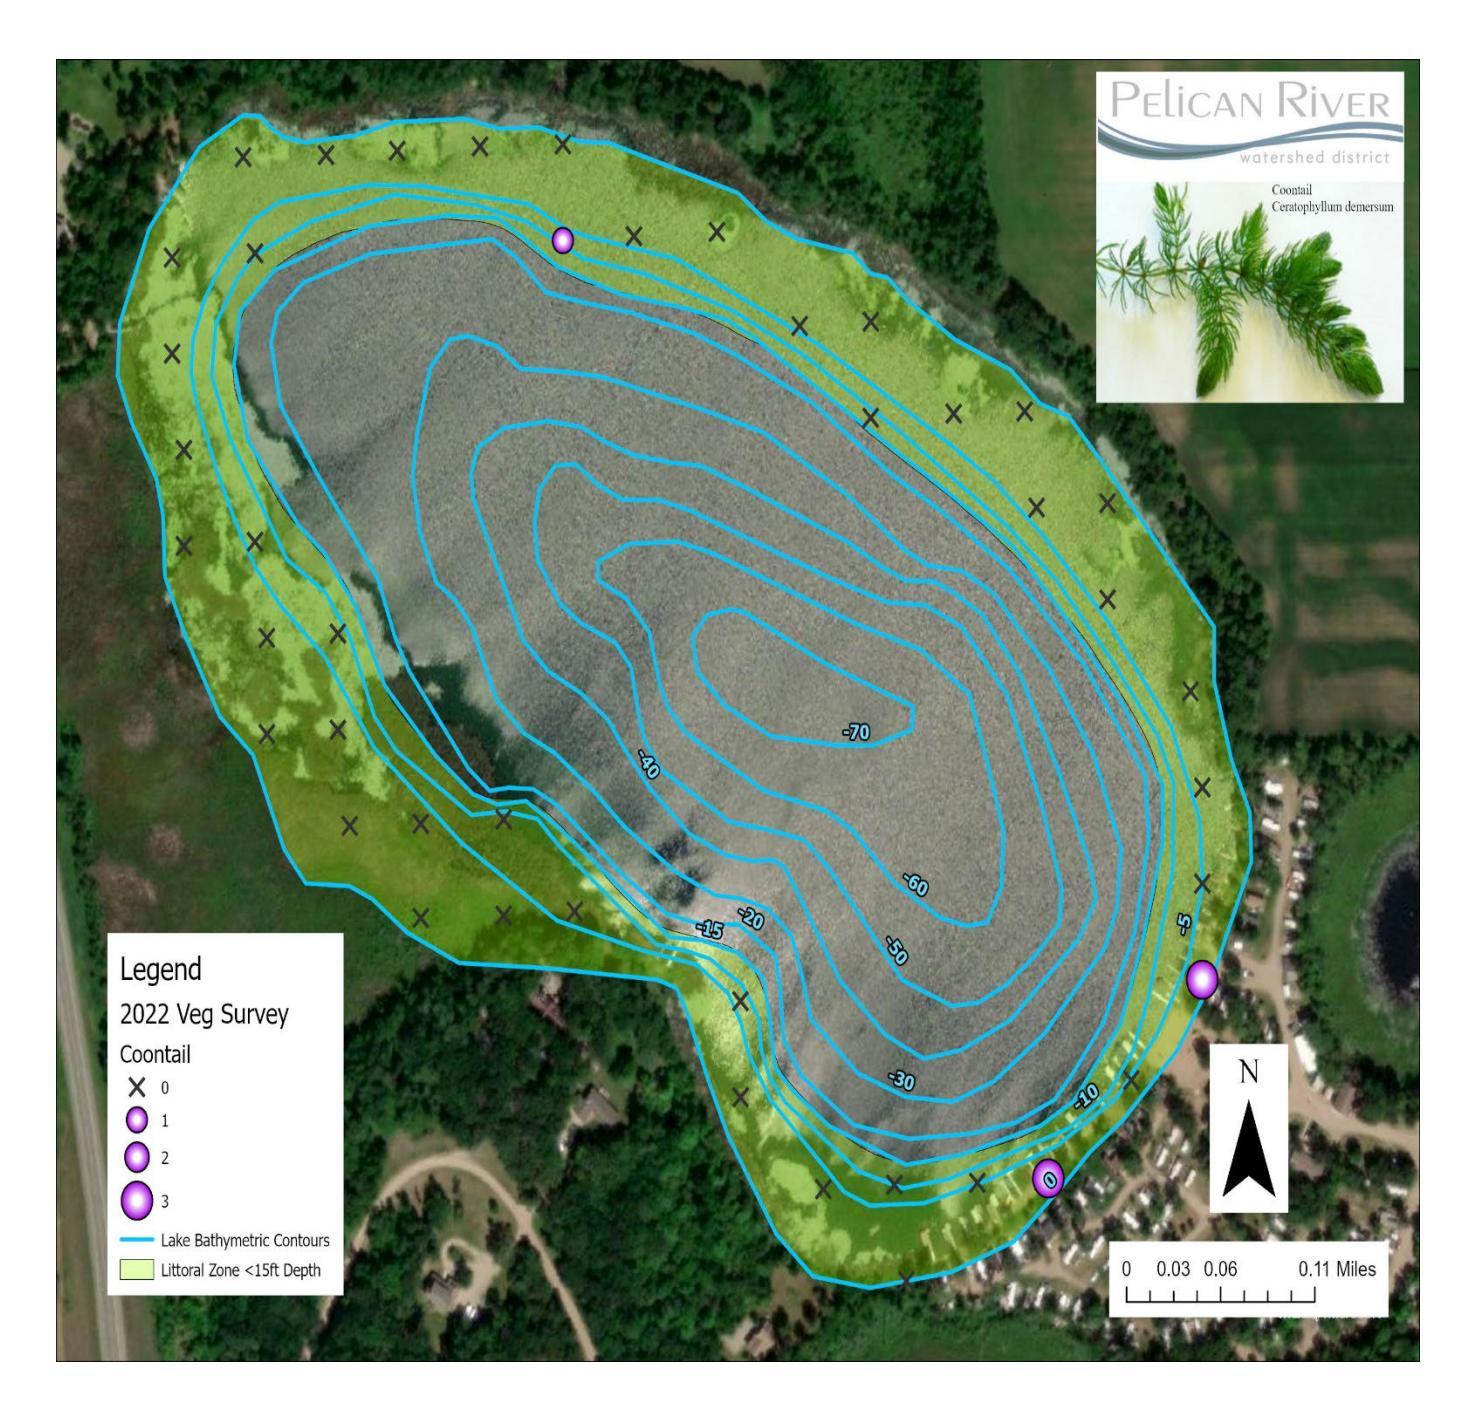
Figure 4 – Coontail Distribution. Plant distribution from the 2022 point-intercept survey for Coontail in intercepts Meadow Lake, Becker County (EQuIS# 03-0371-00-201). Densities ranged from 0 to 3 at each point, with a 3 indicating dense plant presence and 0 indicating no plants.

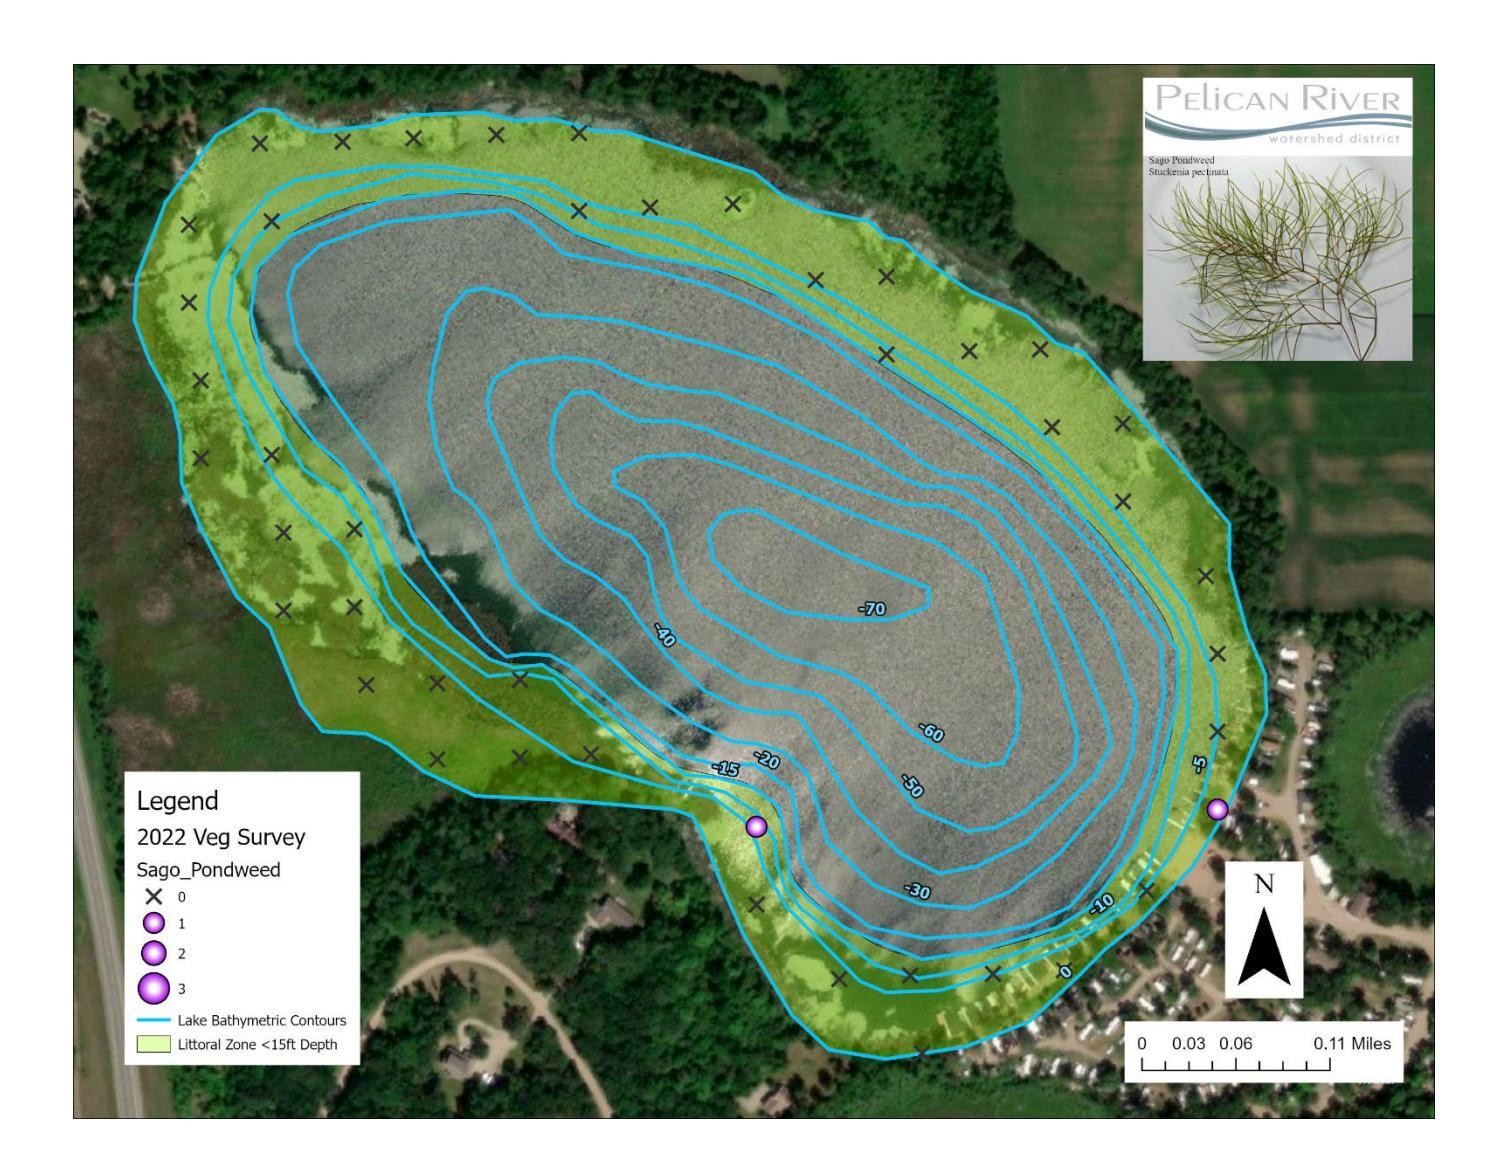
Figure 5 – Sago Pondweed Distribution. Plant distribution from the 2022 point-intercept survey for Sago Pondweed in intercepts Meadow Lake, Becker County (EQuIS# 03-0371-00-201). Densities ranged from 0 to 3 at each point, with a 3 indicating dense plant presence and 0 indicating no plants.

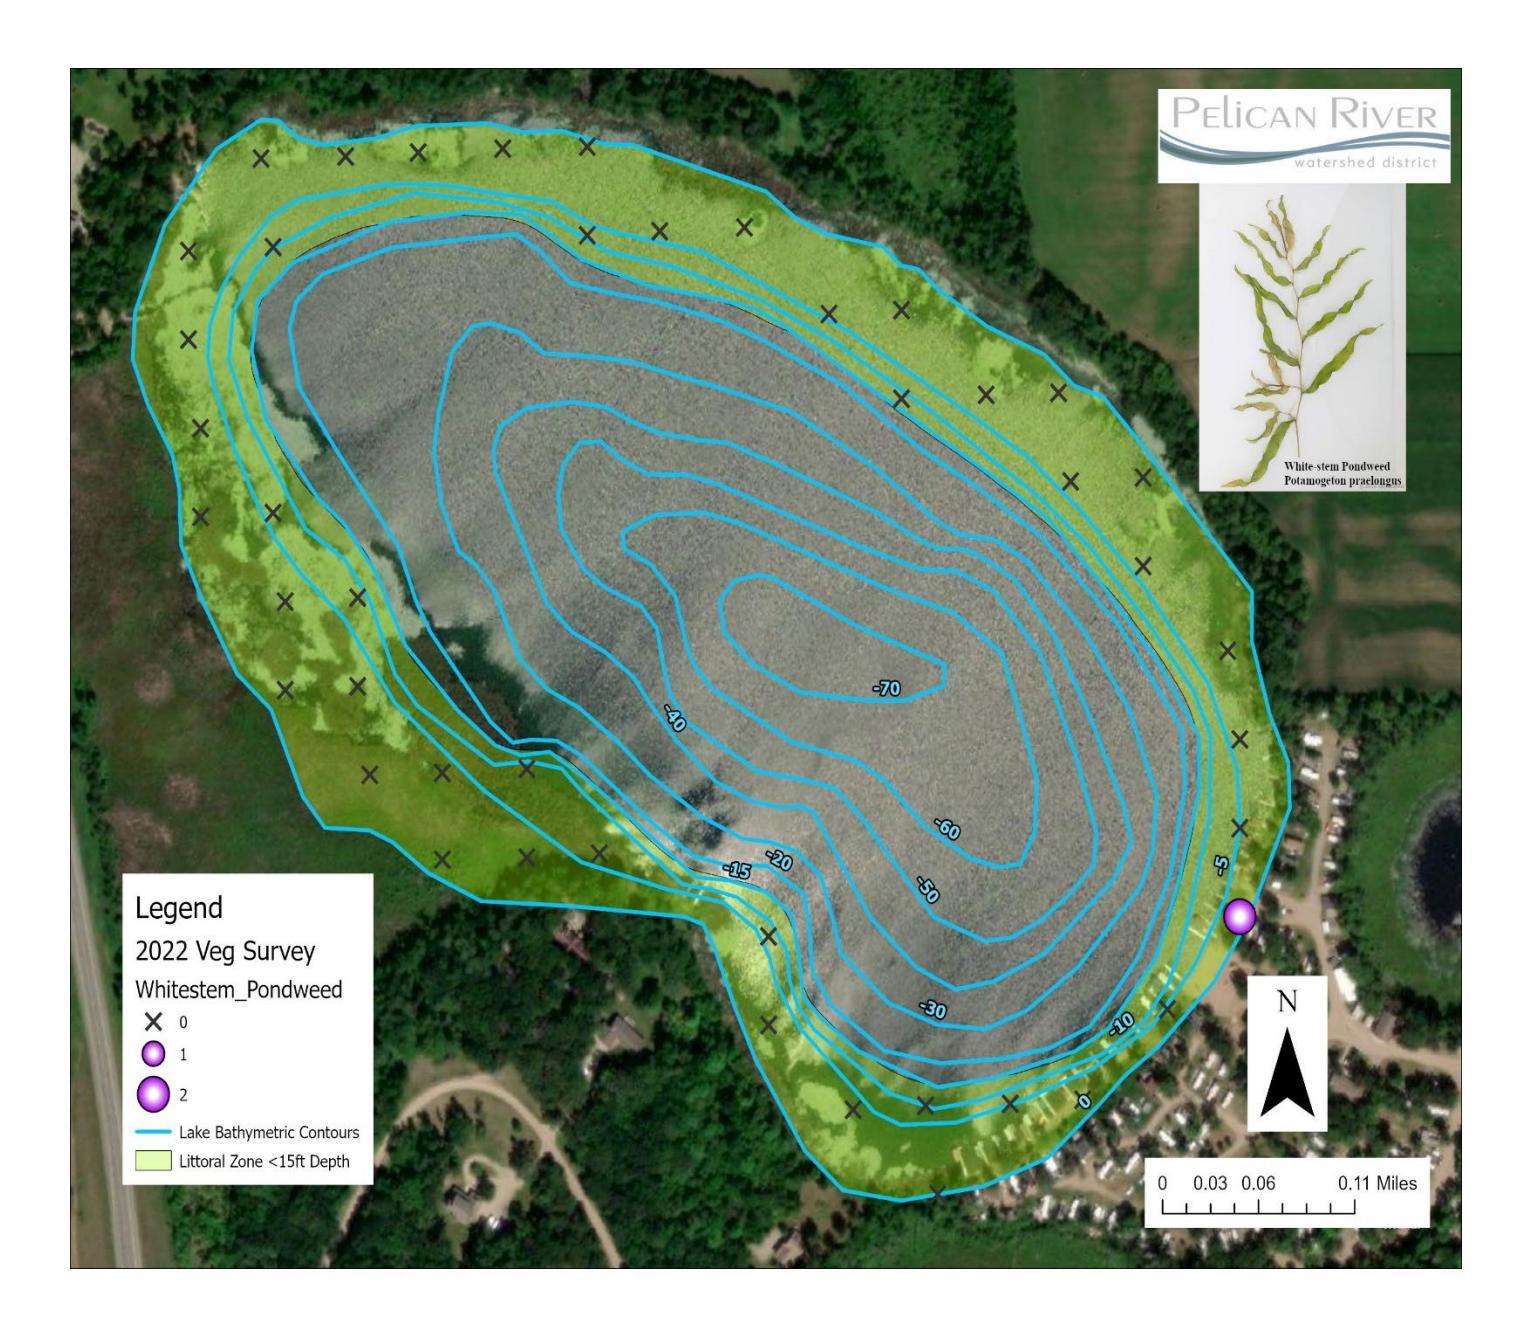
Figure 6 – White-stem Pondweed Plant distribution from the 2022 point-intercept survey for White-stem Pondweed in intercepts Meadow Lake, Becker County (EQuIS# 03-0371-00-201). Densities ranged from 0 to 2 at each point, with a 2 indicating dense plant presence and 0 indicating no plants.

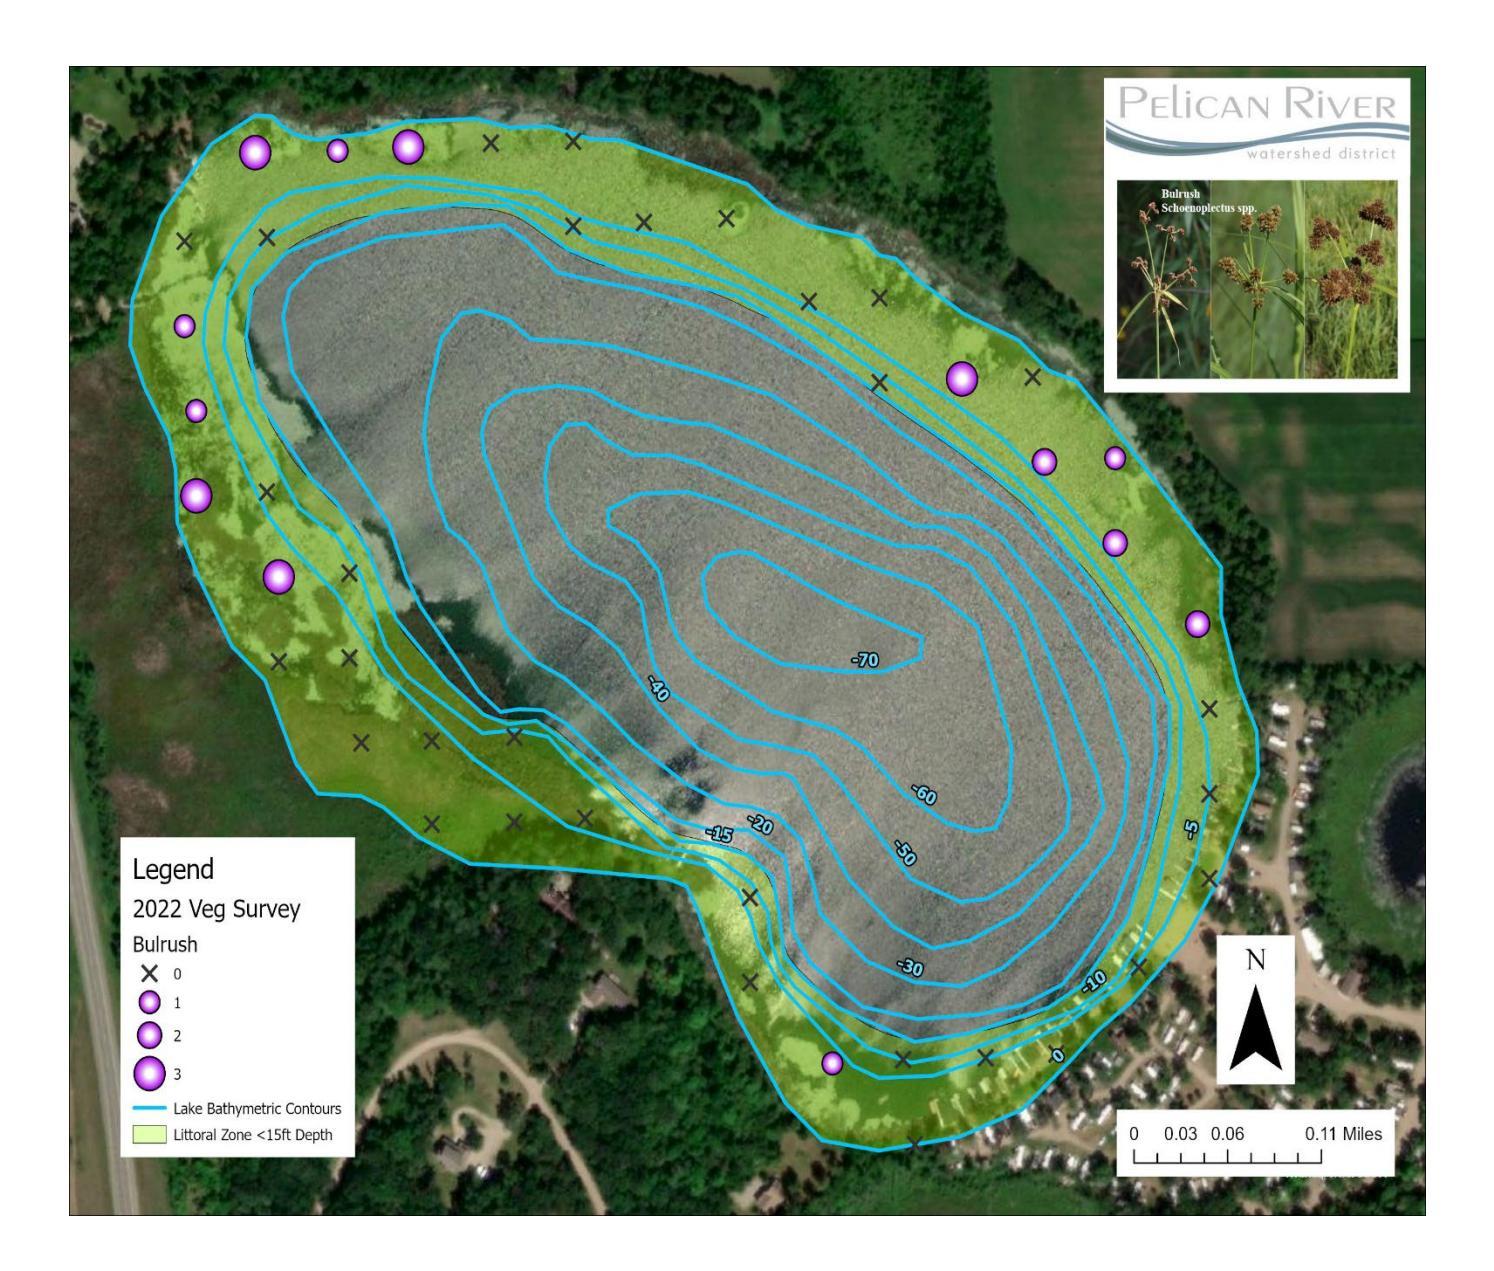
Figure 7 – Bulrush Distribution. Plant distribution from the 2022 point-intercept survey for Bulrush in intercepts Meadow Lake, Becker County (EQuIS# 03-0371-00-201). Densities ranged from 0 to 3 at each point, with a 3 indicating dense plant presence and 0 indicating no plants.

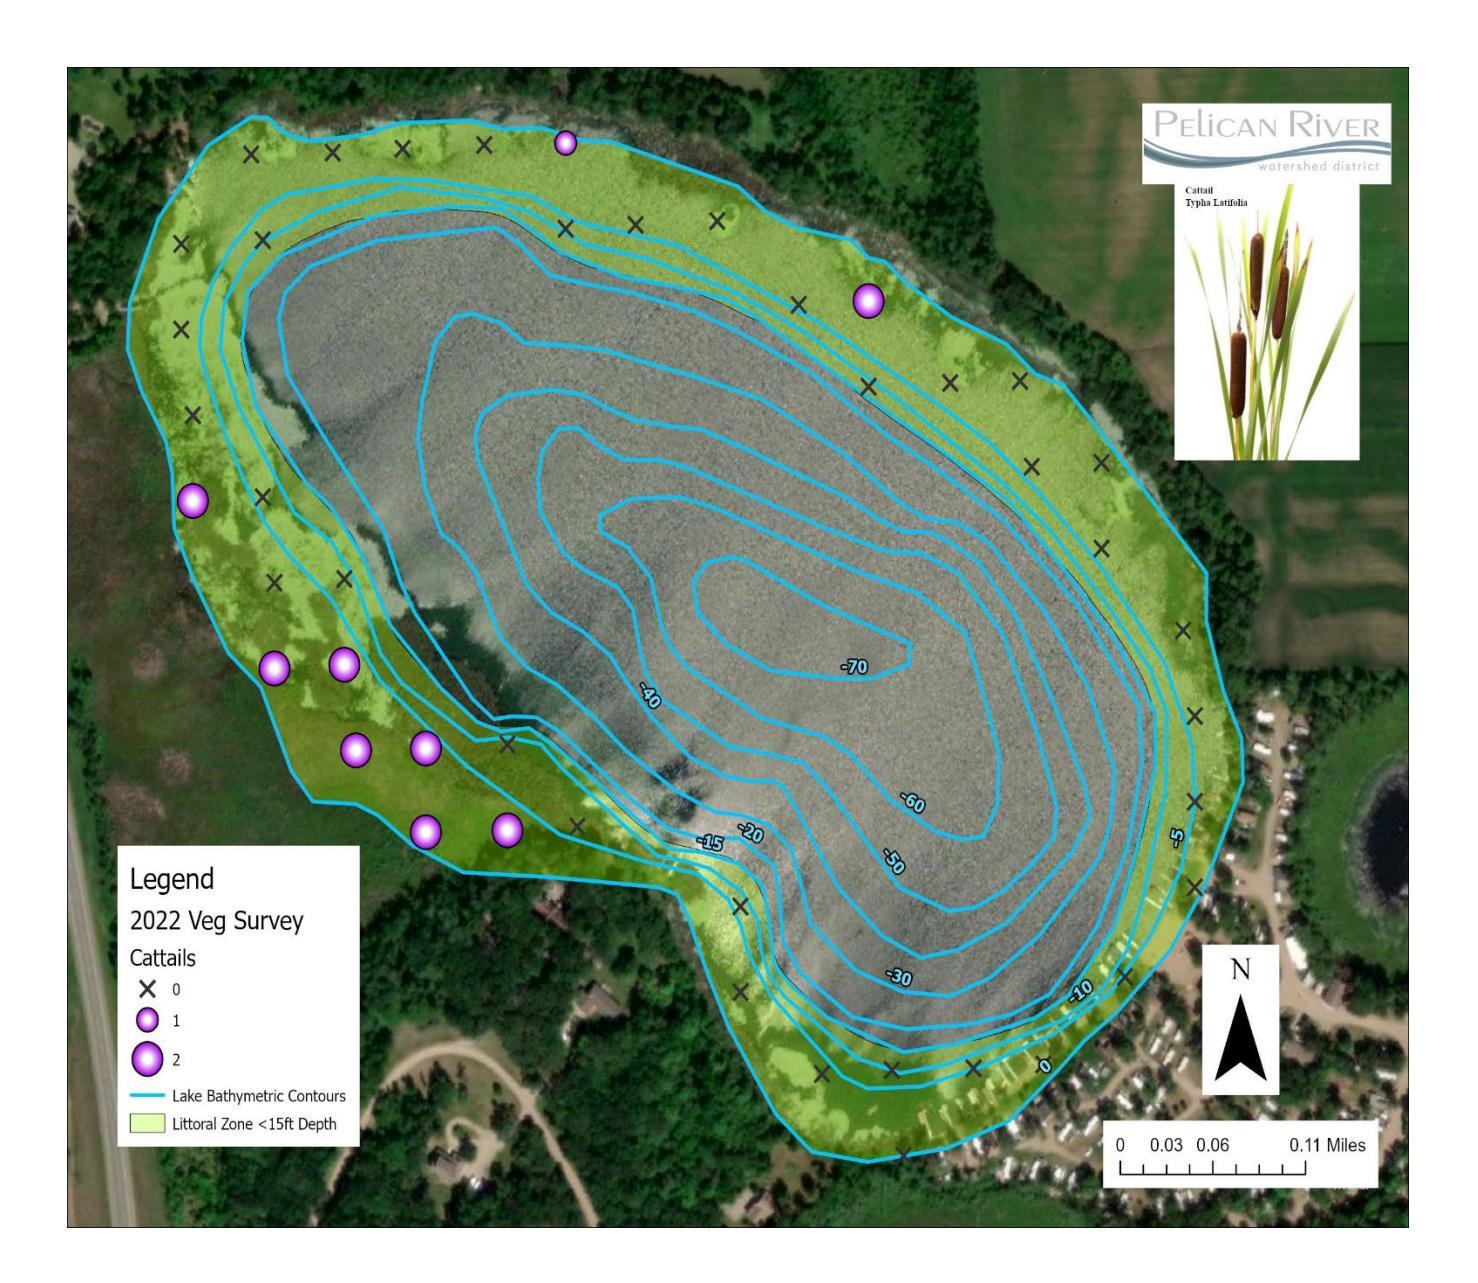
Figure 8 – Cattail Distribution. Plant distribution from the 2022 point-intercept survey for Cattail in intercepts Meadow Lake, Becker County (EQuIS# 03-0371-00-201). Densities ranged from 0 to 2 at each point, with a 2 indicating dense plant presence and 0 indicating no plants.

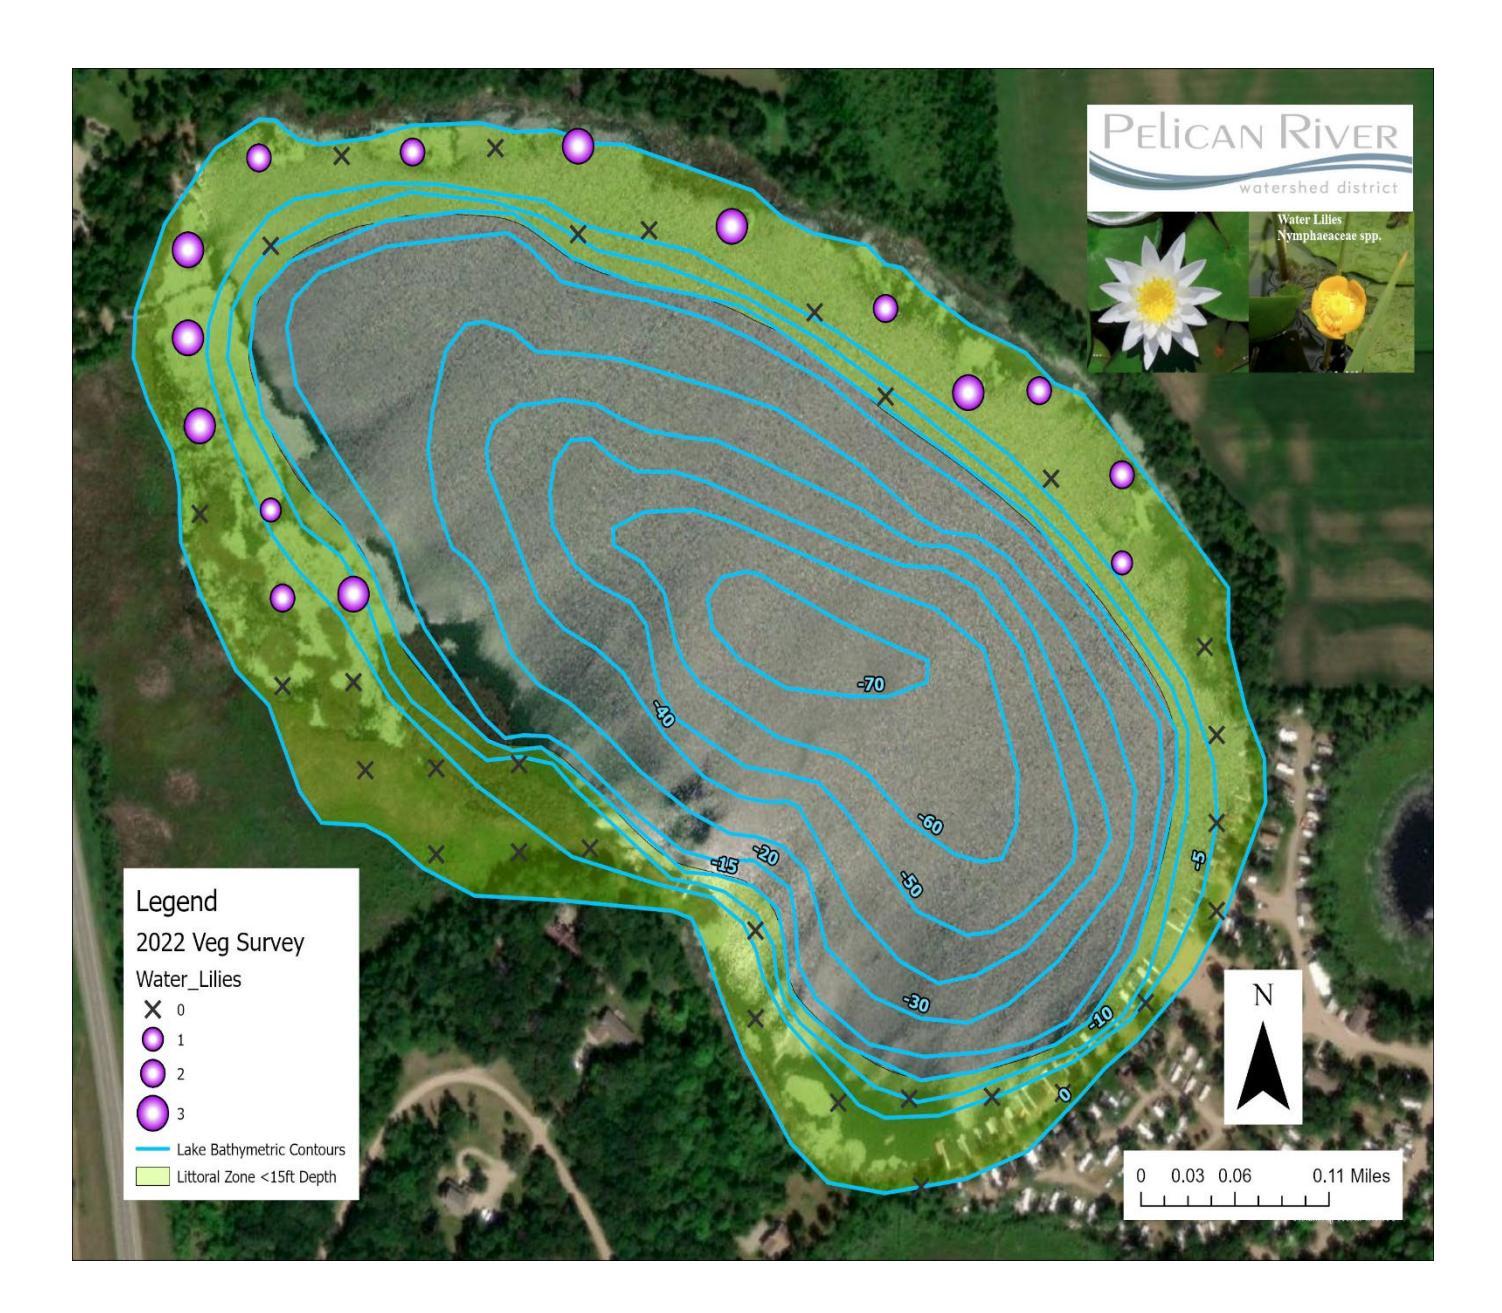
Figure 9 – Water Lilies Distribution. Plant distribution from the 2022 point-intercept survey for Water Lilies in intercepts Meadow Lake, Becker County (EQuIS# 03-0371-00-201). Densities ranged from 0 to 3 at each point, with a 3 indicating dense plant presence and 0 indicating no plants.
