# BRANDY/WINE WATER MANAGEMENT AREA

## LAKE WATER QUALITY NUMBERS 2023

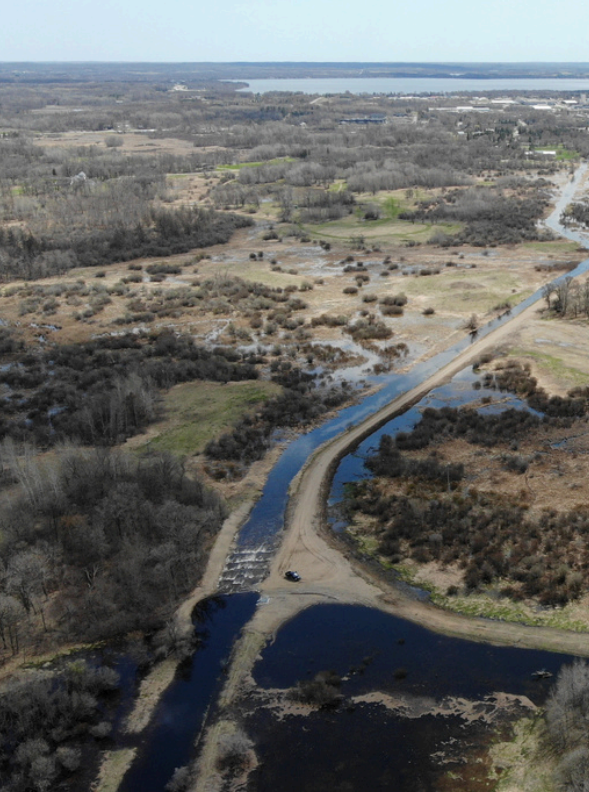
In the 1970's, the Rice Lake Wetland, was identified as the primary source and contributor of "legacy" phosphorus loading to Big Detroit. To address this issue, the wetland was restored in 2022 (see photo on the right with the construction of rock arch rapids to raise the wetland water level and to allow for fish passage). This wetland is located between Little Floyd Lake and HWY 34. 2023 monitoring results showed a decrease in phosphorus from the wetland to the Pelican River from previous years data.

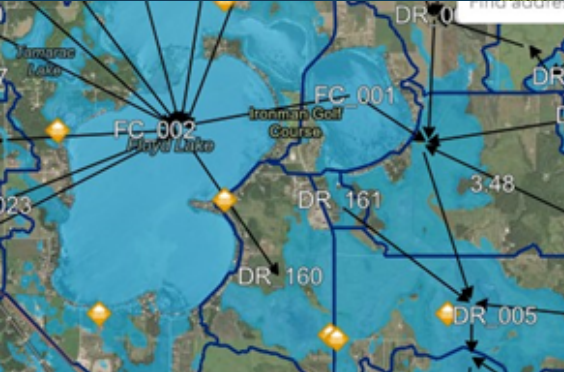
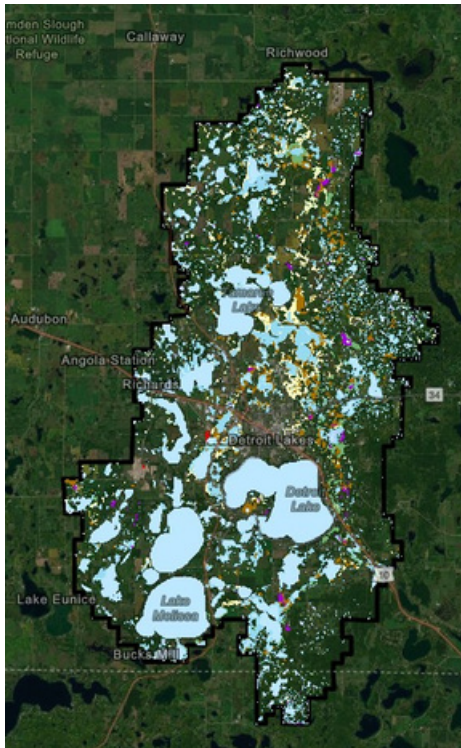
PRWD is completing the FEMA Flood Mitigation project in 2024. A Hydrologic & Hydraulic (H&H) model map was developed to identify flood prone areas. This information will assist with developing future projects to reduce flood risk.

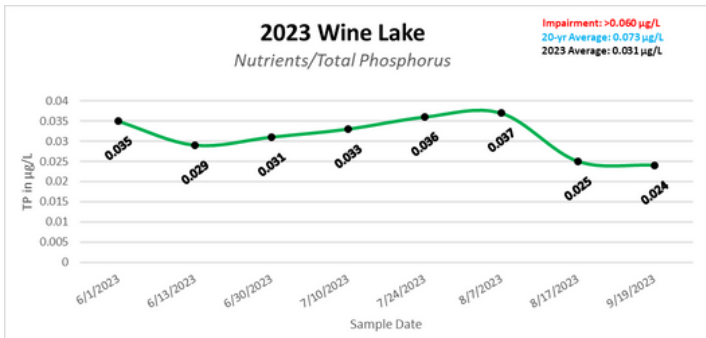
### TOTAL PHOSPHORUS BY TEST DATE

WINE (Shallow Lake)	2023 Average	20 Year Average	MNPCA Lake Standards
Total Phosphorus (TP)	0.031 ug/L	0.073 ug/L	> 0.060 ug/L
Chlorophyll-a (Chl-a)	5.51 ug/L	18.48 ug/L	> 20 ug/L
Secchi depth	5 feet	3.5 feet	< 3.3 feet

**Phosphates** are chemicals that enter waterways from both natural and human caused sources. Phosphates become detrimental when they over-fertilize aquatic plants and increase the rate of natural eutrophication. Eutrophication results in an increase in the carbon content and the amount of "mucky" or organic-laden sediments. This in turn leads to nuisance conditions such as algal growth.

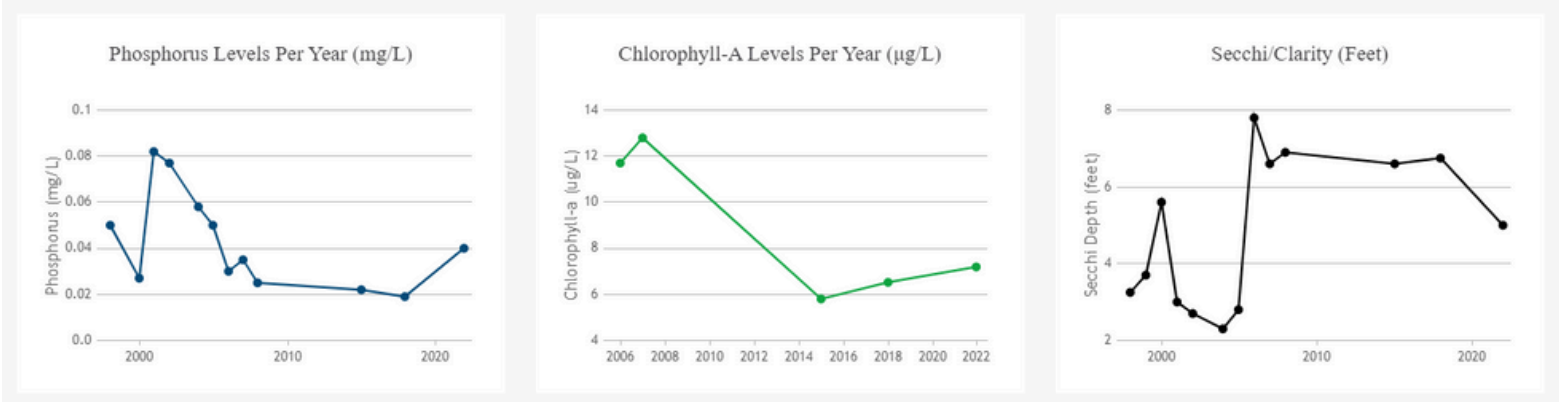
### BRANDY

Water quality testing for the Brandy/Wine WMA lakes is performed according to our 2020-2030 Monitoring plan. Brandy Lake was last tested in 2021 and scheduled for monitoring in 2027. For more detailed information on historical water monitoring in this area, please see the 'Our Water' Section of our website at [www.prwd.org](http://www.prwd.org).

**Phosphates** are chemicals that enter waterways from both natural and human caused sources. Phosphates become detrimental when they over-fertilize aquatic plants and increase the rate of natural eutrophication. Eutrophication results in an increase in the carbon content and the amount of "mucky" or organic-laden sediments. This in turn leads to nuisance conditions such as algal growth.

**Chlorophyll-a** is a naturally occurring compound found in all algae. Measuring Chlorophyll-a concentration in lake water is a reasonable estimation of the presence or absence of algal growth in a lake system. An increase in the biomass of algae in a body of water can result in decreased levels of dissolved oxygen, which is needed by many aquatic animals to survive.

A **Secchi** depth measurement is a visual measure of water clarity through water column. Measuring clarity of the water is another test of eutrophication of a water body.

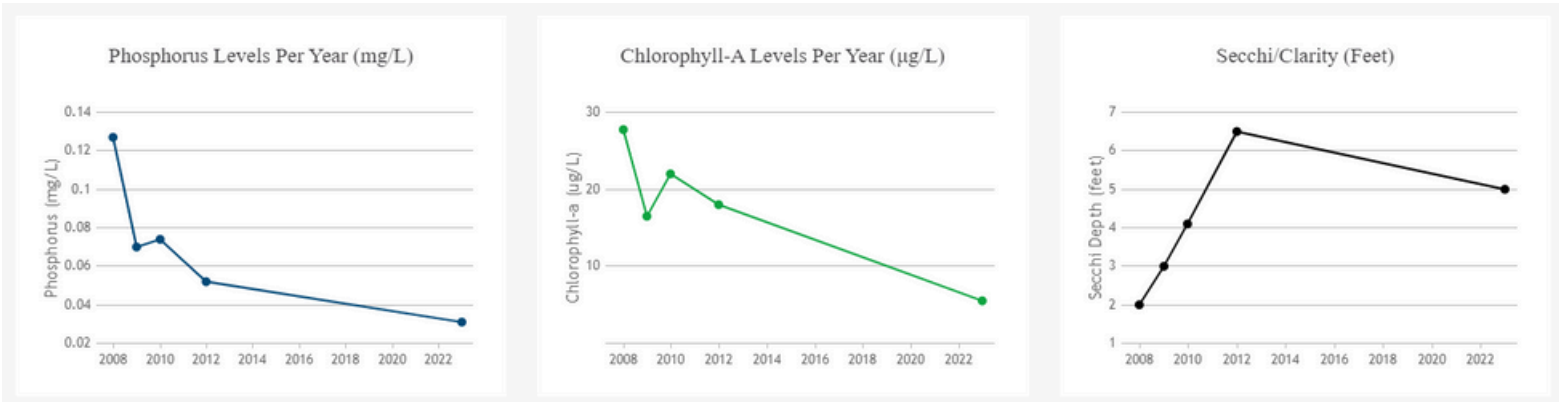
### WINE

The Brandy/Wine WMA contains about 3,000 acres. Four named lakes exist within this area; Brandy, Wine, Oak, and Oar, however several small unnamed lakes and wetlands also dot the WMA. Land in the Brandy WMA is mostly used for cultivated crops or pasture, and shoreline along the lakes is mostly undeveloped. This is partly because the shallow nature of these lakes makes them ill-suited for recreation. Approximately 10 percent of the WMA is owned by the U.S. Fish and Wildlife Service. Brandy Lake historically suffered from poor water quality from the former Becker County Landfill but has improved through remediation. Wine Lake is impaired due to excess nutrients, and the District will work with MPCA to develop a TMDL.

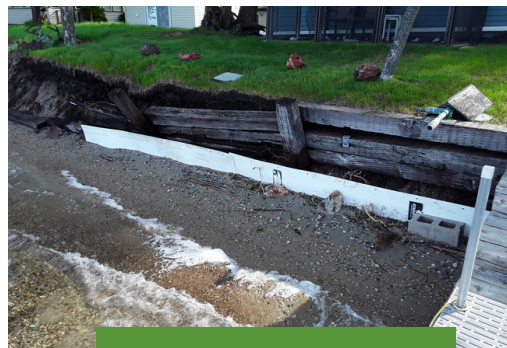
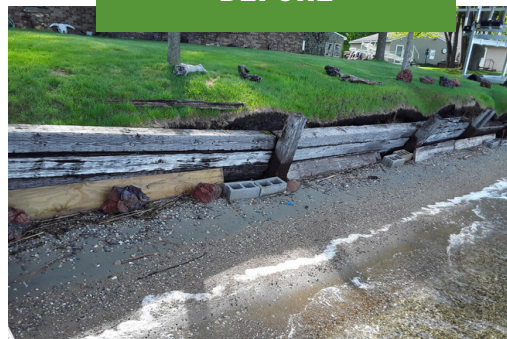
BEFORE

This property in 2022 utilizing Watershed Best Management Processes (BMP) funding. The homeowner removed the old railroad tie retaining wall and replaced with erosion controlling native plants and a small toe of riprap. PRWD reimbursed the homeowner \$500 for plants, mulch and erosion control materials.

- Plants hold, especially native plants. Plants put down roots which will protect the shore against fluctuating water levels.
- The gentle slope lessens the risk for ice push damage on the shore
- Shrubs and trees provide habitat for wildlife.
