# FOX/MUNSON WATER MANAGEMENT AREA

# DISTRICT-WIDE PROJECTS

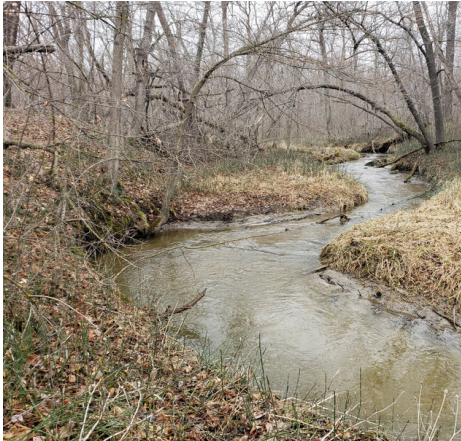
The District was awarded a federal 319 grant to address excessive sediment and phosphorus in the Campbell Creek sub-watershed area. In early 2024, the project area workplan was approved by the Environmental Protection Agency to construct: (1) 3,750 linear feet of streambank stabilization above and below Becker County HWY 149 using a variety of practices, (2) a multi-stage drainage and control structure near Campbell Lake, and (3) a grade stabilization project in a nearby farm field. The planning, design, and engineering work is starting this summer, with construction to occur in 2025 and 2026 for an estimated cost of \$500,000. The grant will be matched using Otter Tail 1W1P grant and District funds.

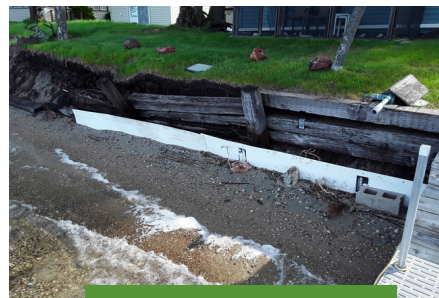
BEFORE

This property in 2022 utilizing Watershed Best Management Processes (BMP) funding. The homeowner removed the old railroad tie retaining wall and replaced with erosion controlling native plants and a small toe of riprap. PRWD reimbursed the homeowner \$500 for plants, mulch and erosion control materials.
